# Drying Out a Crawlspace

by Terry Brennan

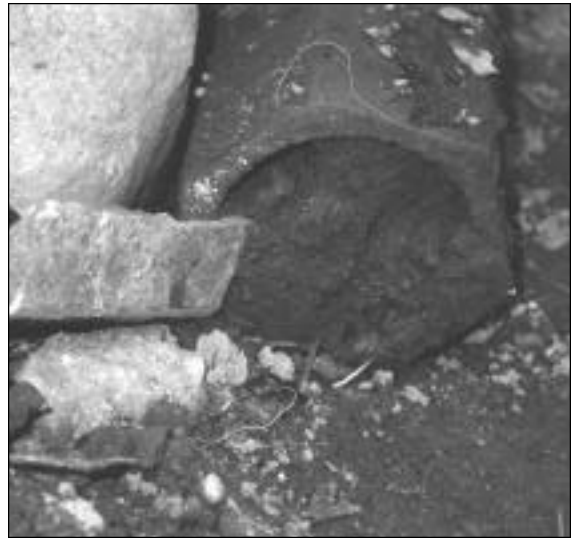
The existing clay drain tiles were found to be completely filled with soil.

1. Install or rehabilitate the existing exterior perimeter drainage.
2. Insulate and air seal the existing crawlspace wall.
3. Air seal the return ductwork in the crawlspace and the floor deck between the living space and the crawlspace.
4. Close off the supply ducts that open into the crawlspace.
5. Install an exhaust fan to depressurize the crawlspace.

- I installed an exhaust fan in the crawlspace during the first visit, and within a week made it a permanent installation.
- I sealed the crawlspace vents. The crawlspace was running about 2 Pa negative. A thorough cleaning of all the soft materials in the occupied space—including books and carpets—was undertaken to remove accumulated allergens from the household. This was a critical step in alleviating the occupant's symptoms.
- The exterior of the foundation was excavated by hand to conserve flowers and shrubs. The existing clay tiles, which were used to channel water around the house in the original drainage system, were found to be completely filled with soil. Damp-proofing, insulation, and new drainage were installed (see Figure 1). The ductwork and penetrations through the floor were sealed.
