# Fixing Air Leakage in Connecticut Town Houses

*After energy improvements were made to some town houses, a second look revealed big opportunities for energy and money savings.*

by Courtney Moriarta

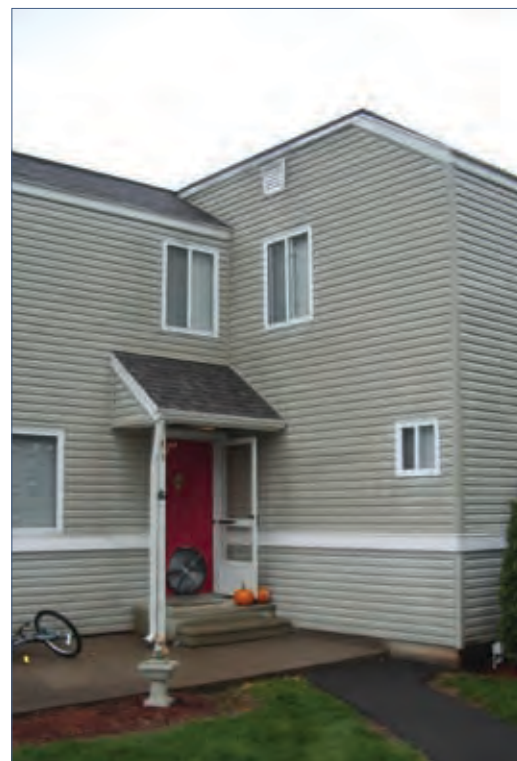
A blower door was set up in this typical townhouse unit. Testing indicated substantial leakage under the porch roof.

Blower door tests were conducted on a sample of these units. They were found to have an average air leakage rate of 1,700 CFM<sub>50</sub>. Based on the size of the units, the target CFM<sub>50</sub> for these apartments without adding mechanical ventilation is approximately 1,000. An air leakage rate of 1,700 CFM<sub>50</sub> is

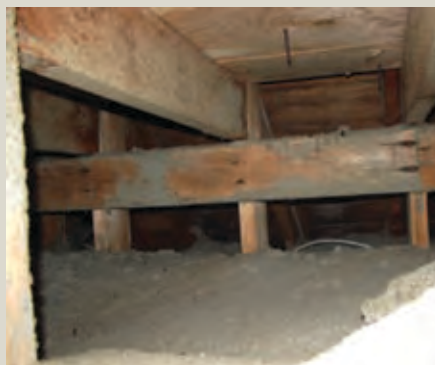
There is not much space to access the existing attic.

in an unoccupied unit. The attic space was very tight, with approximately 20 inches of clearance between the top of the ceiling joists and the bottom of the roof rafters. Additional cellulose insulation had been blown over the original insulation, making it more difficult to move through the attics. The observable air leakage paths in the attic were minimal. The top plates were already covered in a manner similar to that used in modular construction. There was a gap of approximately 2–3 inches around the plumbing vent stack that could be sealed, but SWA determined that to access the gap for sealing would be more trouble than it was worth. At this point, it looked as if not much air sealing could be done in the town house attics.

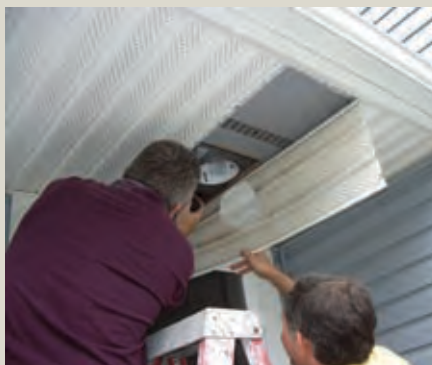
Workers open the porch roof for inspection.

To seal the leaks, each porch roof had to be opened up for access. A carpenter was hired to make temporary openings, and to close them up after the air sealing crew had done its work. The crew used rigid foam insulation and expandable foam sealant to seal each area. Blower door test results indicate that this work alone reduced envelope leakage by over 200 CFM<sub>50</sub> per unit. In addition, this work will protect the existing fiberglass wall insulation from windwashing, so it will now perform at its rated R-value.

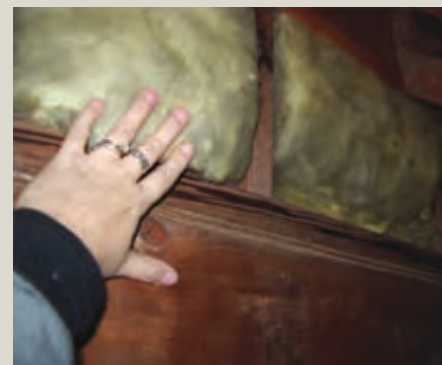
The porch roof connection has a gap in the wall sheathing.

The main entrance to the town house unit has a small porch roof above it. This porch roof is located directly below the hallway window seen in the infrared photo. When the perforated-vinyl soffit panel was removed to access the area above this porch roof, it was found that entire sections of sheathing, some as large as 3–4 square feet, were missing, leaving the fiberglass insulation in the walls directly exposed to outside air (see photos, p. 28). As the photos show, the insulation in these areas is discolored with dirt from years of air passing through it. This windwashing reduces the effective R-value of the insulation in the wall in addition to being a source of air leakage.
