# FLOOD TESTING GETS A REALITY CHECK

Although the structural damage to a home from flooding cannot always be prepared for, the use of flood-resistant materials can minimize the cost of rebuilding.

BY HESHMAT AGLAN AND ROBERT WENDT

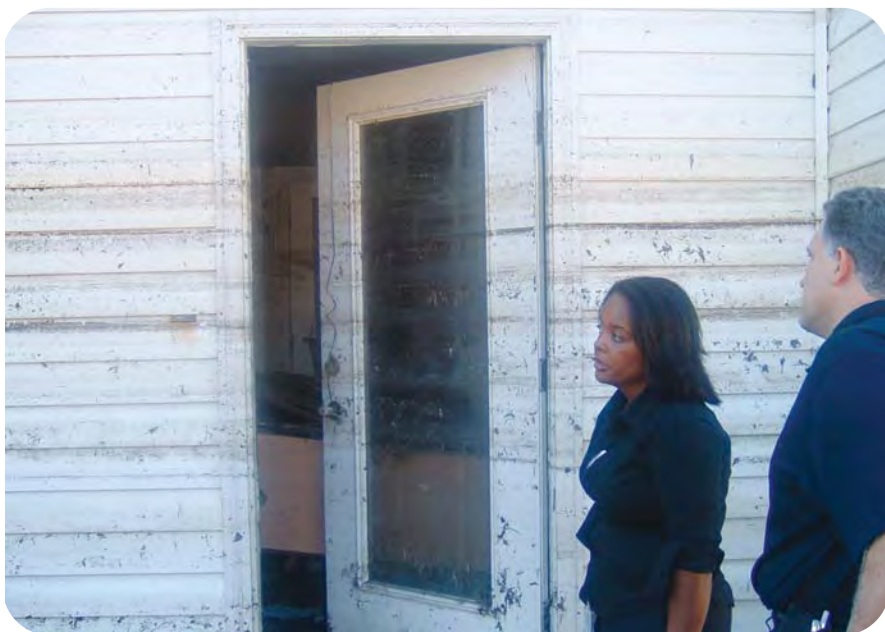
This homeowner and inspection team member are about to enter a flooded home. The flood level (scum lines) can be seen on the door and siding. Note the multiple distinct scum lines. These suggest that in this area draining occurred incrementally.

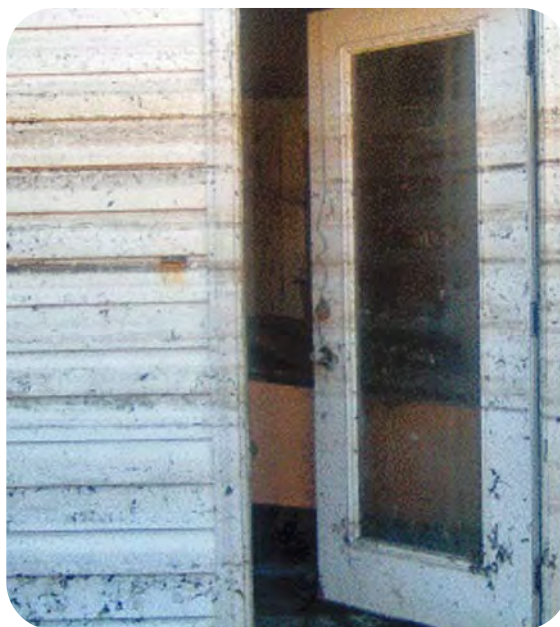
This is what a building exterior from a New Orleans home looked like after Katrina.

and doors (see photos). Similar debris remnants and staining can be seen on both units. The New Orleans home displays more staining, which is probably due to the longer flood duration and higher concentration of debris in the floodwater. Note that steel doors in both instances show minimal damage and appear to be able to be restored by washing.

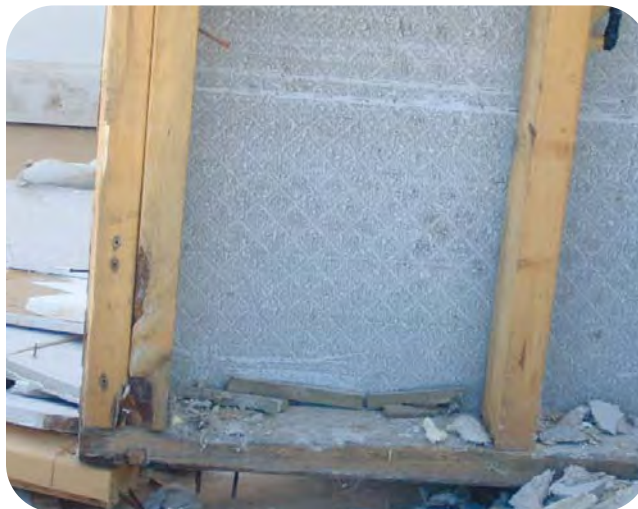
No mold or severe staining was observed in the TTF framing at autopsy, which occurred 15 months after the flood test.

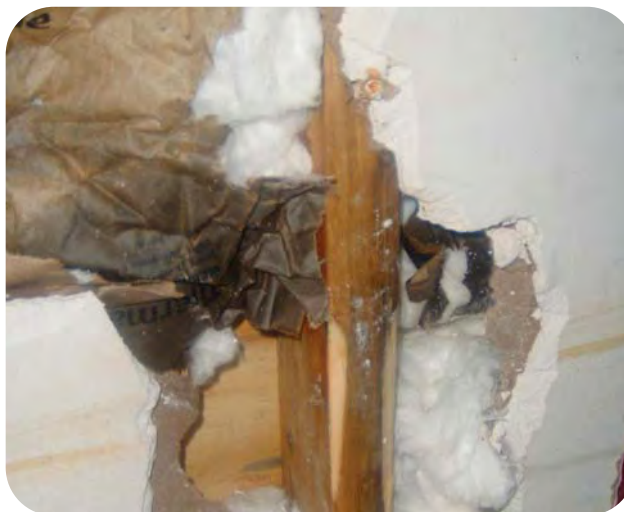
Inspection of these exterior, insulated wall cavities in a New Orleans home revealed no damage to the studs and plywood sheathing. The fiberglass insulation was also undamaged. However, moisture levels of adjacent materials were elevated. The back side of the gypsum wallboard showed no evidence of mold growth.
