# FURTHER WRESTLING WITH RECESSED-CAN LIGHTS

How do you air seal IC-rated light fixtures that aren't accessible from above? Do the air sealing from below.

by LARRY ARMANDA

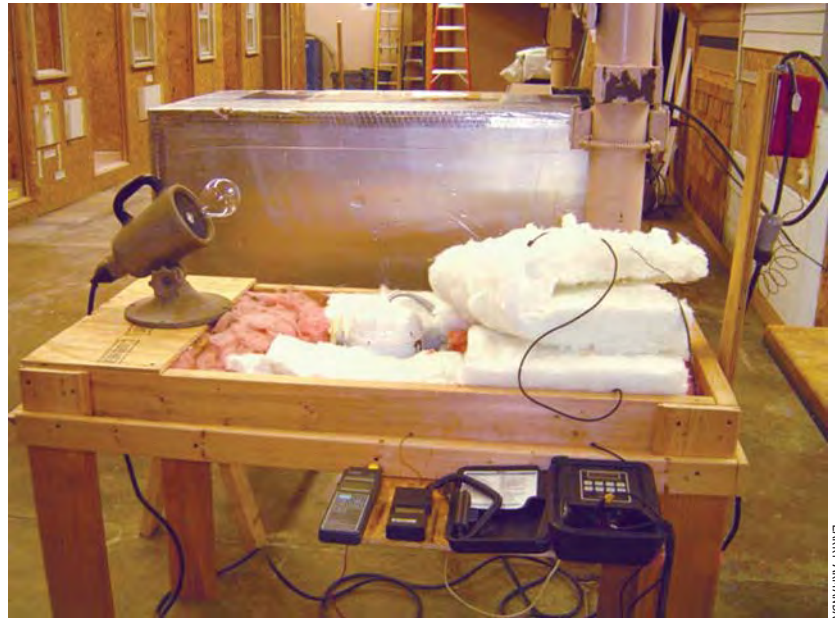
mockup (see photo above). I removed the 13 inch x 16 inch x 10 1/4 inch air-sealed drywall box from over the top of the fixture, attached a thermal sensor to the side of the fixture, and placed R-19 fiberglass batt insulation over and around the fixture. I placed a second sensor above the insulation to record the ambient temperature and then placed the original 28 inch x 53 inch x 24 1/2 inch box made with insulation board over the entire mockup. The inside of the insulated box was heated with a 300 watt lamp controlled by a Chromolox thermostat, in order to simulate a hot ambient attic air temperature of 140°F. All the tests were performed at this summer ambient air temperature. I disabled the thermal cutout switch on the fixtures before testing them.

This mockup was used to test recessed-can lights. The 300W lamp on the left was used to simulate an attic temperature of 140°F.
