# Kansas City's Water Heaters

Our programs in Kansas City replace between 50 and 100 water heaters a year for our low-income clients. As these pictures show, some of these water heaters are very dangerous.

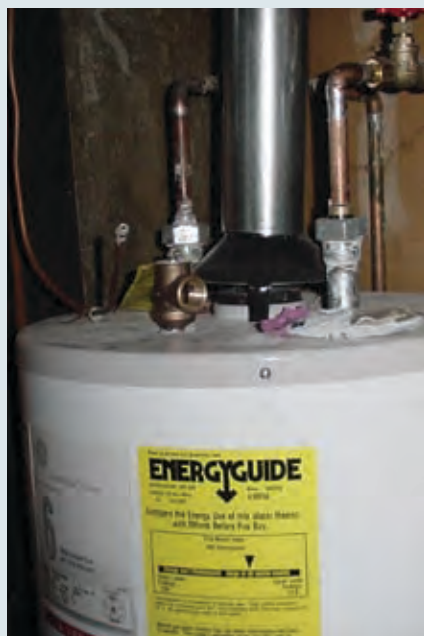
This photo shows a newly installed gas water heater before the overflow pipe was installed. Overflow pipes are very important; they safely divert hot water in case the pressure relief valve goes off. At this height, the scalding hot water could blow out onto a person's face.

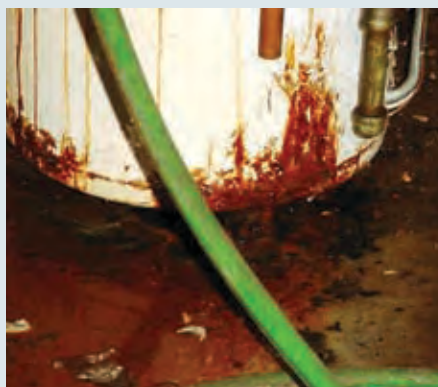
More rust and hot water leaking onto the floor.

These are all real situations, and all of these bad units were replaced. All of these pictures were taken by City of Kansas City, Missouri, employees Stephen Boniello, Rockie Henry, Richard Smith, Thomas Andrews, and myself. **H<sub>e</sub>**

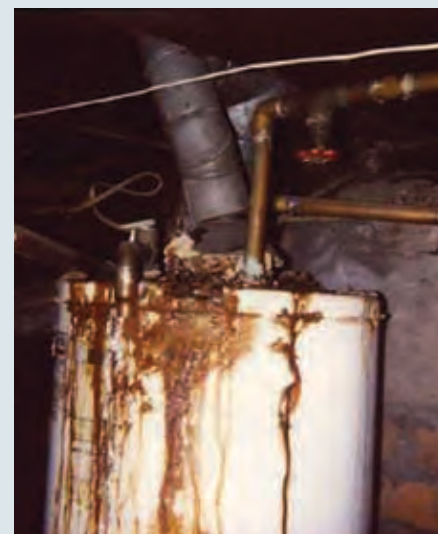
This is another plugged and rusty unit that the client continued to use.

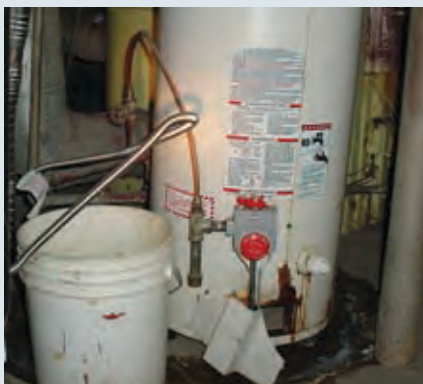
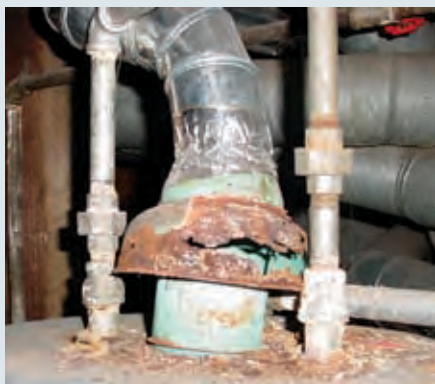
These two rusted-out water heaters were only a few years old.

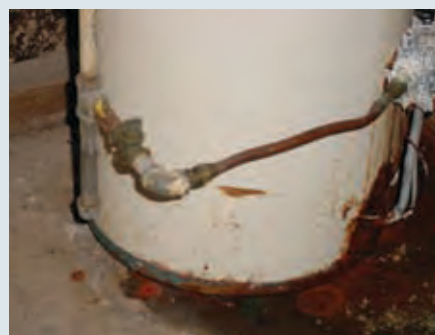
This water heater had a completely corroded gas valve, and water leaks rusted out the bottom.

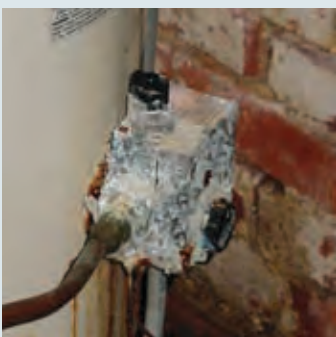
Here is a close-up of the corroded gas valve.

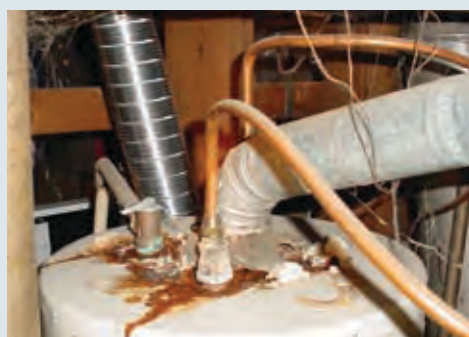
More top rot.

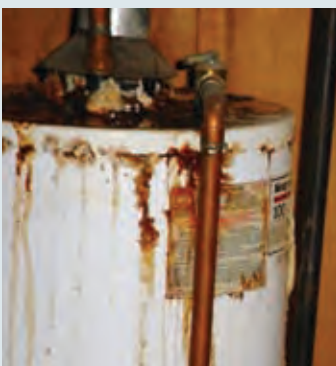
More rust and hot water leaking onto the floor.

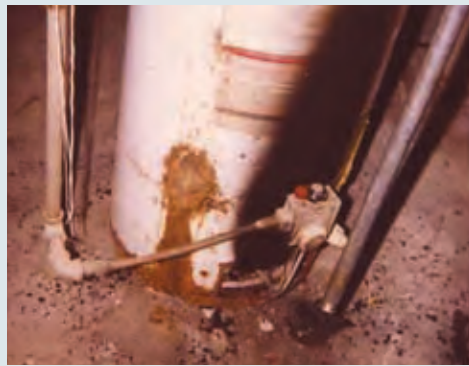
This is a unit with a potentially deadly problem. The black deposit on the side is caused by abundant CO leaking from around the gas valve.
