# Midconstruction LaHouse Meets Katrina and Rita

**LaHouse became an ironically timely and greatly needed exhibition of hazard-resistant, energy-efficient home-building systems.**

**by Claudette Reichel**

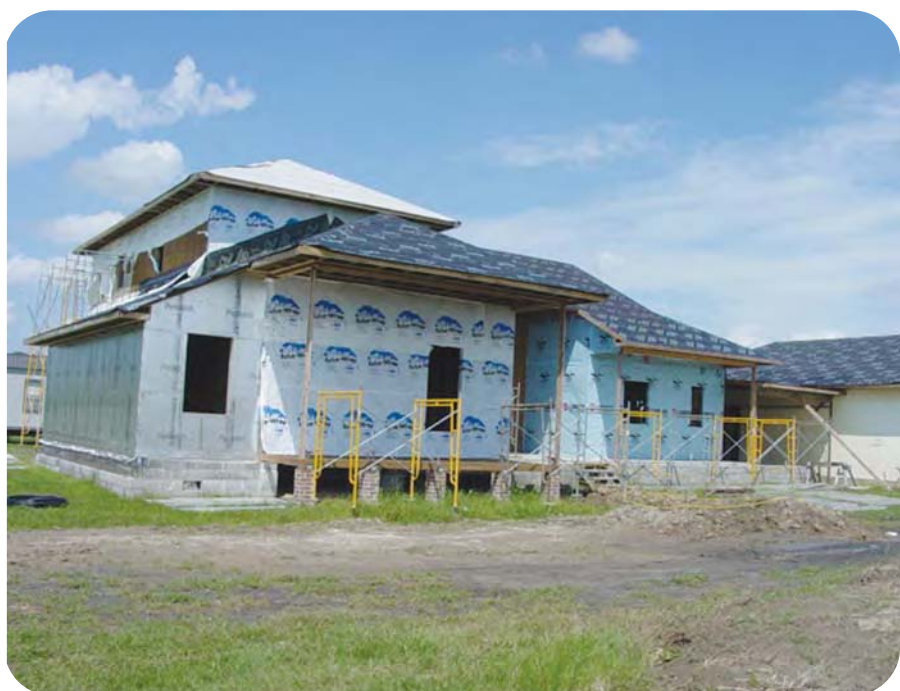
This rear view of LaHouse after Katrina, shows its three types of housewrap, foil-faced OSB, ICF, and three types of roof underlayment.

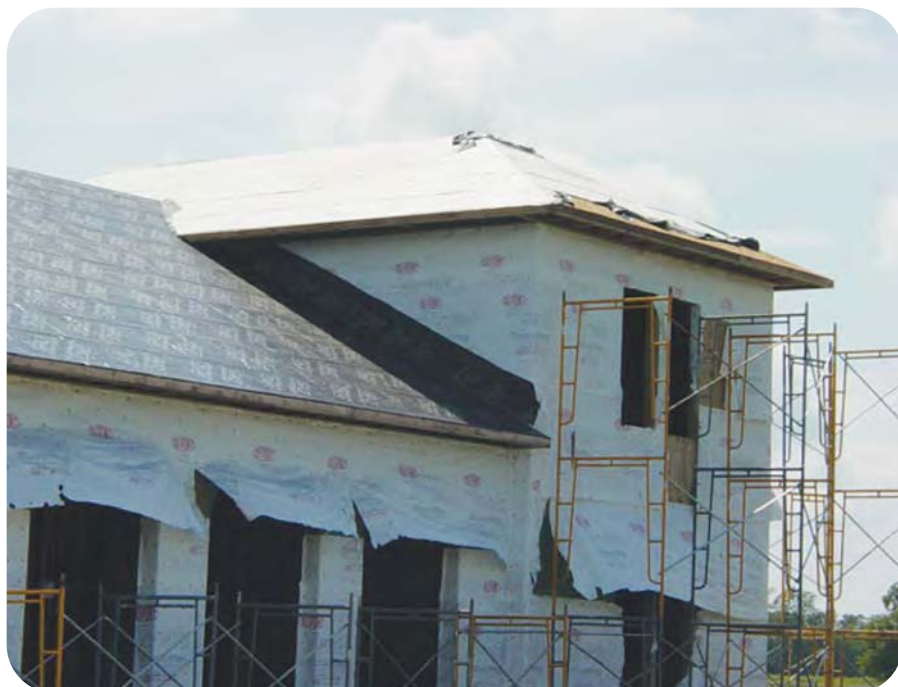
The peel-and-stick roof membrane on the plywood decking (left side) survived Katrina, but the membrane on the unprimed OSB peeled off.

The most enlightening finding was that the peel-and-stick roof membrane (Grace Ice and Water Shield) installed on plywood decking held tightly, but Katrina peeled off another adhesive membrane installed on oriented strand board (OSB) decking. This demonstrated the importance of closely examining the manufacturer's installation instructions. For most adhesive flashing and membrane products, the instructions recommend priming OSB for best adhesion, usually with the manufacturer's primer products. This had not been done, and the resins and finish of the OSB reduced adhesion.

So following Katrina, the OSB decking was primed with Protecto-Wrap's asphaltic primer before installing the company's Rain-Proof 60 peel-and-stick membrane on a second-story roof; it held on flawlessly through Rita.

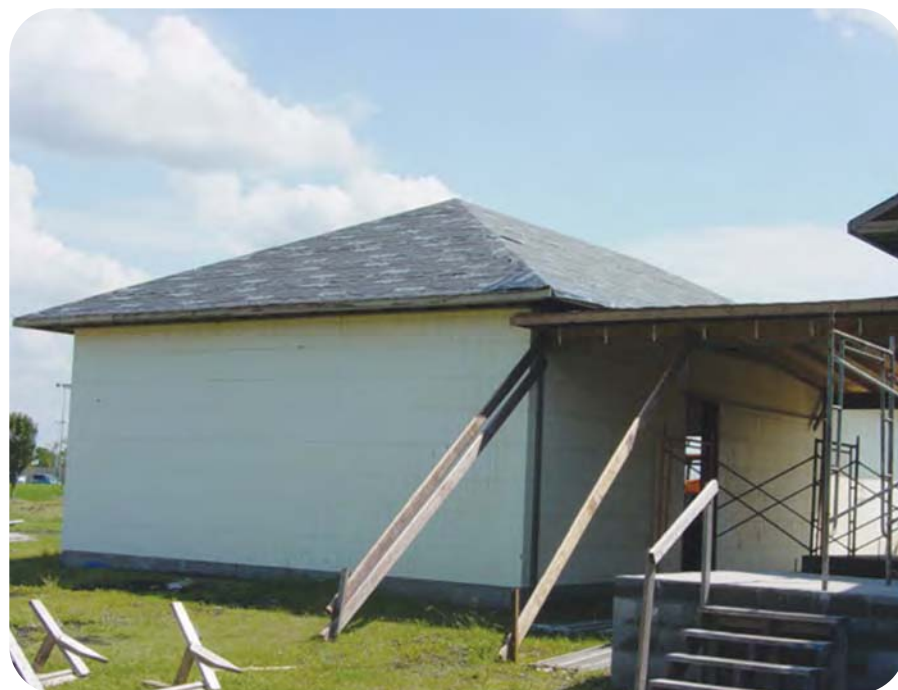
High-strength synthetic roofing felt weathered both Katrina and Rita without a tear.

thetic roofing felt (Grace Tri-flex 30), even though it is lighter in weight than conventional #15 felt. It appeared to be the only exposed roofing felt in town that wasn't shredded after Katrina, and it didn't have a single tear after enduring both storms.
