# Part I: Midrise Housing

## *Family Housing, Roxbury Corners*

### Elderly Housing, Holyoke

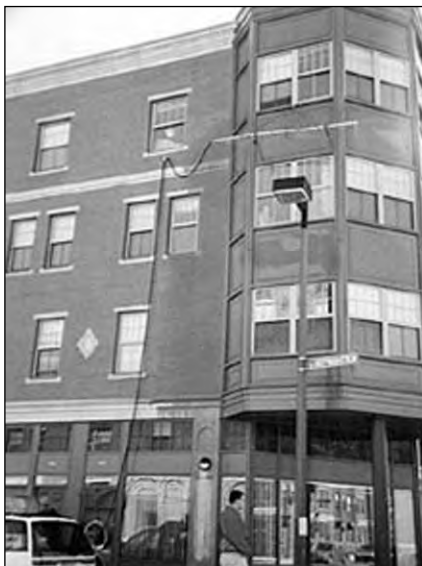
At Roxbury Corners, we performed a rain leakage test to determine if rainwater was leaking into the walls.

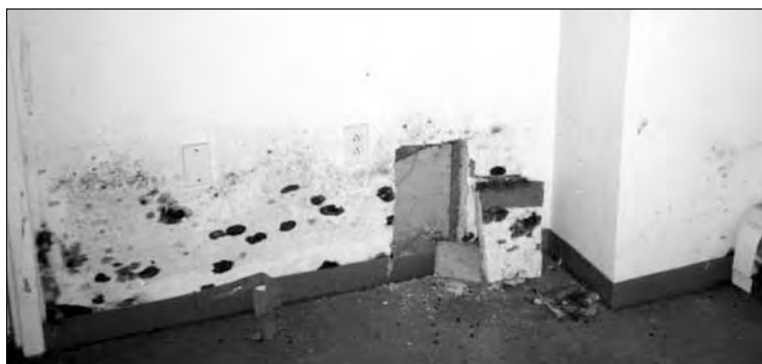
Investigators concluded that the mold growth occurred at Roxbury Corners because warm, humid air drawn into the building during the summer was condensing on cold surfaces, especially at metal studs. Basement level apartments are susceptible to this problem because they experience substantial heat loss to the ground at the below-grade portions of the perimeter walls and the bottom plates of the interior

After the rain leakage test is performed on the building exterior, field engineers removed sections of the interior wall to see if water had leaked into the walls. Because it had not, we knew that condensation was the cause of the mold growth.

*Increase the surface temperature of cold surfaces.* This measure required significant remediation and mitigation efforts in the lower-floor apartments. Investigators recommended reconstructing the lower apartments by adding rigid thermal insulation to the exterior walls in order to eliminate the thermal bridging. This required management to strip the damaged gypsum board and place rigid insulation between the metal framing and the concrete foundations at the perimeter.

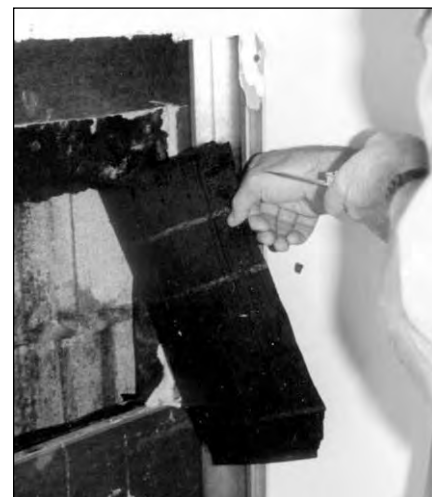
When the wall section at Holyoke was removed, water (and mold) were found within.
