# Missteps with Mold

*Building professionals should follow a thorough mold and IAQ investigative protocol when they tackle mold remediation cases.*

by **Bill Boles**

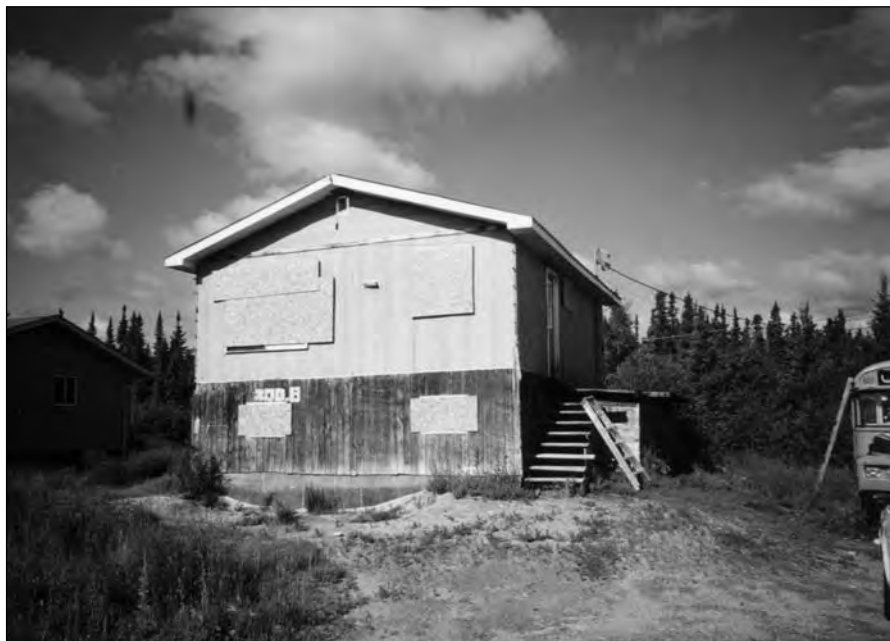
One of the replacement trailers had extensive areas of mold under the carpet.

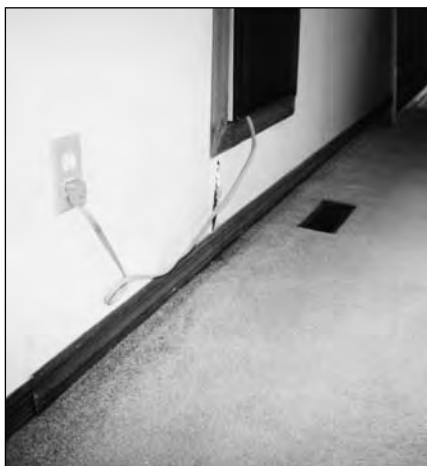
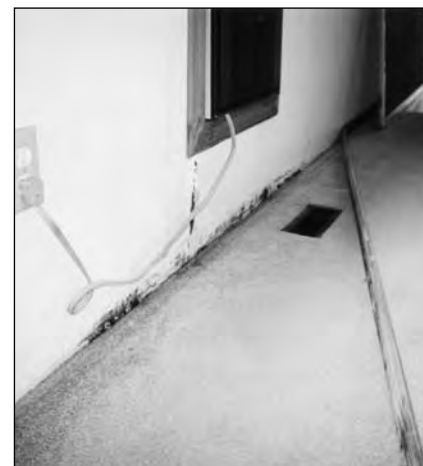
(left) The cracking drywall implies a moisture problem. (right) Removing some baseboard reveals the first signs of mold.

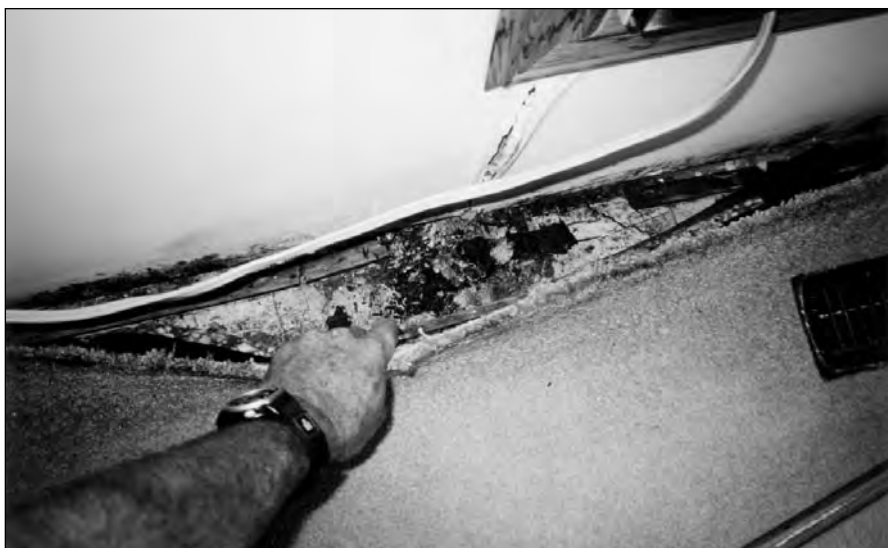
Pulling back carpet reveals the heart of the mold problem.

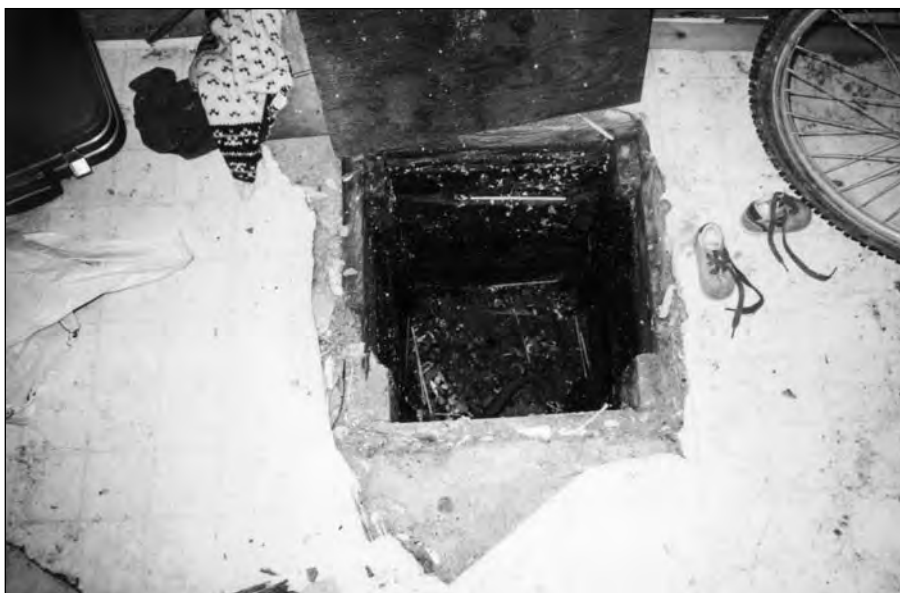
Located in a heavily trafficked area, this wooden sump pit has provided an optimal environment for mold growth.
