# Moisture Problems in Manufactured Housing

*Manufactured homes are affordable to many. A study points the way to making them healthy by dealing with moisture problems.*

by Neil Moyer

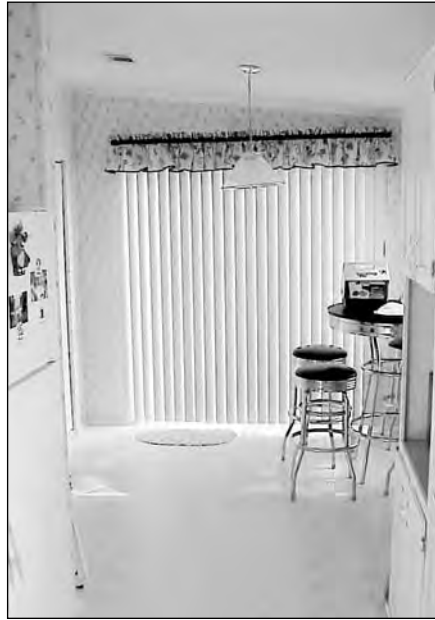
A pattern of floor moisture and staining problems appears when the duct system is located overhead, in an attic space. We found stained and warped vinyl-covered floors in areas under the ceiling registers. The areas that were being washed by cold air from the supply reg-

isters showed the worst staining. It is reasonable to assume that areas being washed by the supply air will tend to be cooler than other areas. This cooling of the floor surfaces creates temperatures below the dew point temperature of the crawlspace and condensation occurs.

This kitchen has a vinyl floor covering and an overhead supply register. Mold can occur under the vinyl that is washed by cold air from the register.

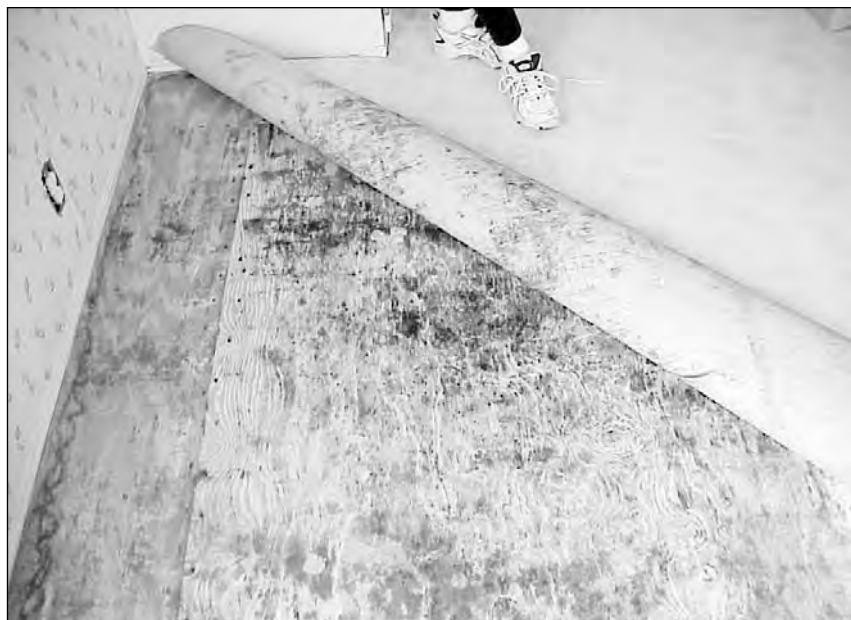
Vinyl flooring in manufactured homes can cause moisture damage, since the low moisture permeability of vinyl can lead to condensation.
