# New Construction Report Card

*In order to make energy-efficient and comfortable new houses, California builders need to pay more attention to the details.*

by **Marc Hoeschele**  
and **Rick Chitwood**

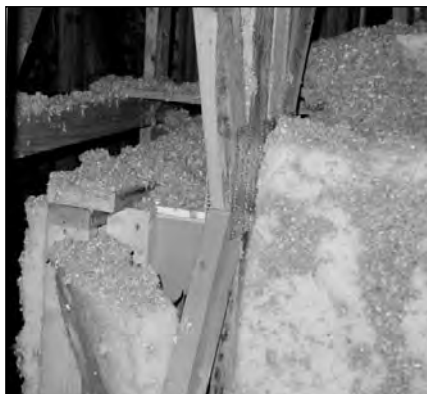
Looking at a kneewall from the attic side we see the common problem of the batt falling away from the drywall. Kneewall performance is also hurt because the batts were only run to the ceiling level. If the batts had been installed 10 inches higher, they would act as a dam for the ceiling insulation.
