# New Construction Report Card, Part II

*Complex building designs make even the best-laid plans for home performance hard to fulfill.*

by Marc Hoeschele  
and Rick Chitwood

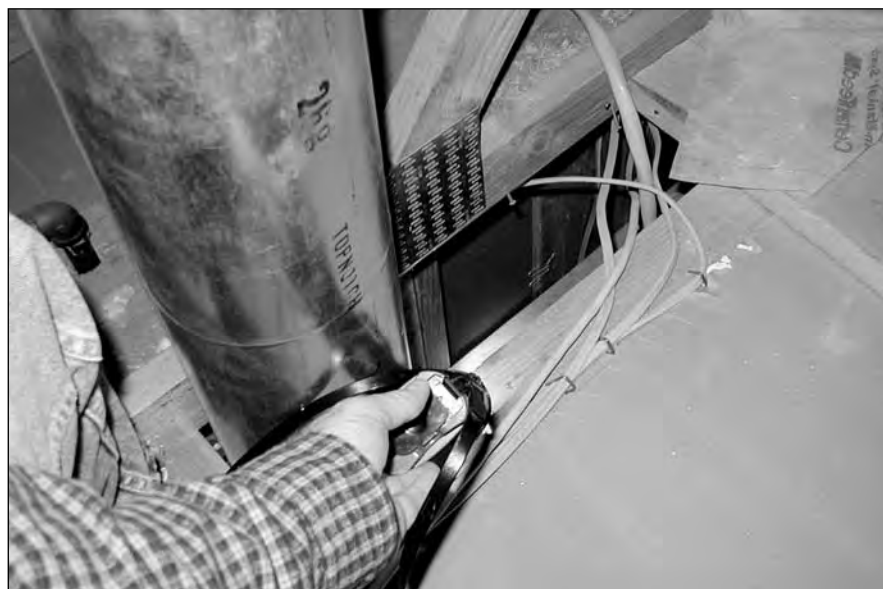
This is a common draftstopping problem—an interior wall cavity open to the attic.

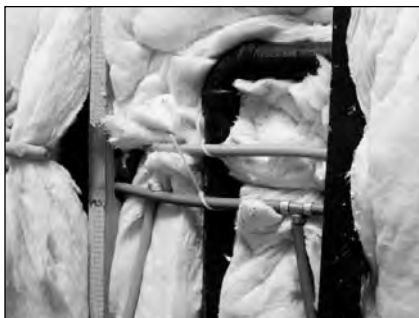
This subpar fiberglass batt insulation job shows three problems that affect performance: the insulation is not fully lofted so that it will touch the drywall air-barrier once it is installed, it is compressed behind the wiring and in narrow cavities, and a void is created in front of the wiring.

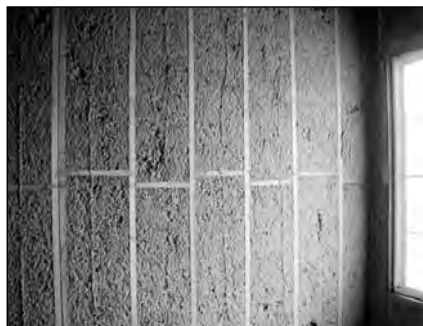
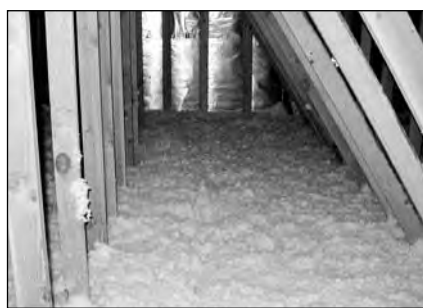
(top) This is an ideal wall insulation. The cavity is filled and there are no voids. (bottom) This is the way attic insulation should look—it has the proper thickness and is nice and even.
