# Public Housing Breaks the Mold

## Part II: Veterans Era Housing

In Part I, we discussed the particular moisture- and air quality-related problems of midrise housing, and we took a close look at two cases. Here we explore issues unique to Veterans Era Housing and present three cases where moisture problems were successfully addressed.

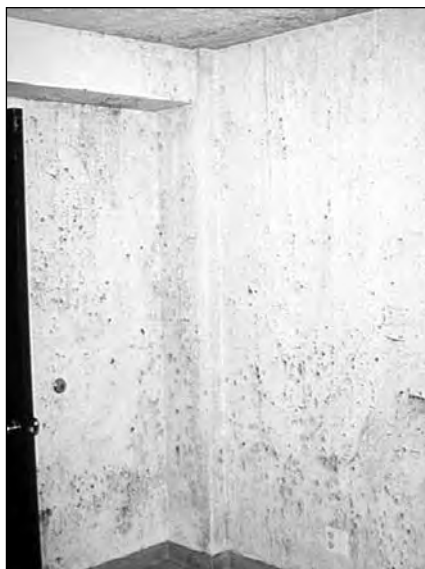
Mold growth on exterior walls was one of the most visible symptoms of moisture problems at this Cleveland Housing Authority apartment.

activities also implied high moisture generation in the apartments. Specific examples include hanging up laundry to dry indoors and heavy use of the installed gas stoves for cooking with inadequate kitchen exhaust ventilation (see Table 1). We observed mold growth at exterior corners and condensed water and water stains on window frames. The window stains indicated significant current and past condensation on the window glass.

Investigators concluded that high interior moisture levels, due to inadequate ventilation and to high moisture source strength, caused the sensation of dampness. They also decided that the mold and mildew, window condensation, interior paint damage, and plaster damage were caused by high interior moisture levels combined with cool surfaces.

**Reduce interior vapor pressure.** Installing controlled mechanical ventilation in each apartment would dilute interior moisture and other pollutants. We recommended installing exhaust-only ventilation to provide approximately 15 CFM per occupant, extracting air from the washrooms and stairwell/hallway areas, and exhausting this air to the exterior via ductwork. Ventilation should operate continuously in order to maintain interior moisture levels between 30% and 45% relative humidity at 72°F during the winter months.

recommended undercutting all interior doors 2½ inches (from the top of the floor covering to the underside of the door) to promote air change in the secondary rooms. The continuously operating exhaust fan would then induce the 2-3 Pa pressure differences neces-

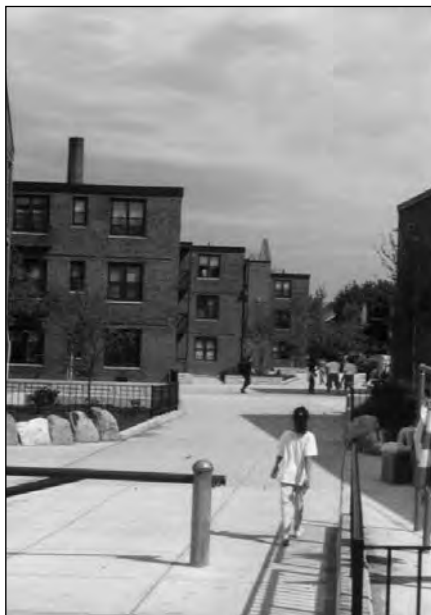
Strategically placed exhaust fans have solved most of the moisture problems at Merrimack Courts apartments in Lawrence, Massachusetts.

In 1993, LHA hired a building investigator to assess the moisture problems and develop solutions to prevent water damage and related mold growth in the apartments. Test results measured relative humidity in excess of 65% at 70°F during winter months. In addition, test results measured extremely tight building construction (1–2 ACH at 50 Pa). The investigator concluded that high levels of interior-generated moisture caused the problems. Specific sources of moisture included high occupant loading, moisture migration from dirt crawlspaces, condensation on cold water pipes, cold exterior wall surfaces, and back-ups from city storm drains.

In a follow-up phone conversation with LHA's maintenance director, we confirmed that LHA believes that it has solved most of the moisture problems at Merrimack Courts. However, LHA management was unable to install a central ventilation system due to difficult access in the existing pipe chases. In lieu of the central ventilation system, LHA installed individual bathroom and crawlspace exhaust fans.

The 80 CFM exhaust fans were installed on the bathroom ceilings vented out through the upper sash of the bathroom window. The fans are hard-wired to the bathroom light switch and run whenever the light switch is turned on. In addition, LHA installed fourteen 2,000 CFM (at 1 inch static pressure) exhaust fans, one in each basement crawlspace. The crawlspace fans are hard-wired to

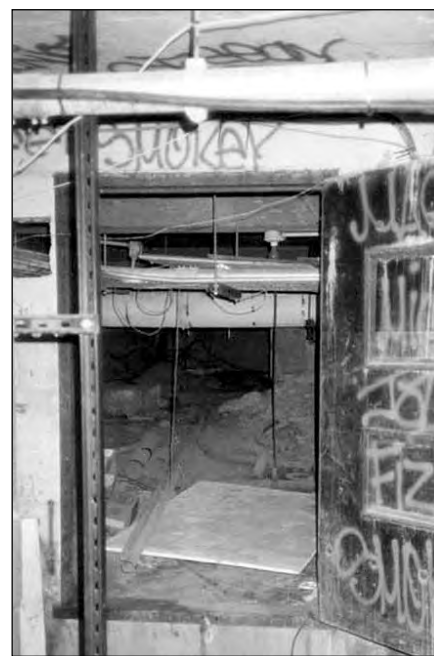
To reduce moisture levels in Merrimack Courts' moist crawlspace, 2,000 CFM exhaust fans cycle on for two hours, three times a day.

timer switches that cycle the exhaust fans on for two hours, three times per day. In retrospect, LHA should have installed small fans and run them continuously.

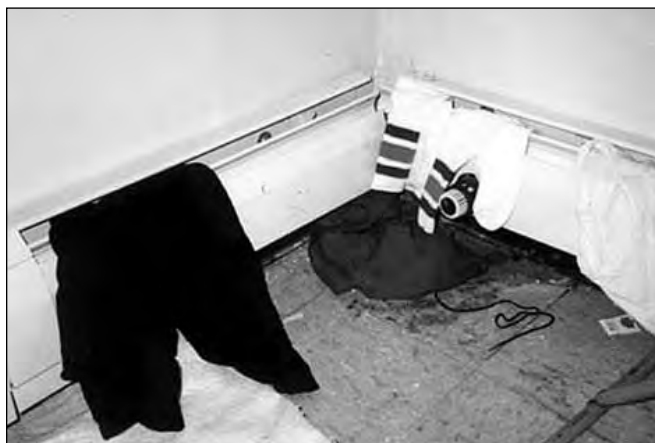
Residents can drive up indoor humidity levels by drying clothes on baseboard heaters.

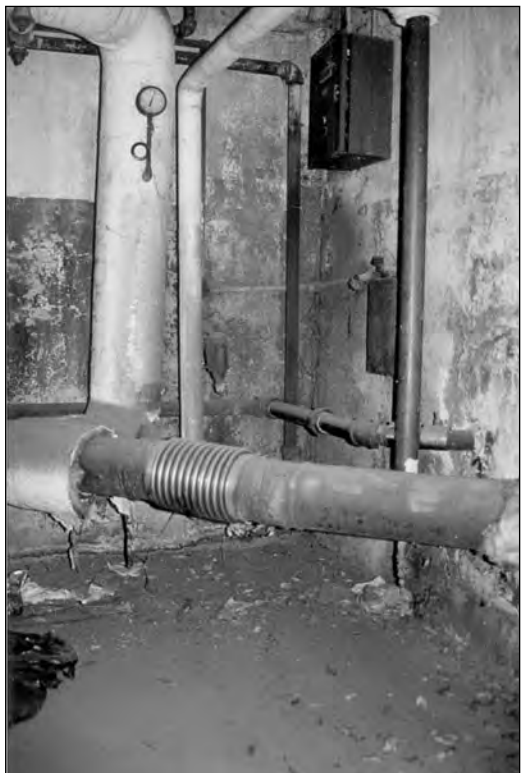
The 50-year-old steam heating distribution system was at the end of its life expectancy.

**Repair water leaks.** We recommended replacing the failed underground steam heating distribution system with individual gas-fired, high-efficiency distributed forced hot water heating and DHW systems, one per building. We also recommended installing low-volume toilets and other measures to help pay for the cost of repairing or replacing the leaking potable water and heating system piping with additional water cost savings. Water meters should be read regularly to monitor the consumption at West Broadway. Future water leaks should be identified and repaired quickly.

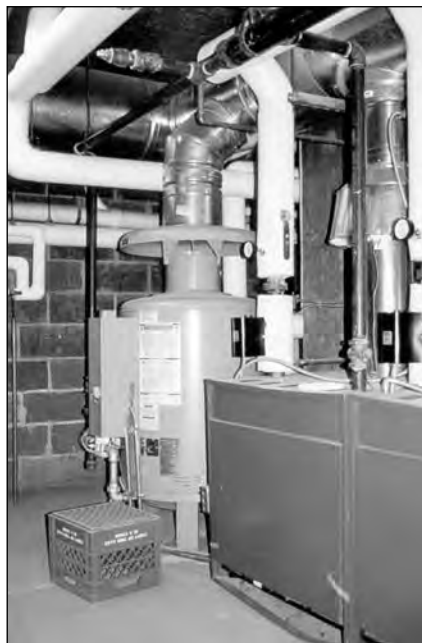
The new boiler and domestic water heater at West Broadway helped to improve apartment temperature control.

BHA completed an energy performance contract project at West Broadway Apartments in December 2000. Measures installed under the contract include individual forced hot water boilers—one per building—and low-volume toilets,
