# Raise the Roof?

*The King County Housing Authority adds insulation and slope while removing ventilation to make a more energy-efficient and durable roof.*

by Dan Auer and Claude Iosso

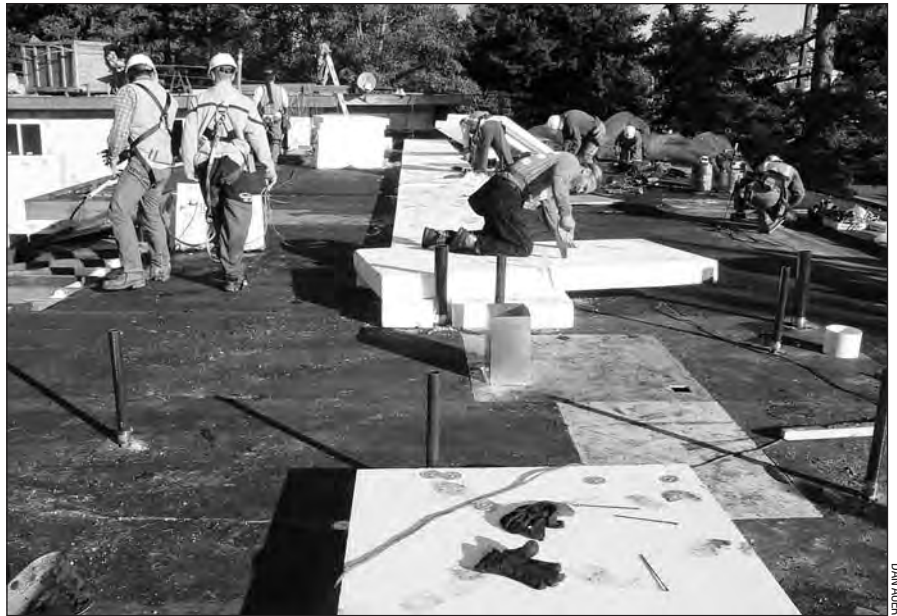
Rigid insulation is installed as part of a new roof.

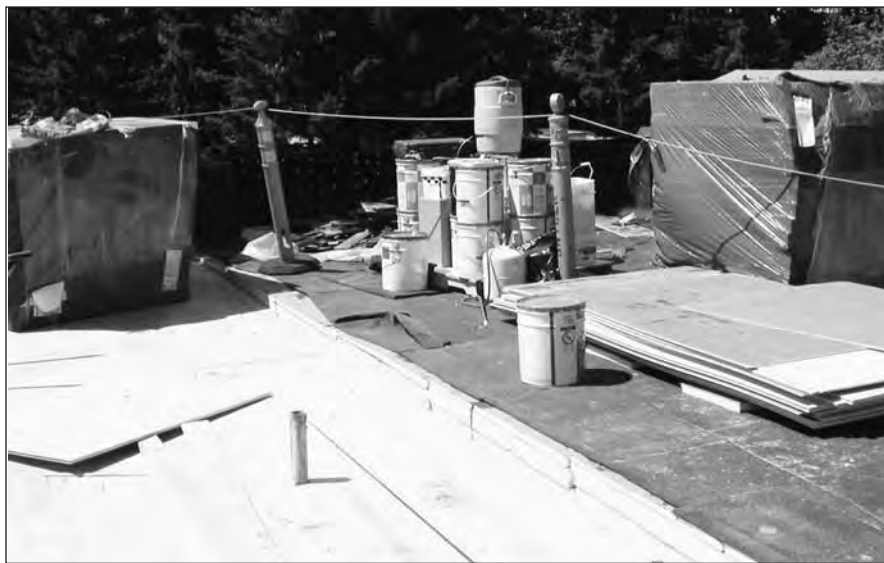
The new insulated roof system employs tapered insulation to move rainwater off the roof.

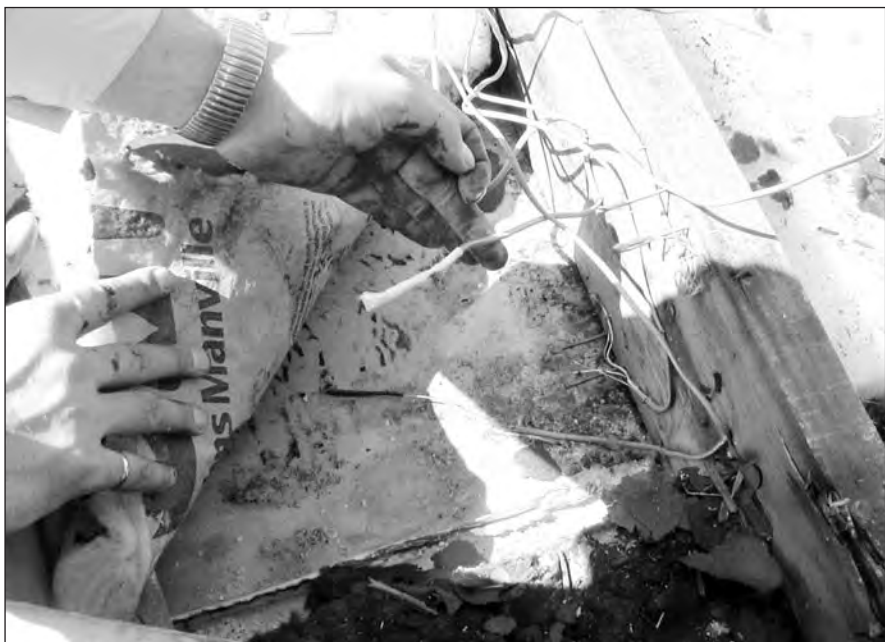
Moisture and temperature sensors were installed at four different locations in the attic space.
