# Rebuilding Your Flood-Damaged Home

Testing and first-hand observation provide the best available information about how to rebuild.

by Robert Wendt and Heshmat Aglan

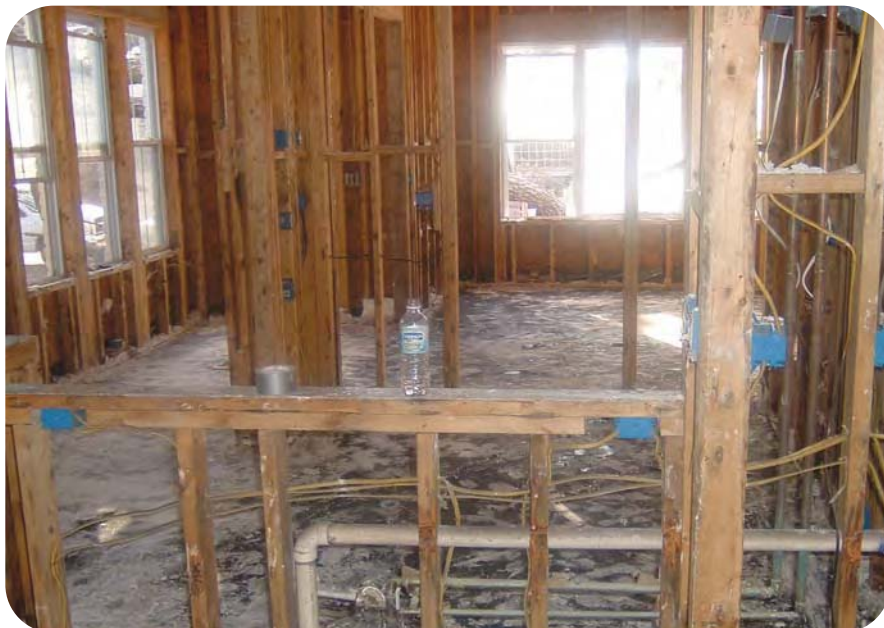
Wood framing in this New Orleans house was undamaged by flooding.

**Wood framing (D).** Testing and observation have shown that moisture levels in studs and floor framing will in most cases return to preflood levels and create no long-term problems. Autopsies of the tests showed no visible evidence of mold growth on the wood framing. Wood framing resists flood damage as long as the wall or floor system of which it forms a part will permit it to dry to normal levels (see photo).

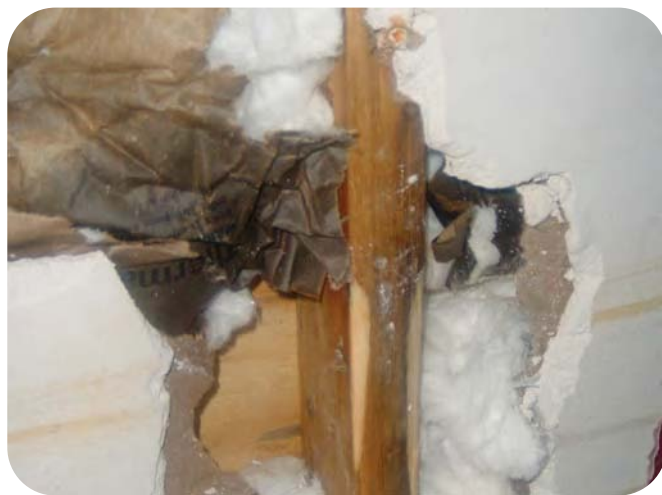
Inspection of these exterior, insulated wall cavities revealed no damage to the studs and plywood sheathing. The fiberglass insulation was also undamaged. However, moisture levels of adjacent materials were elevated. The back side of the gypsum wallboard showed no evidence of mold growth.

long-term damage to subflooring, flooring, wall framing, and gypsum wallboard. The paper facing on batts can also slow the drying process, because the facing acts as a partial vapor barrier. We have not tested cellulose insulation under flood conditions. However, given the nature of the material, we can envision several problems. First, cellulose insulation will retain significant moisture and will probably be slow to dry. Second, the insulation may consolidate after being saturated by floodwater, leaving it full of gaps. Third, because cellulose insulation is made from the same material as drywall paper facings, which supported mold growth, it may also support mold growth within the wall cavity. Fiberglass and spray polyurethane foam (SPUF) insulations did not support mold growth. We recommend that fibrous insulation that has been subjected to floodwater be removed.

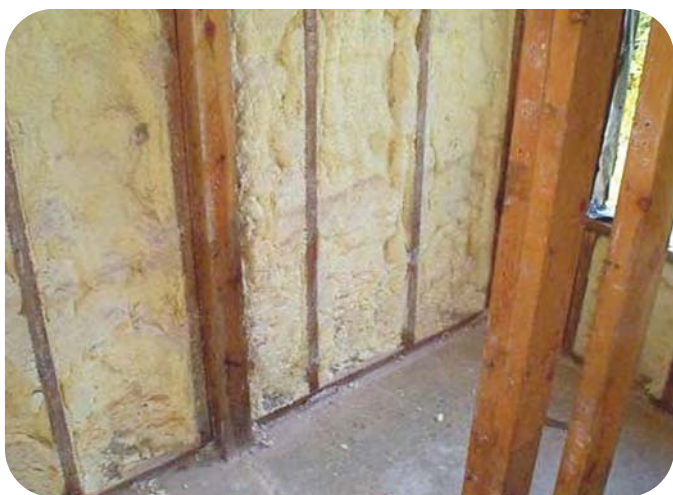
SPUF insulation tested in the wall cavities enabled the wallboard and wood studs in the exterior walls to dry at the same rate as in the interior walls with empty cavities. SPUF absorbs water very slowly and was undamaged by flooding. SPUF did not retain moisture and does not adversely effect the materials around it. There was no visible evidence of mold growth on the SPUF insulation. SPUF is recommended where insulation is expected to be subjected to flooding (see photo).

SPUF insulation performed well during Tuskegee tests. A slight scum line is the only visible evidence of flood exposure.

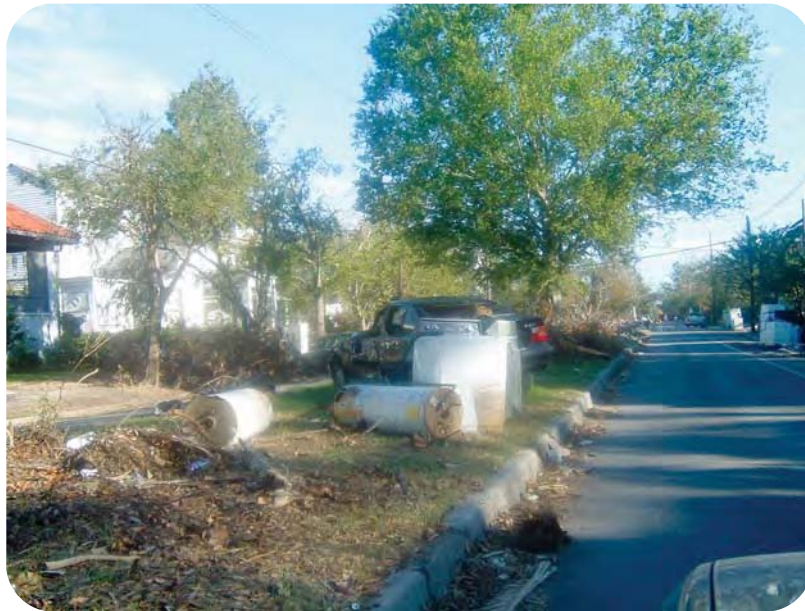
Homeowners in New Orleans discarded many appliances because they were too old or too difficult to clean.

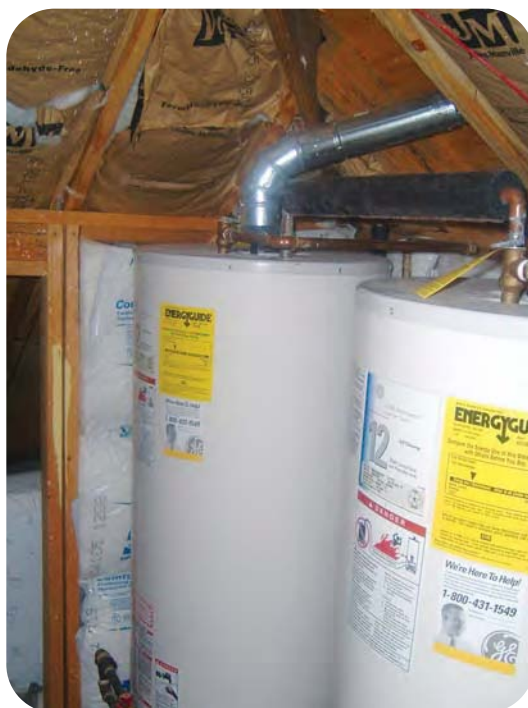
A flood-conscious New Orleans homeowner located the water heaters in the attic in an easily accessible location. They were completely undamaged by the flooding.

it is near the end of its service life, it should be replaced with an appropriate new unit located on a raised platform, on the second floor, or in the attic to keep it above projected future flood levels. Instantaneous, or tankless, water heaters may be a desirable option when the water heater is relocated to the attic. These require less space and weigh less than conventional water heaters. Spillage pans with a visible overflow drain must be installed when the water heater (especially a tank-type unit) is moved to the second floor or attic. This will reduce the potential for water damage from a leaky water heater that has reached the end of its service life. When moving the replacement unit to the attic, the contractor should be careful to provide good access for maintenance, repair, and ultimate replacement (see photo, p. 26).
