# Retrofitting Residential HVAC Systems

*In this case study, we show how DOE's Best Practices Guide For Residential HVAC Retrofits works—as well as some of the installation practice and building code official problems that can arise.*

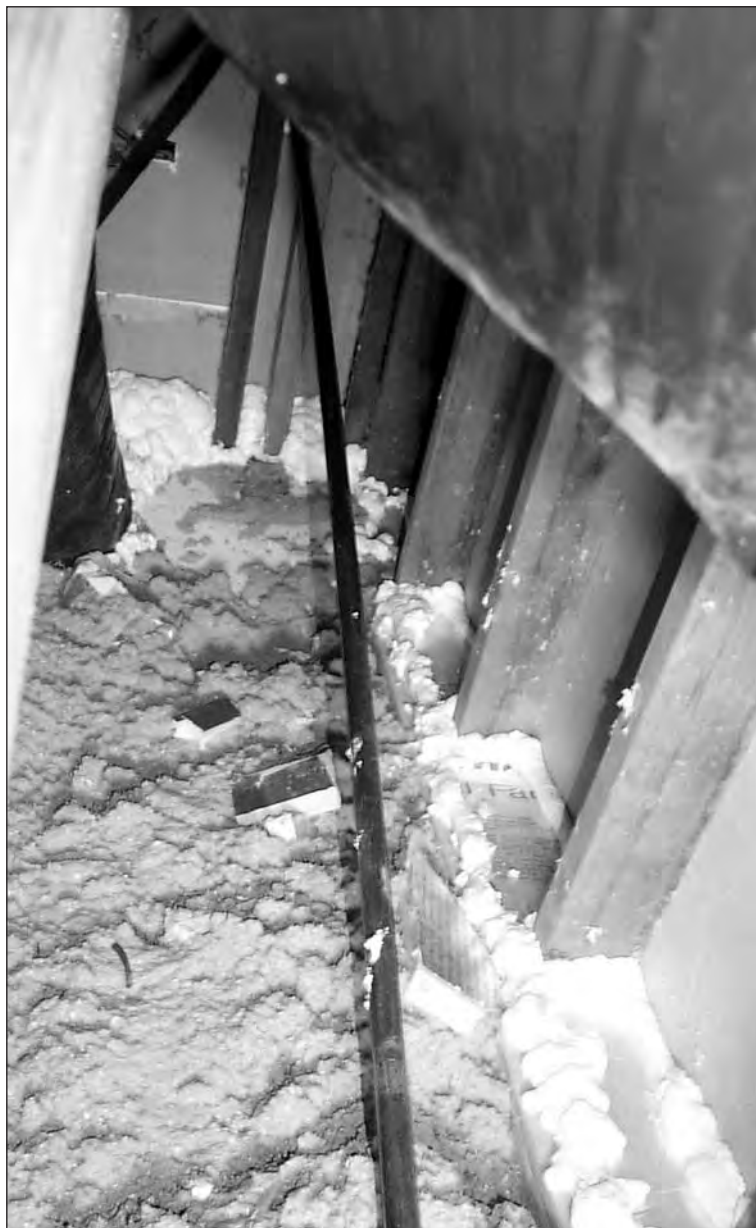
It's important to seal cavities connecting the house to the attic. Foam was used for sealing small holes and cracks at building component intersections.

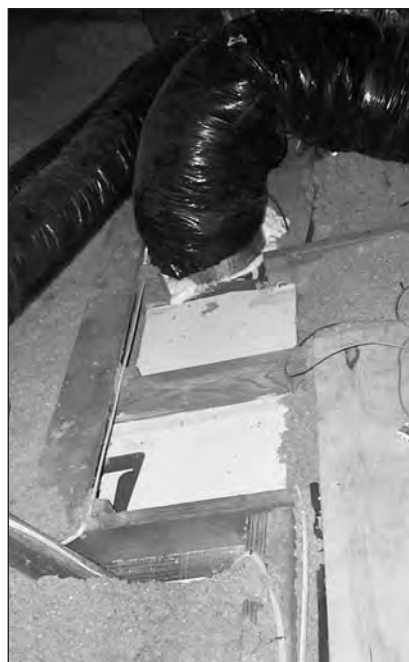
Duct board insulation was used to block off large open areas.

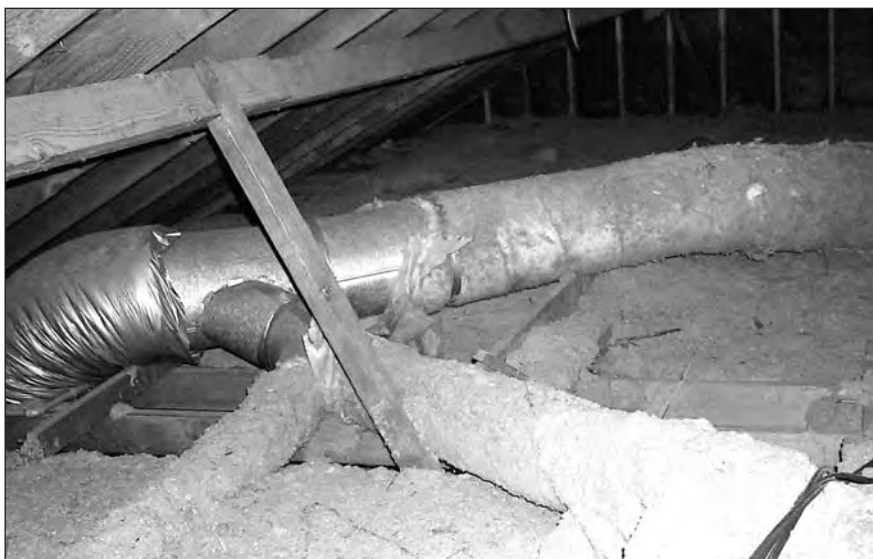
Here we see the poorly insulated sheet metal ducts and blown-in insulation in the attic before the retrofit.

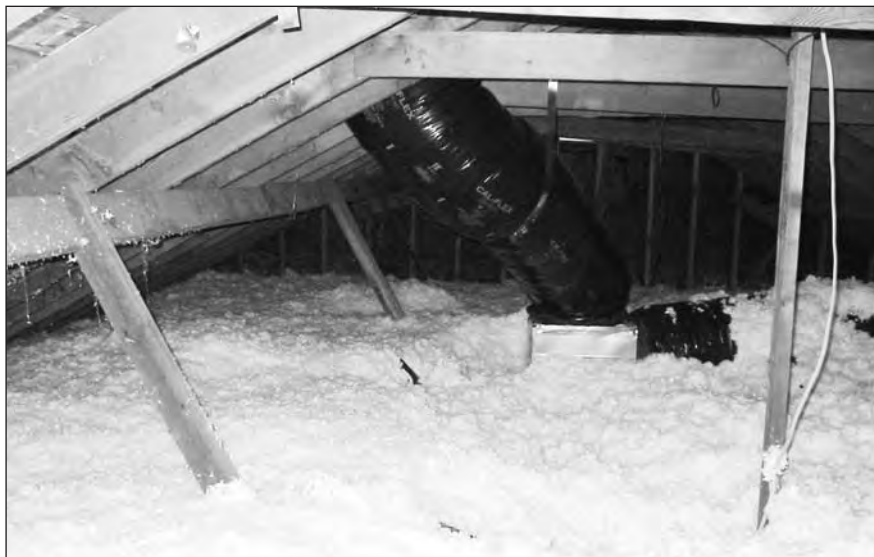
- The metal ducts in the attic were replaced with new R-4 flexible ducts (despite clear and repeated instruction to retain the original ducts) because the contractor thought the original ducts were undersized. Initially the contractor hung the flex-ducts from the attic ceiling with smooth bends. However, since the ducts would be covered with insulation, the contractor placed the new ducts on the floor, but

consumption, and possibly too low a flow through the furnace and air conditioner). This problem was made worse by the many extra bends in the flex duct due to poor layout.

The new flex ducts in the attic are covered by additional blown-in insulation after the retrofit.
