# Revisiting New Orleans

## A Photo Essay

**by Robert Wendt**

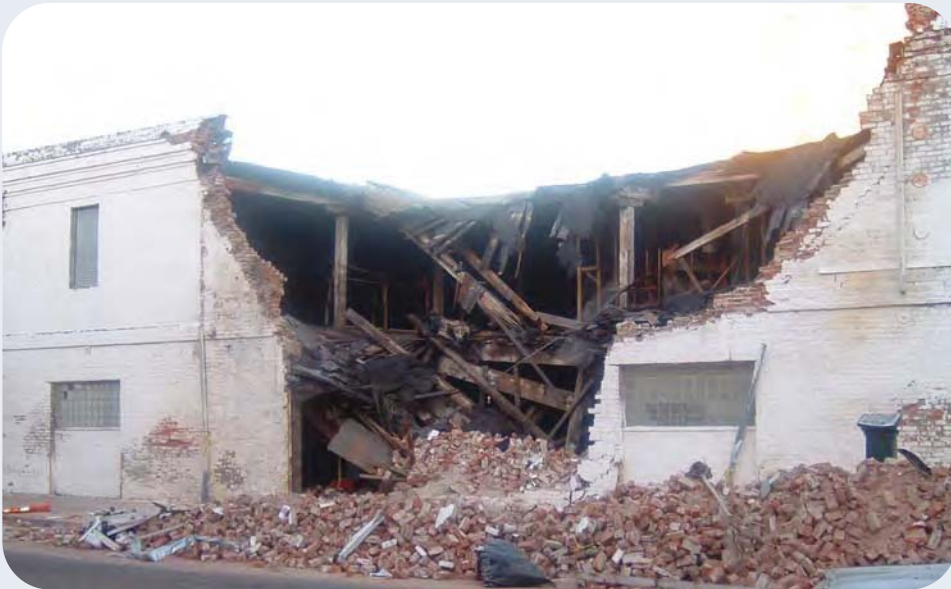
This damaged warehouse is located near the New Orleans Convention Center. The front wall of the structure is approximately 24 inches of solid brick.

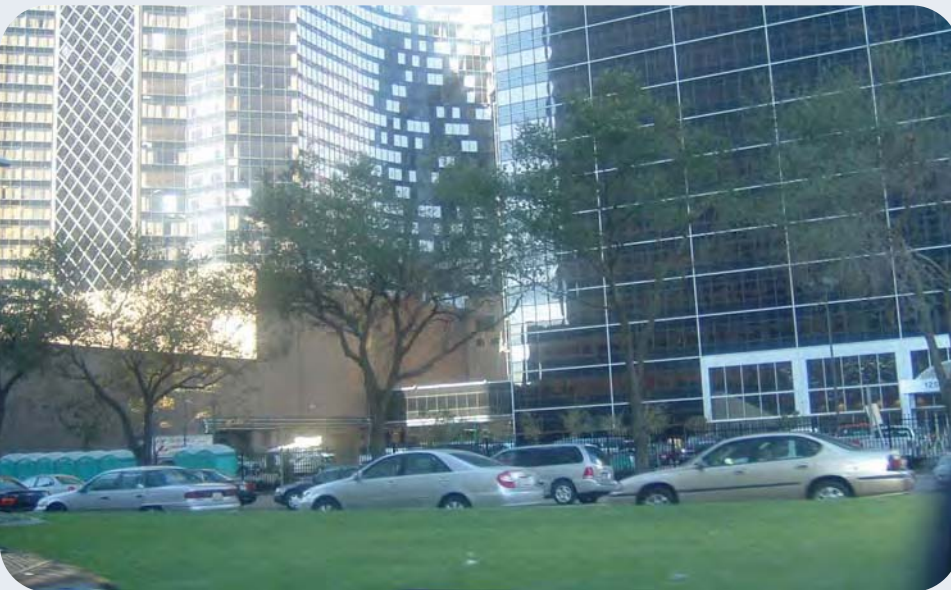
The Hyatt Hotel and other downtown buildings sustained major window loss (white panels) due to wind-borne shrapnel from upwind ballasted roofs. Several floors received major water damage from the storm once the windows failed.

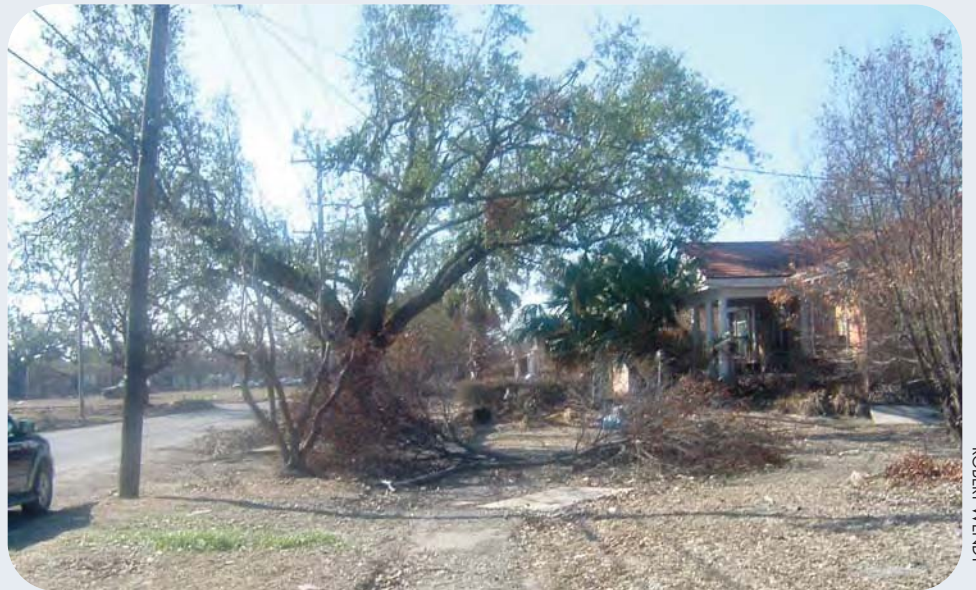
This is a typical front yard in the Gentilly District of New Orleans in October 2005. Trees were broken and the grass and shrubs were by-and-large dead. A covering of sludge from the flood remained on the walkways and the edges of the street. The smell was that of a Louisiana bayou: wet, decaying vegetable material.

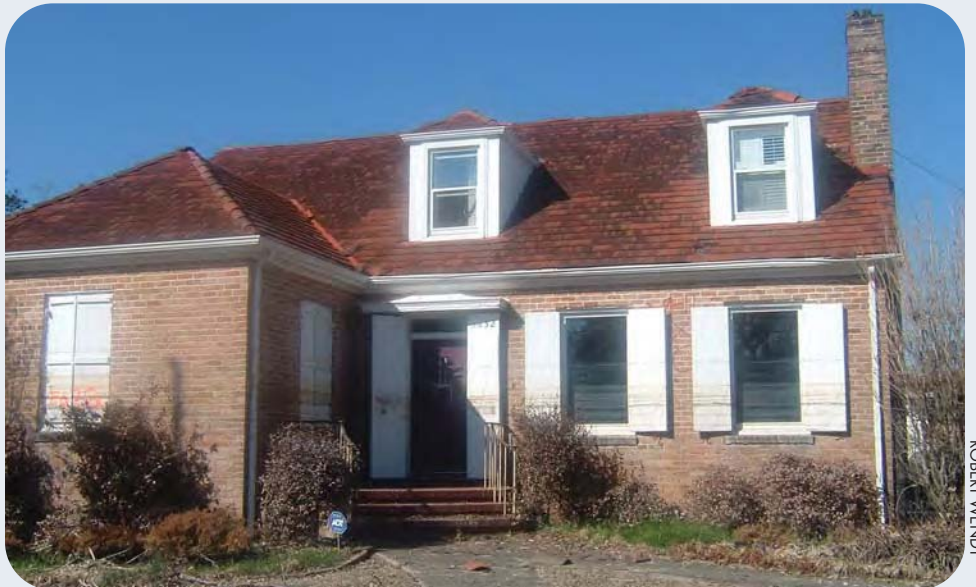
This is a home in the Gentilly District that got flooded; I took this photo in October 2005. The flood level (scum line) can be seen on the lower third of the window shutters. This house sustained little wind damage from the hurricane.

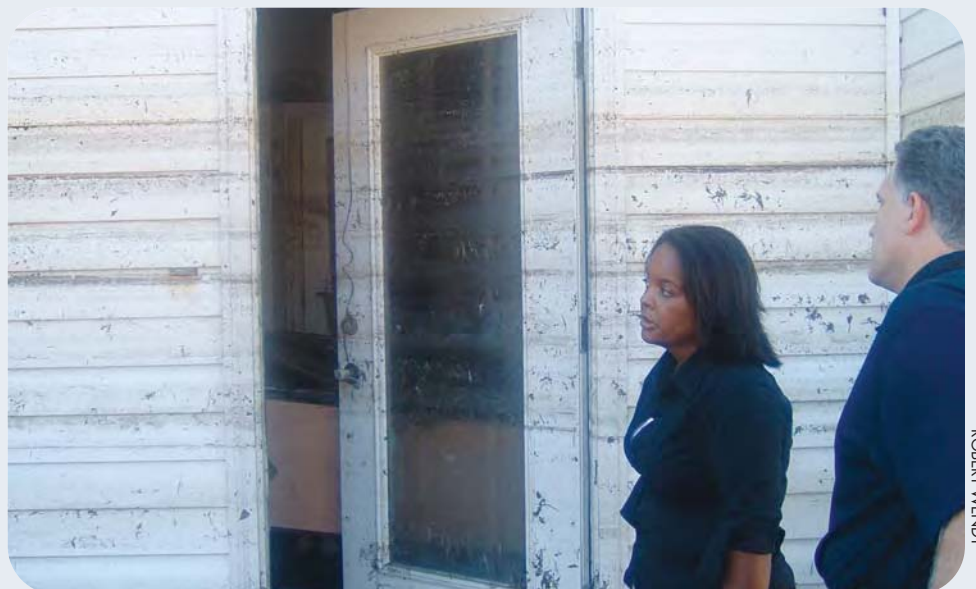
This homeowner and inspection team member are about to enter a flooded home. The flood level (scum lines) can be seen on the door and siding. Note the multiple distinct scum lines. These suggest that in this area draining occurred incrementally—about 6 inches at a time—with periods of no change in between. Draining of the last three feet or so appears to have been accomplished without interruption.

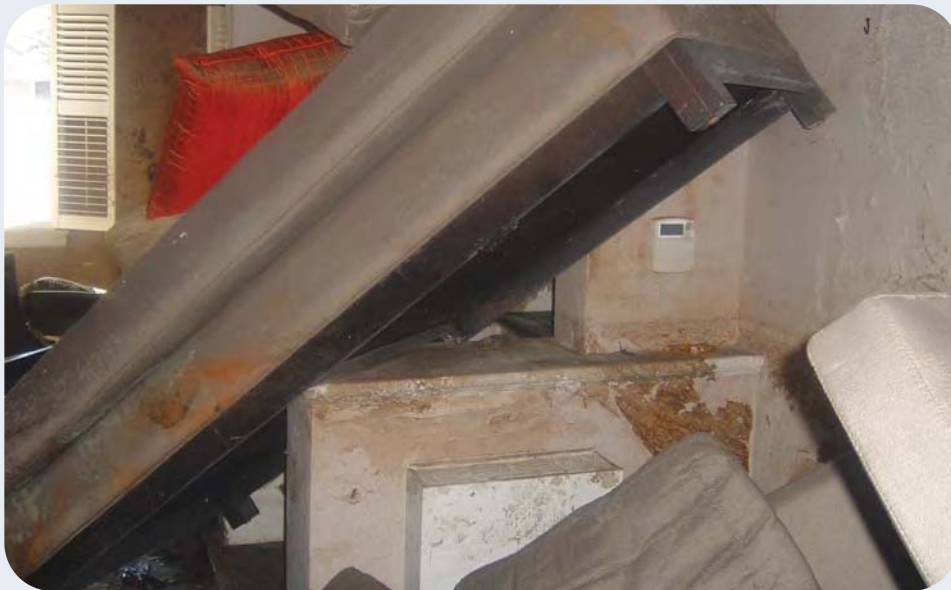
The interiors of flooded homes were chaotic. In this home, major pieces of furniture had been dislocated to all sorts of strange locations. In some homes, these displaced items presented hazards to homeowners as they reentered their homes for the first time.

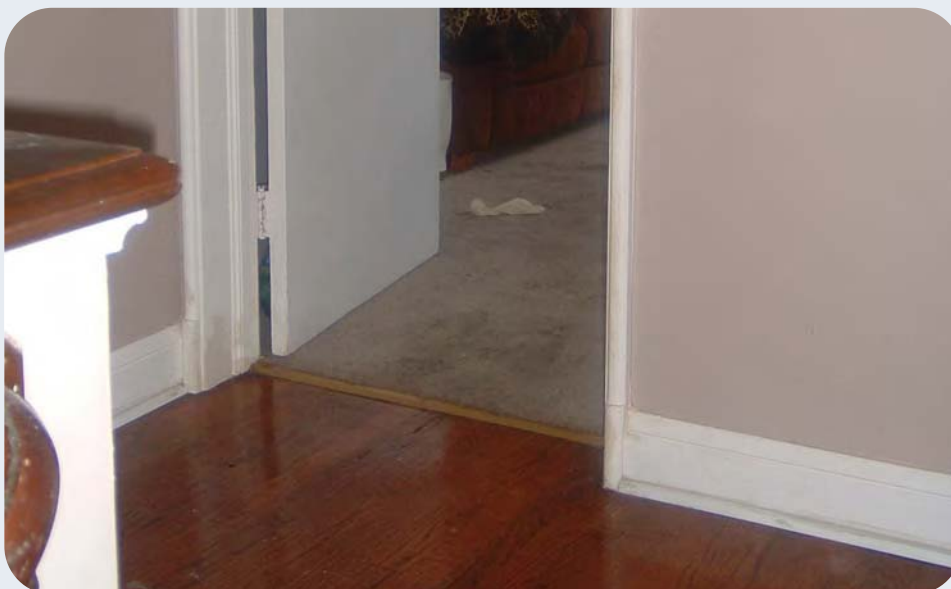
In addition to the chaotic interiors, mold was omnipresent. Typically, the lower portion of the walls (below flood level) experienced some staining, while that portion above the flood level was where the mold thrived. Mold growth extended from as little as six inches to as much as four feet above the flood level. The duration of the flood, as well as the delay in reentry (about 4–6 weeks combined), appeared to have encouraged the massive amounts of mold growth in many New Orleans structures.

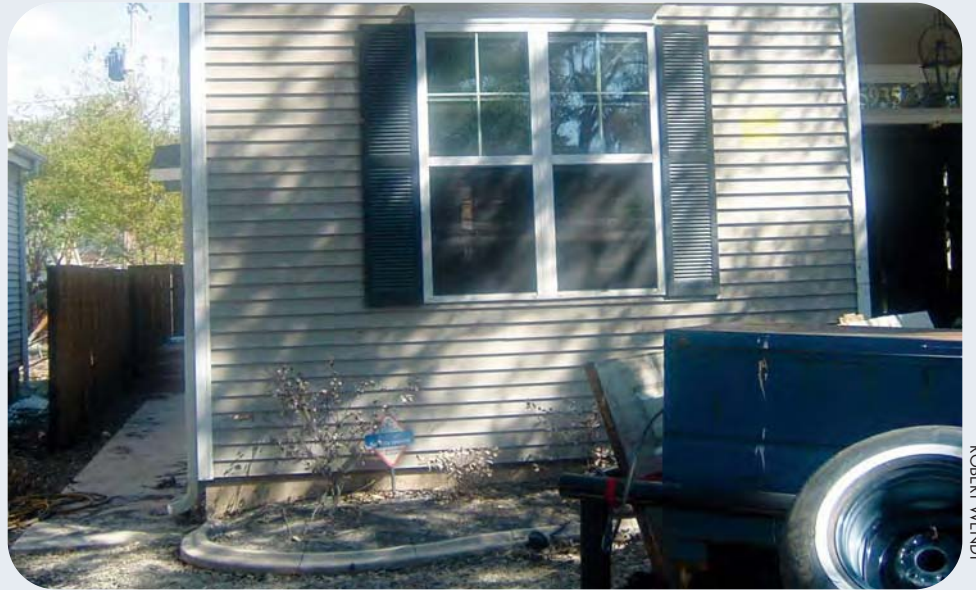
This fairly new home in New Orleans was built with its lowest floor seven inches above the maximum expected flood. Unfortunately, the Katrina-induced flood levels were about four to five feet above the maximum expected flood. The homeowner had begun the gutting and restoration process by early October 2005.

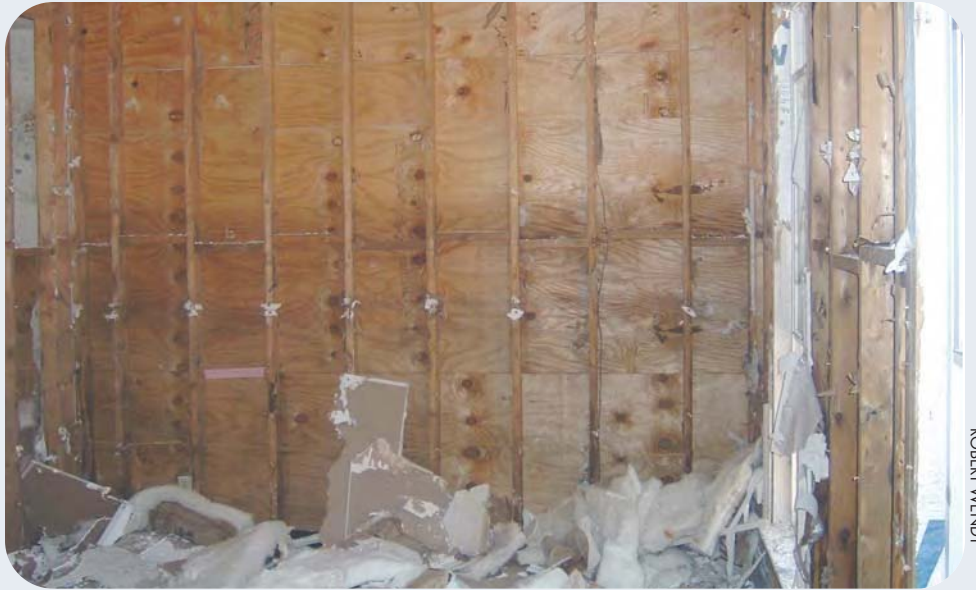
The sheathing and framing of this home were not damaged by flooding. Only staining of the wood from the flood and high moisture levels remained as evidence of the flood in October 2005.

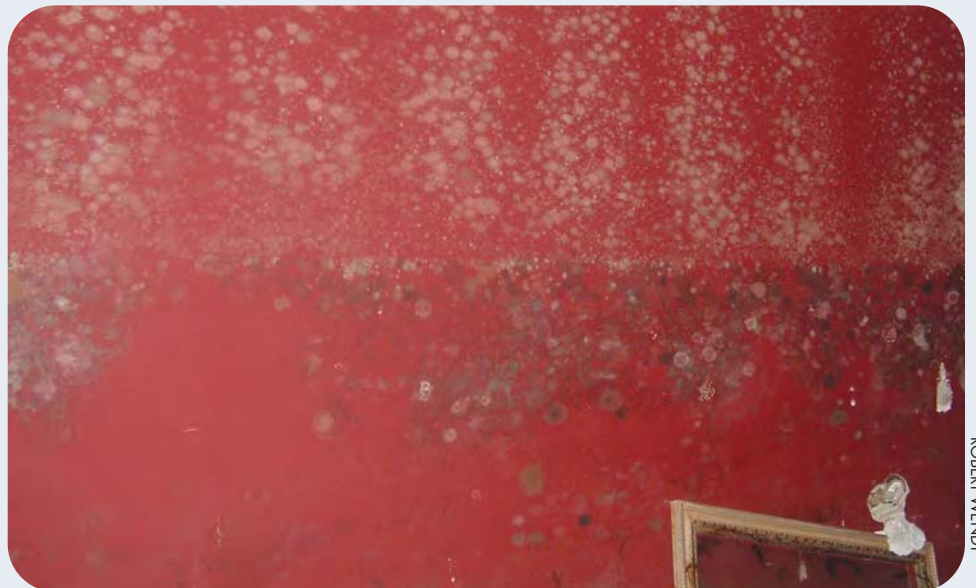
The painted gypsum wallboard of this home shows some interesting mold patterns. The dark band in the middle is typical of the mold growth that occurs above the flood level in what is known as the wicking zone. The white mold above that appears to be another specie that developed from the high moisture induced by wet fibrous insulation located in the cavity behind the wallboard. Note the periodic stripes where the mold is absent; these are the locations of the studs behind the wallboard. This picture was taken about five weeks after the onset of flooding.

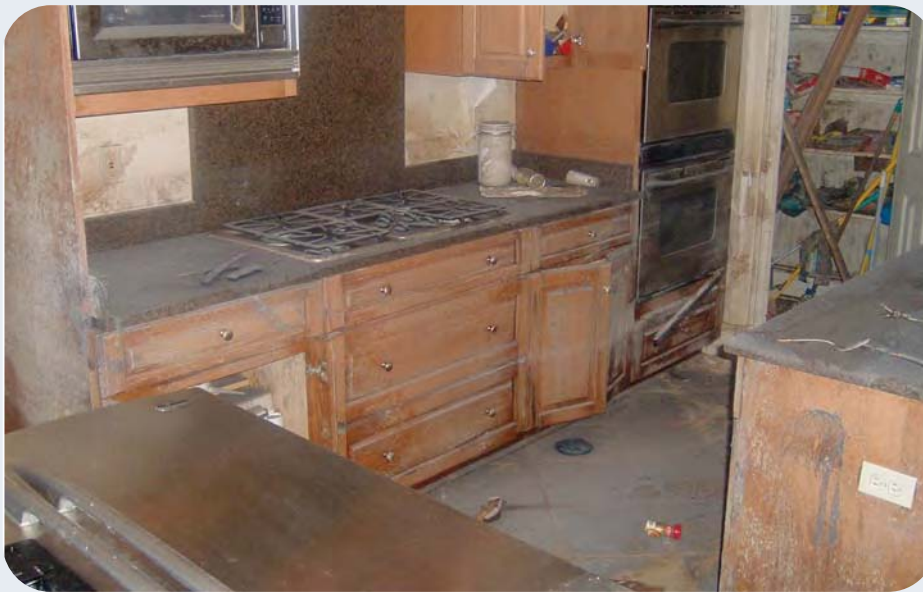
The solid cherry kitchen cabinet fared poorly when exposed to flood water. Some of the wood had cracked, some warped, and much of it was water stained. The granite countertops appear to have survived; the only question remaining is what the impact of the contaminants in the floodwater would be on their continued usefulness.

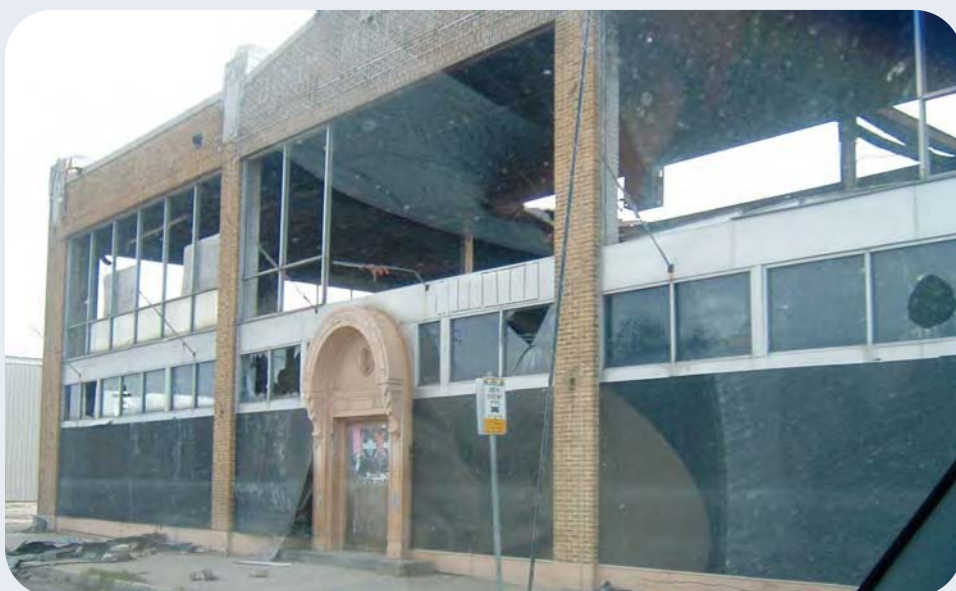
This building was severely damaged by flooding and wind. The flood (scum) line is about four feet above the sidewalk. The unprotected windows were blown in, which pressurized the structure and led to the major roof structure failure. (See the missing roof in the middle of the structure.)

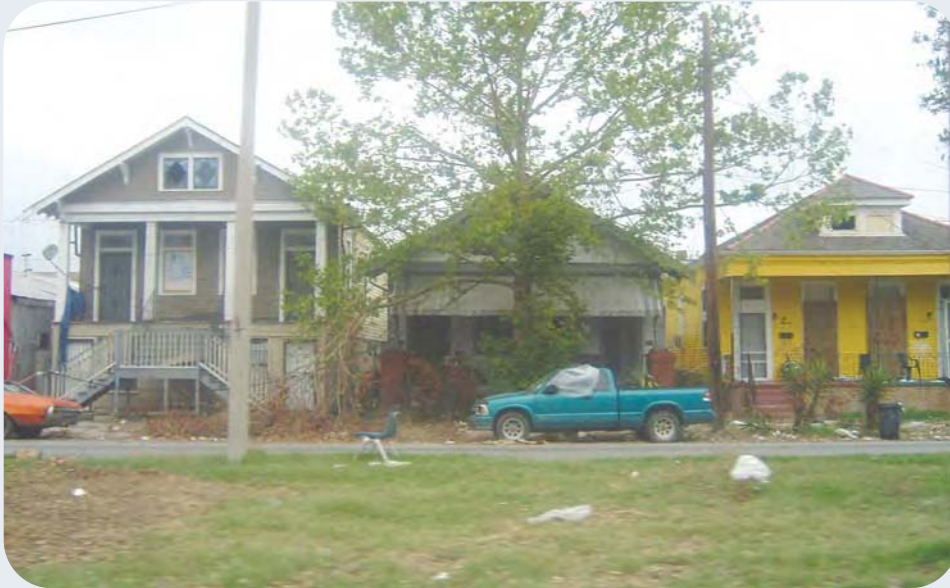
Elevating a house (notice the one on the left) was a traditional New Orleans approach to avoiding flood damage. The two houses to the right had flood damage in the occupied portions of the homes. The house on the left had water only in the masonry “basement” portion of the structure.

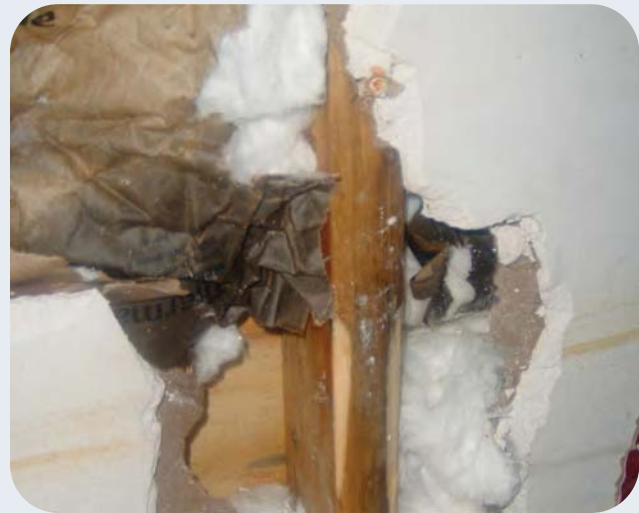
Significant mold growth occurred in this closet even though the flood only reached several inches above floor level. The backside of this wallboard (see photo below) was the only location where mold growth inside a wall cavity was confirmed.

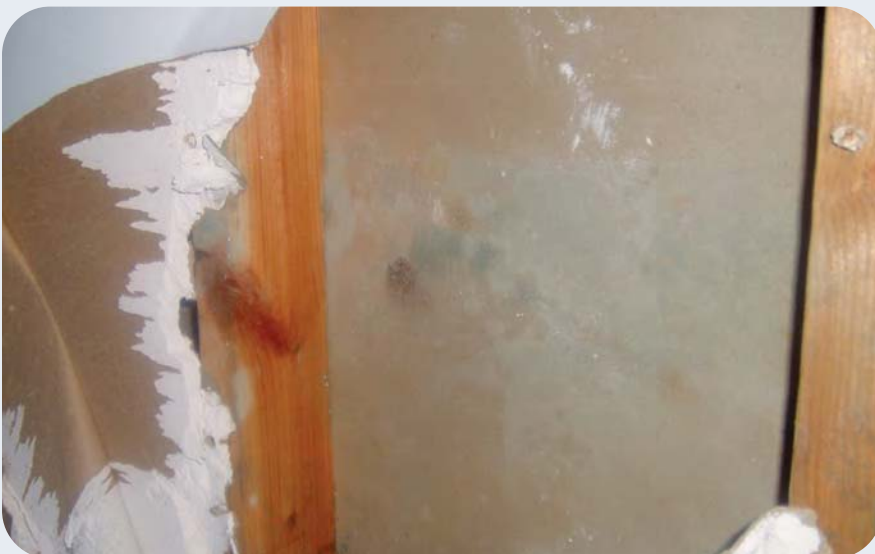
Inspection of these exterior, insulated wall cavities revealed no damage to the studs and plywood sheathing. The fiberglass insulation was also undamaged. However, moisture levels of adjacent materials were elevated. The back side of the gypsum wallboard showed no evidence of mold growth.
