# The Chicago Green Bungalow Project

*The Chicago bungalow has been around for a century. A Green Team is working to make sure these houses last for another hundred years.*

**by Paul Knight**

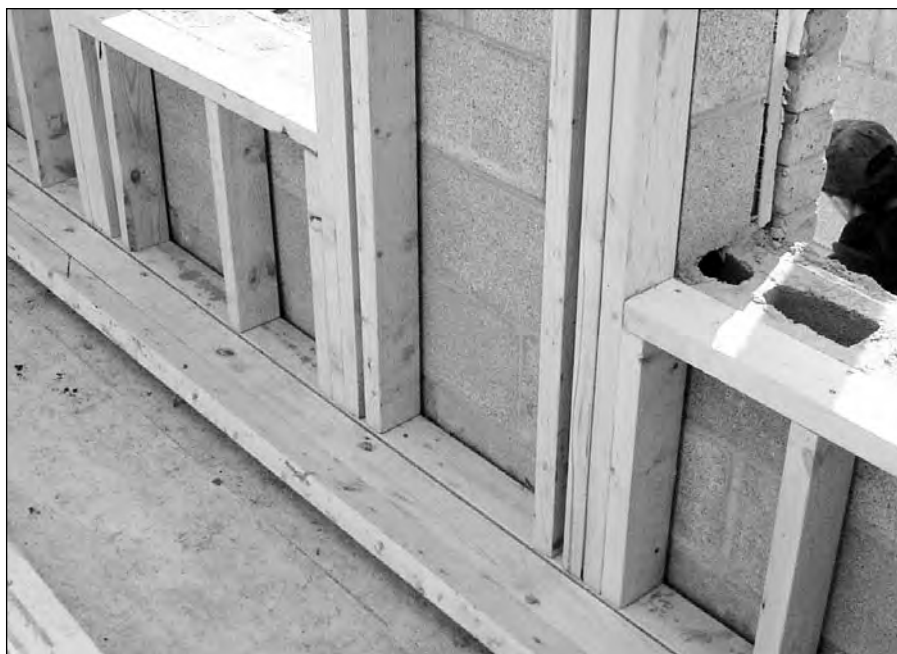
The rigid foam insulation between brick and block in this addition at 6423, combined with R-13 batts in the wood-framed interior walls, results in an R-18 wall.

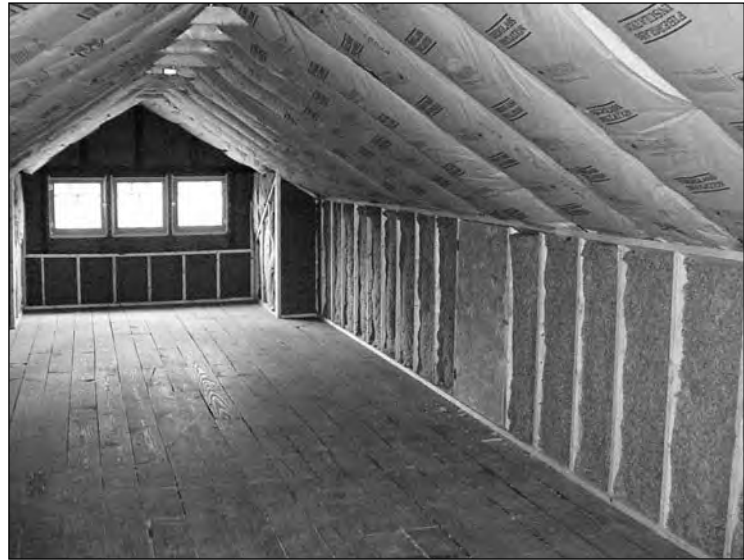
(left) The payback period for the four unique bungalow renovations ranged from approximately 5 years to just over 12 years. (above) The as-yet unheated attic at 6448 was framed and insulated with denim insulation and can be finished as a living space in the future.
