# Training in the Canadian Arctic

*Those who are charged with enforcing building performance standards in Canada's newest territory have miles to go before they begin.*

by Stewart Selman

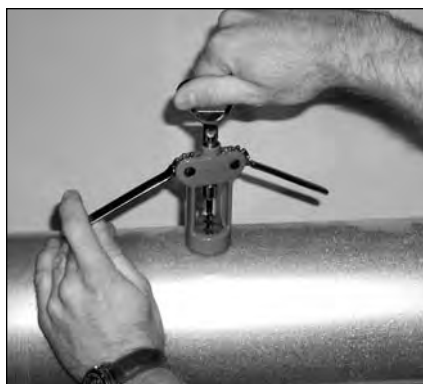
This is drilling a hole the Nunavut way in preparation for worse case draft testing.

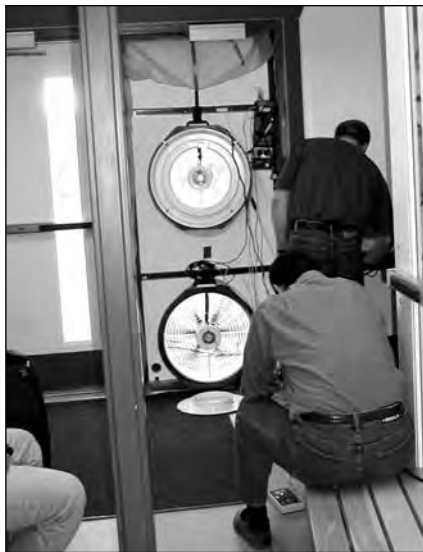
This Minneapolis Blower Door canvas allows the insertion of two fans—for larger buildings with large leaks.
