Maintenance checks report

Checklist name	Year
05_MV - Site proposal - season 6	6

Site	Turbine serial number	Order number
	WK49 - 1121489	60606610
Language	Revision date checklist	Approval date
en-US	2/21/2024	3/21/2024

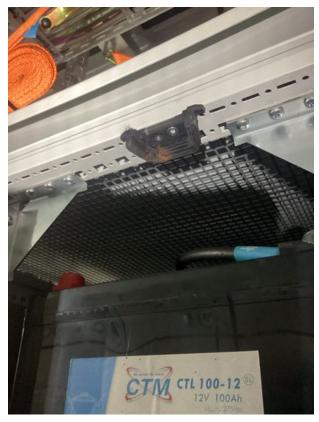
1 Figure from Checklist 'AD 5-135_1_1_5_MV_year_null', Task 20 - Remarks

AD 5	-135_1_1_5_MV_year_null			[2/0]		
#	Measuring points	Remarks	Tools	Status		
Locat	Location: Tower					
19	ADWI017124.1: Main UPS - External cover panels - Inspection and torque					
20	ADWI017124.2: Main UPS - Cabinet doors are correctly closed and the handles work properly - Inspection	Remark 1 See annex 'Taken photos': 1 Remark 2		×		
21	ADWI017124.3: Main UPS - Upper/ lower locking plates - Inspection and torque	See annex 'Taken photos': 2 Remark 1 See annex 'Taken photos': 3 Remark 2 See annex 'Taken photos': 4		×		
22	ADWI017124.4: Main UPS - Fastening claws - Inspection and torque	occ annex raken photos. 4				
23	ADWI017124.5: Main UPS - Locking brackets - Inspection and torque	Remark 1 nearly worn out		×		
24	ADWI017124.6: Main UPS - Locking rods - Inspection and torque	See annex 'Taken photos': 5				
25	ADWI017124.7: Main UPS - Locking rod end - Inspection			/		
26	ADWI017124.8: Main UPS - Hinges - Auditory inspection

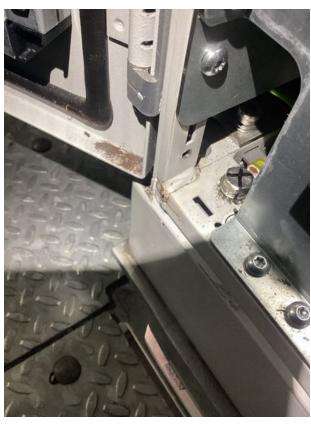
6 Figure from Checklist 'AD 5-135_1_1_5_MV_year_null', Task 27 - Remarks

27	ADWI017124.9: Main UPS - Internal structure - Inspection and torque	Remark 1 crack welding		×		
		See annex 'Taken photos': 6 Remark 2 See annex 'Taken photos': 7 Remark 3 how to reach the rear corner without dismounting back panel or roof?				
28	ATD000311.6: Wind turbine system - Emergency stop button at lift frame - Test					
29	ATD000383.0: Converter - Main components on the CCU - Inspection			/		
30	ATD000383.10: Converter - Ground connection - inspection					
31	ATD000383.11: Converter - Lateral fan with heater in CCU - inspection			<u> </u>		
32	ATD000383.12: Converter - Roof fan in FIU - Inspection			<u></u>		
33	ATD000383.13: Converter - Roof and door fan in POU - inspection					
34	ATD000383.14: Converter - Roof and door fan in DLU - inspection			/
