# Maintenance checks report

| Checklist name | Year |
|---|---|
| MV Maintenance Year 7 | 7 |

| Site | Turbine serial number | Order number |
|---|---|---|
| Wikinger | WK16 - 1121456 | 61160911 |

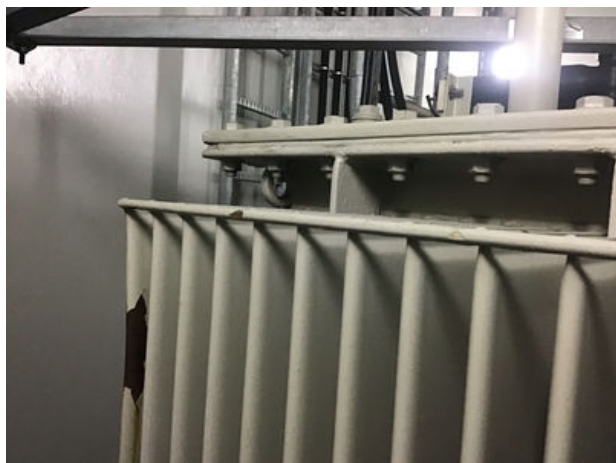
1 Figure from Checklist 'AD 5-135\_1\_1\_5\_MV\_year\_null', Task 59 - Remarks

| AD 5-135_1_1_5_MV_year_null | | | | |
|---|---|---|---|---|
| 59 | ATD000647.1: Main transformer - Paint - Inspection | Remark 1<br>See annex 'Taken photos': 1<br><br>Remark 2<br>See annex 'Taken photos': 2<br><br>Remark 3<br>See annex 'Taken photos': 3<br><br>Remark 4<br>See annex 'Taken photos': 4<br><br>Remark 5<br>Paint damage | | ✗ |
