Perth and Kinross
COUNTRYSIDE
TRUST

Kirkmichael 2023 Path Network Survey

Report

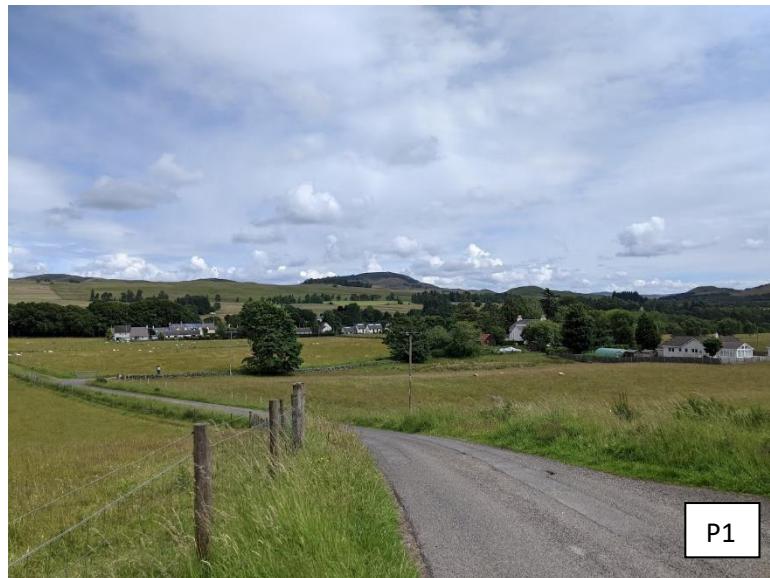
Figure 2 - Road walking conditions near Village Loop

Much of the Village Loop features paved road walking sections which are in a good condition. The road is not busy but does not feature pavements for pedestrians, regardless (see *Figure 2*). Although not on the Village Loop, many walkers will use the main bridge in town over the river to the small shop. This bridge also features no pavement but does have a painted designated area for pedestrians.

- Undefined path beside dry, empty burn to be revised [P10]
- Safer pedestrian protections on bridge in Kirkmichael
- Cateran Trail logo discs to be removed on sections of Pitcarmick Loop
- Inconsistent colours on waymarker arrow discs on Pitcarmick Loop to be revised
- Screws to be installed where missing on waymarkers
- Signage clutter and third-party sign to be revised on waymarker post [W2]

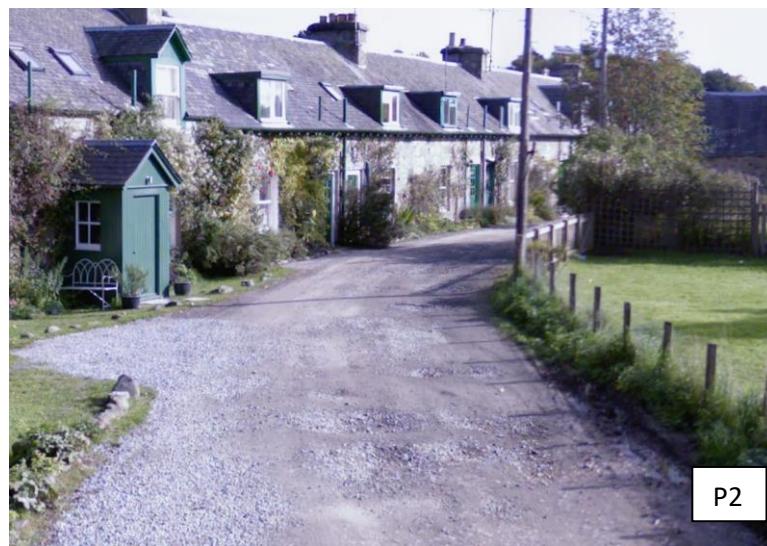
Figure 3 - Gravel road walking conditions on Village Loop

In the section by the cottages by the river, the Village Loop features gravel road walking. Other than numerous potholes, the condition is good (see *Figure 3*). Residents of these cottages use this same road to park their vehicles.

- Potholes to be repaired by Kirkmichael cottages [P2]
- Mount Blair Community Develop Trust website link on interpretation panels to be updated [S1, S2, S4]
- Narrow path to be widened [P8]

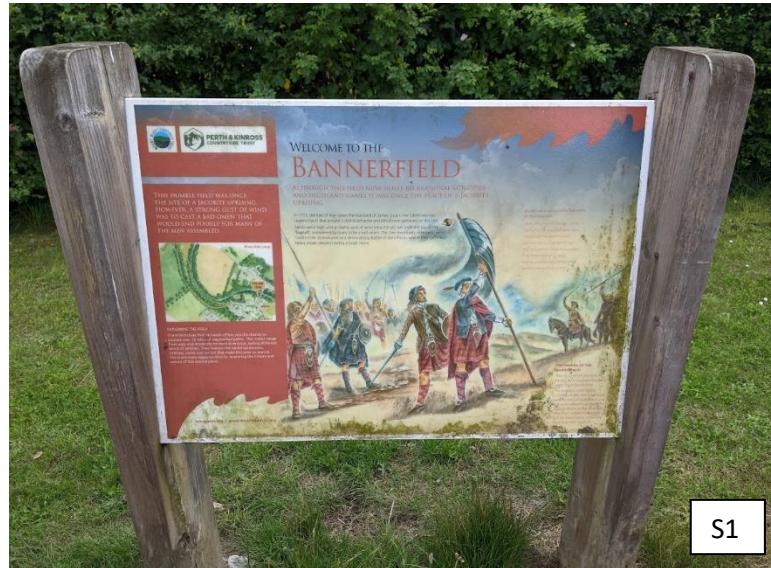
The structure of the ‘Welcome to the Bannerfield’ lectern is in good condition with no evidence of rotting or graffiti, it also has no lichen or moss. However, the panel itself requires some care (see *Figure 4*). The panel has not faded

and shows no sign of vandalism or deterioration. However, moss/dirt has stained many of the corners and sides of the panel.

Figure 4 - 'Welcome to the Bannerfield' interpretation lectern

- 'Welcome to the Bannerfield' interpretation lectern to be cleaned [S1]
- 'Kirkmichael Fairs' interpretation lectern to be replaced or fixed: cracks and scratches [S2]
- 'Pitcarmick Round Houses' interpretation lectern to have protective layer replaced: very cracked [S4]
- Convex road safety mirror to be installed by Kirkmichael carpark
- Cracked fingerpost graphics panel to be replaced [W1]
- Cracked fingerpost structure to be monitored: large cracks [W7]
- Rocky and slightly difficult to navigate path to be reviewed [P5]
- Fingerpost at entrance of lodges to be moved to a more visible area and before fork in path [P3]

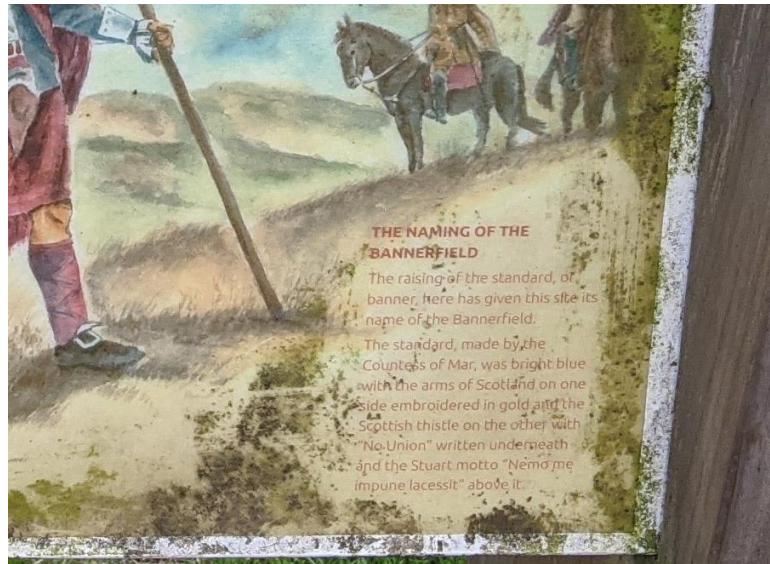
The bottom right of the panel shows evidence of cleaning by users to be able to read the text because of moss/dirt staining rendering it illegible (see *Figure 6*).

Figure 6 - Evidence of users cleaning staining to read text on 'Welcome to the Bannerfield' interpretation lectern

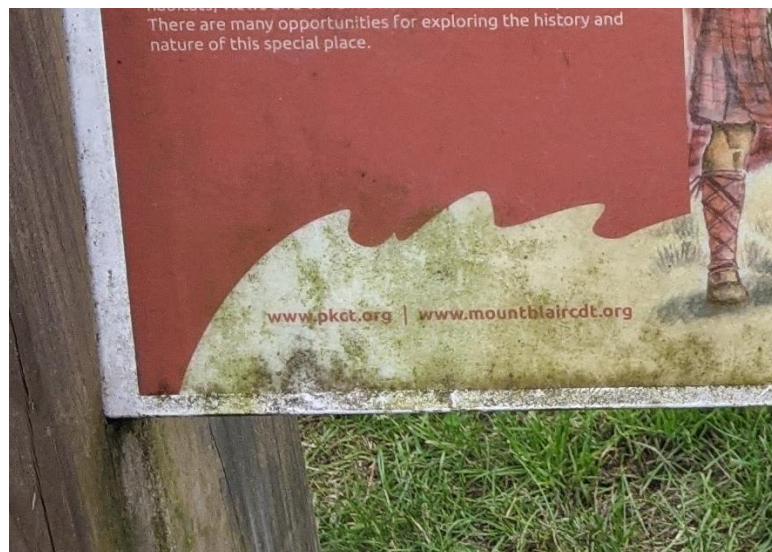
However, the bottom left of the panel has not been cleaned and renders the two internet URLs to PKCT and Mount Blair Community Development Trust (MBCDT), respectively, illegible (see *Figure 7*). Equally, the MBCDT URL is a dead link and does not lead to a live website at time of writing.

Figure 7 - Staining on bottom left of 'Welcome to the Bannerfield' interpretation lectern

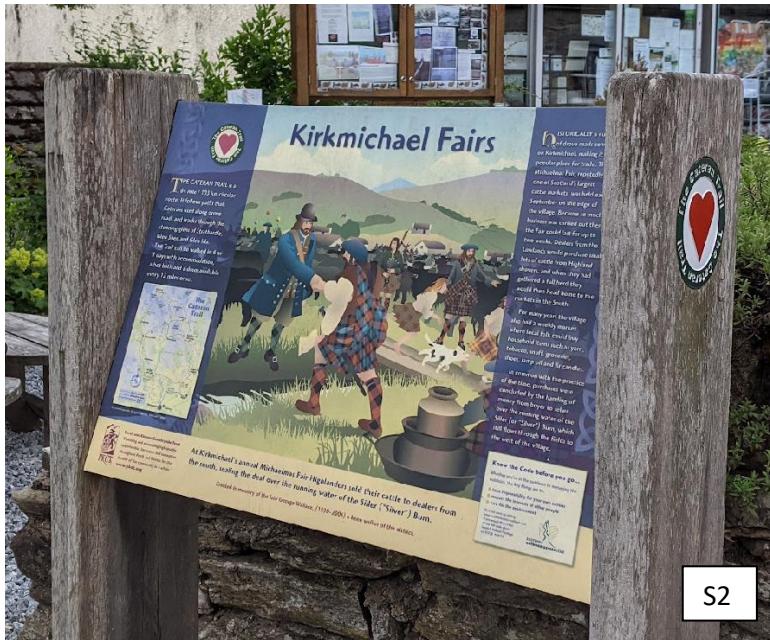
Figure 8 - 'Kirkmichael Fairs' interpretation lectern

The interpretative 'Kirkmichael Fairs' lectern near the village shop is considerably cleaner than its 'Welcome to the Bannerfield' counterpart, but, however, shows signs of graffiti or deterioration.

The wooden structure of the lectern is in good condition minus some minor staining from bird droppings. The painted *Cateran Trail* logo is in very good condition (see Figure 8).

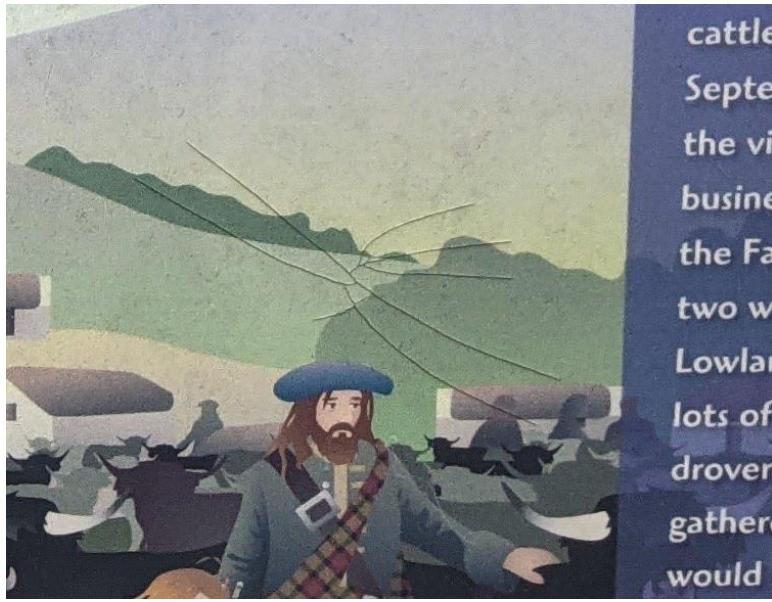
Figure 9 - Cracking on 'Kirkmichael Fairs' interpretation lectern

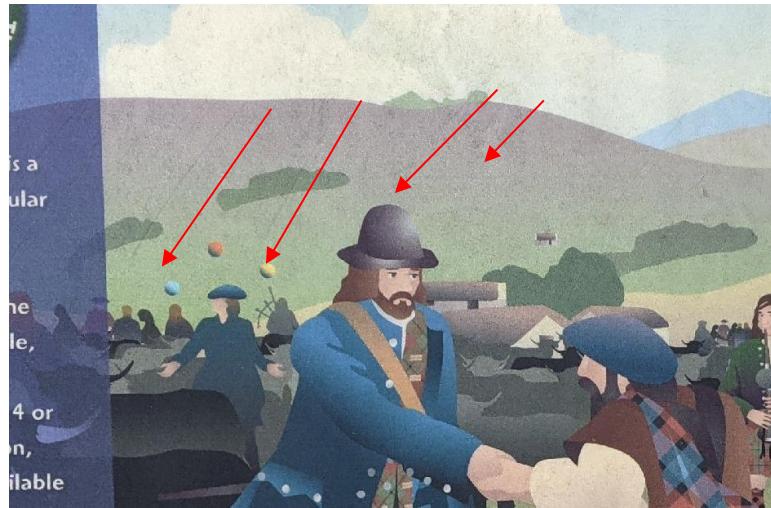
The graphics panel itself is cleaner than the 'Welcome to the Bannerfield' panel but is still stained slightly altogether with dirt more visible in light-coloured areas. There is one crack in the main illustration on the panel (see Figure 9), and there are some faint scratch marks also (see Figure 10). The red arrows highlight the scratches (arrows sit to right of scratches). The panel has a very old PKCT and Scottish Outdoor Access logo and may generally be considered dated overall.

Figure 10 - Scratches on 'Kirkmichael Fairs' interpretation lectern

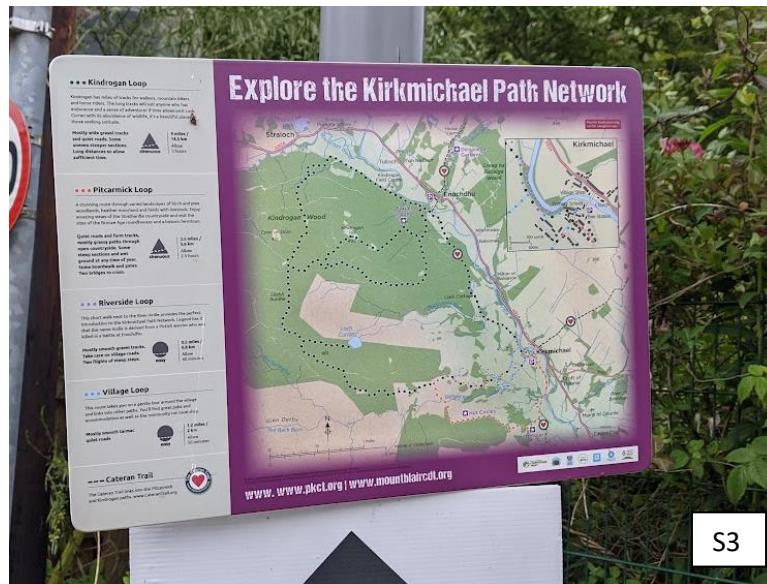
Figure 11 - 'Explore Kirkmichael Path Network' interpretation sign

Beside the primary school there is a small 'Explore Kirkmichael Path Network' sign (see *Figure 11*). The sign is in good condition and very vivid, but with a couple imperfections to note.

The 'Explore Kirkmichael Path Network' sign is surrounded by other signs including a small speed limit reminder sign, a title sign for the primary school nearby, and a temporary corrugated plastic arrow.

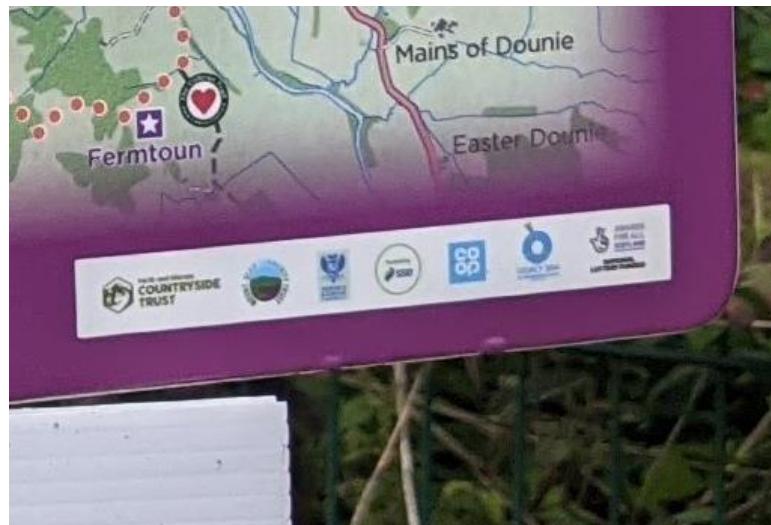
Figure 12 - Close up of 'Explore Kirkmichael Path Network' interpretation sign

Some edges of the panel show evidence of deterioration or weathering, as bubbling can be seen under the graphics print on the panel itself (see Figure 12).

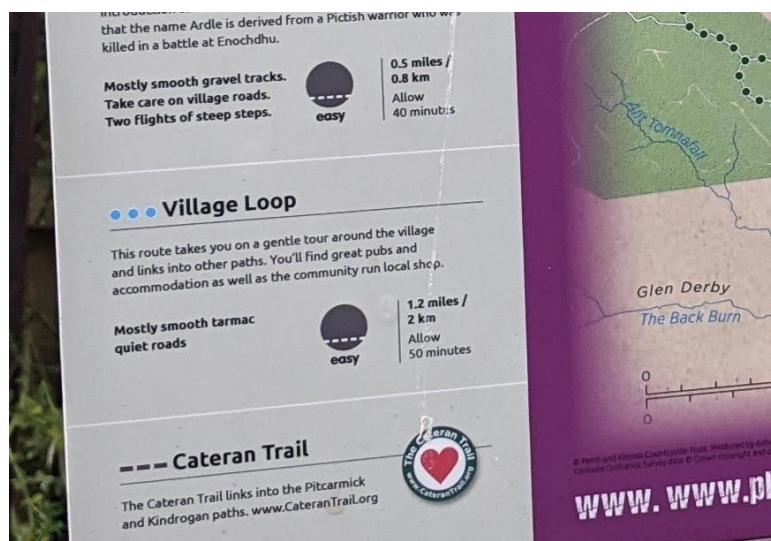
Figure 13 - Close up of 'Explore Kirkmichael Path Network' interpretation sign with visible markings

The left side of the sign has evidence of staining, bubbling and a large scratch mark (see Figure 13). Again, the Mount Blair Community Development Trust link has expired.

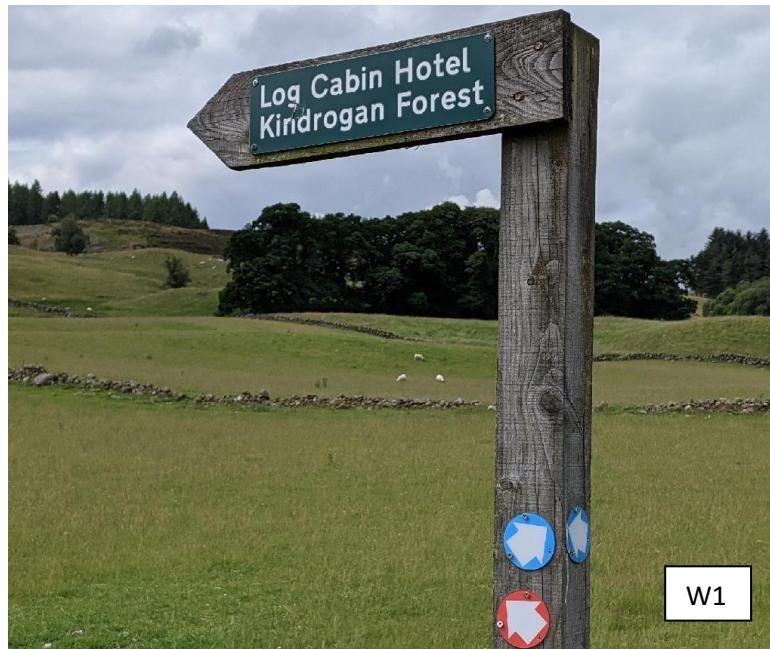
Figure 14

Where the Village Loop turns back into the village, the fingerpost present has a large crack on the sign (see *Figure 14*). Equally, there is at least one screw missing from each waymarker disc.

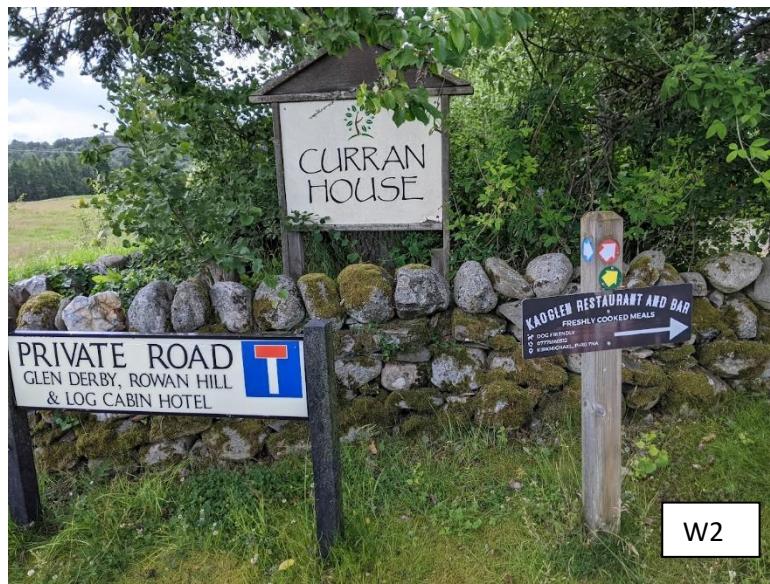
Figure 15

The waymarker post on the Village Loop leaving the village towards the lodges is surrounded by many other signage clutter. Moreover, the post has had a third-party sign affixed to it (see *Figure 15*). Moreover, the waymarker discs have some missing screws.

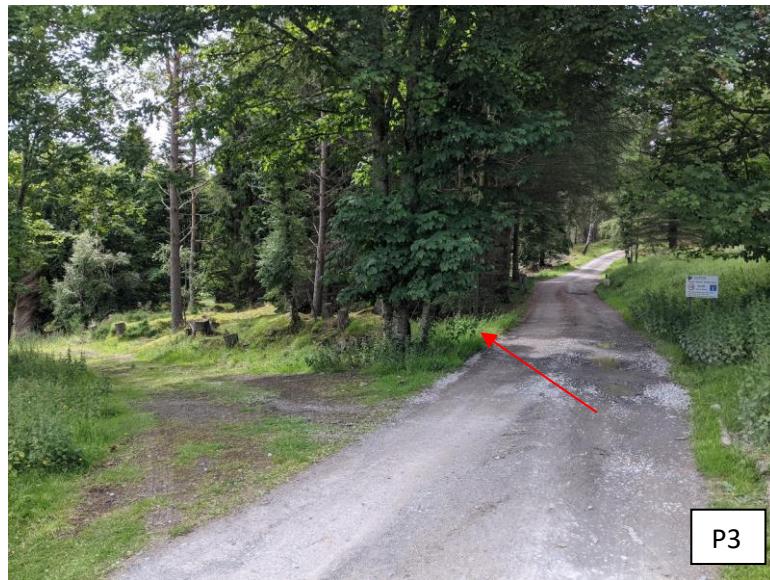
Figure 16

The path at this point stops being paved and turns into gravel roads in a holiday lodge site. The gravel stones are small and so are easy to walk on. There is a finger post (W4, see *Figure 32*) beyond the dirt track to the left which may be missed by some users as it is in the shadows and is beyond the fork in the path (see *Figure 16*, red arrow).

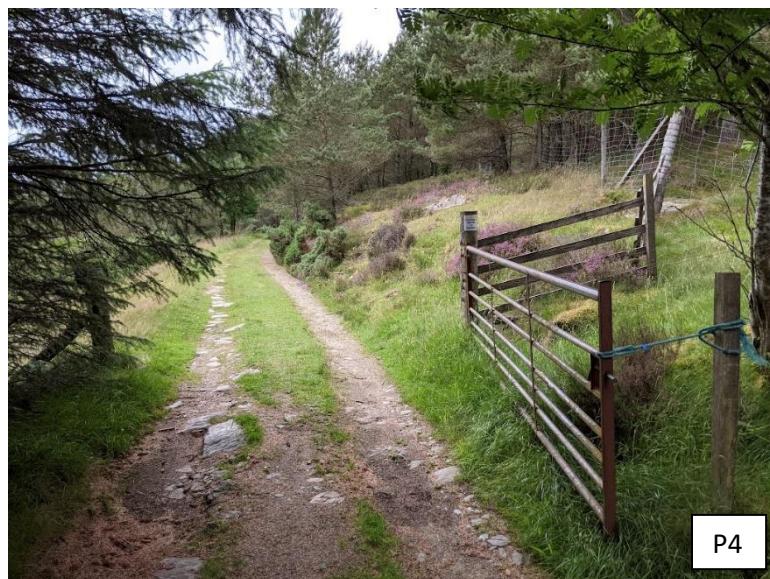
Figure 17

The path onwards from the top of the lodges gravel road forking off to the left here becomes increasingly rocky with a grass median. This area of path is no longer gravel with small stones (see *Figure 17*).

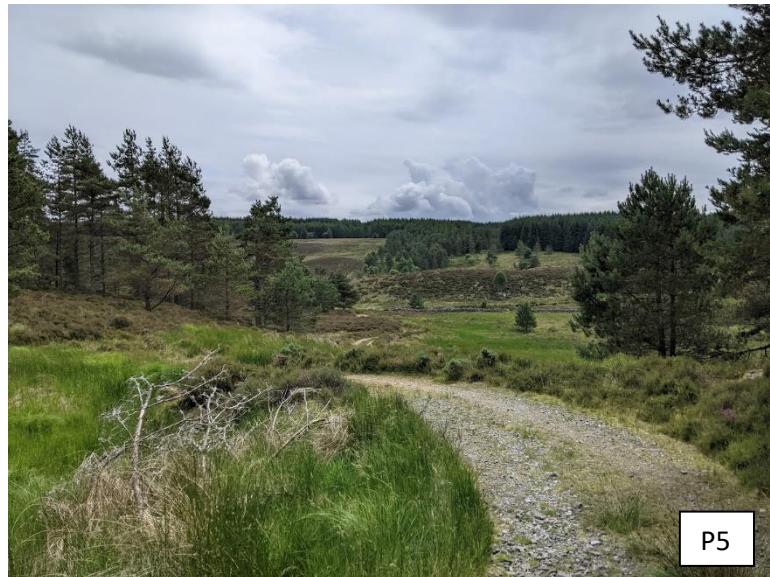
Figure 18

The section of path forking off to the left from the top of the lodges towards the burn is particularly rocky, but is otherwise good. The grass median is not overgrown but the fairly large rocks may cause issues to those with mobility issues

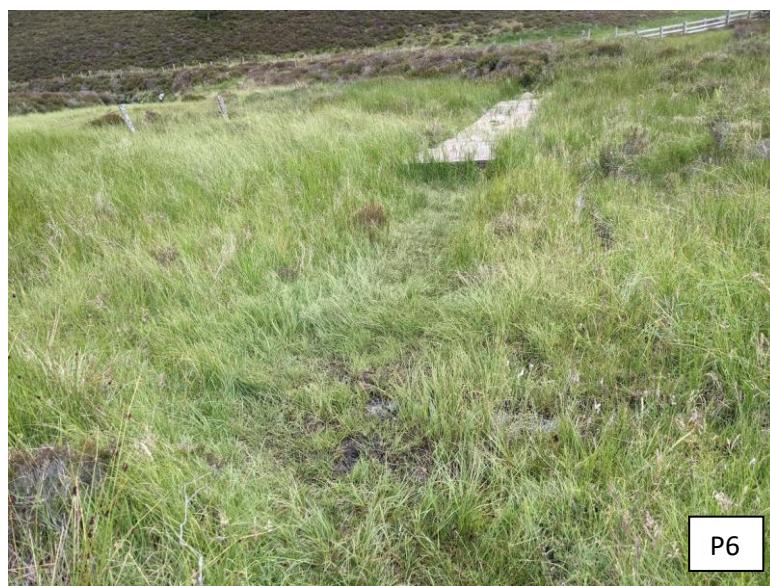
Figure 19

After crossing the metal bridge (see *Figure 59*, *Figure 60* and X3), the immediate area is susceptible to flooding and is thus moderately boggy (see *Figure 19*). A raised recycled plastic boardwalk raises users above the boggy path.

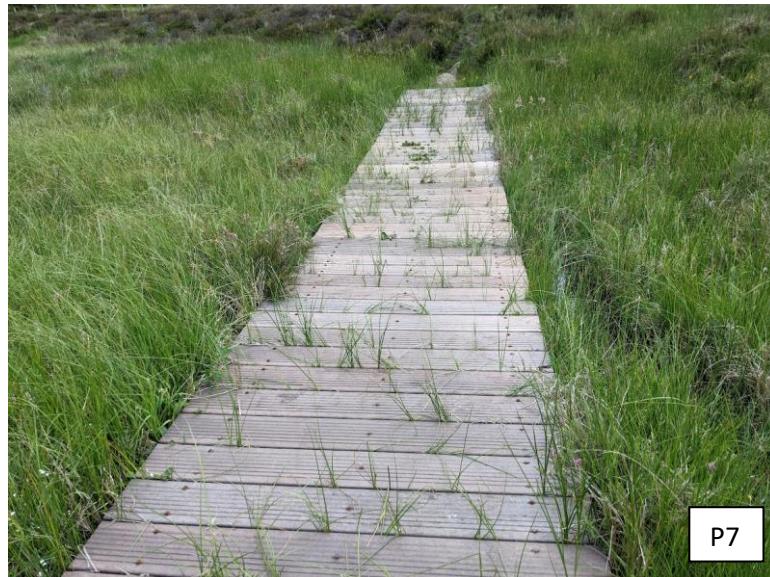
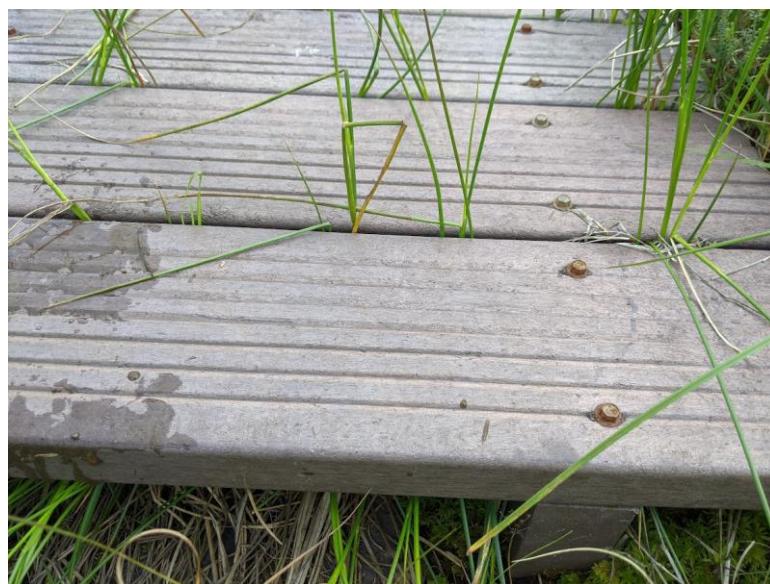
The recycled plastic raised boardwalk is in very good condition and shows virtually no signs of deterioration (see *Figure 20* and *Figure 21*). Tall grass does, however, grow between the gaps. The boardwalk also partially undulates towards the left and right following the ground below.

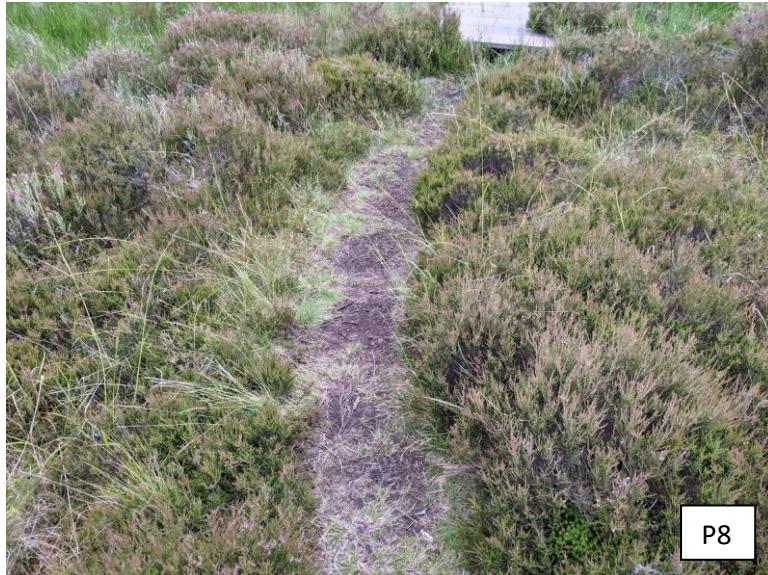
Figure 22

Few sections of the boardwalk path are incomplete and return to thin dirt footpaths between boggy heather and tall grass. The condition of these sections of path is good, if somewhat narrow, and not as boggy as sections nearer to the burn. The height between the boardwalk and the footpath is low and does not feature a noticeable drop either side; it is level and suitable.

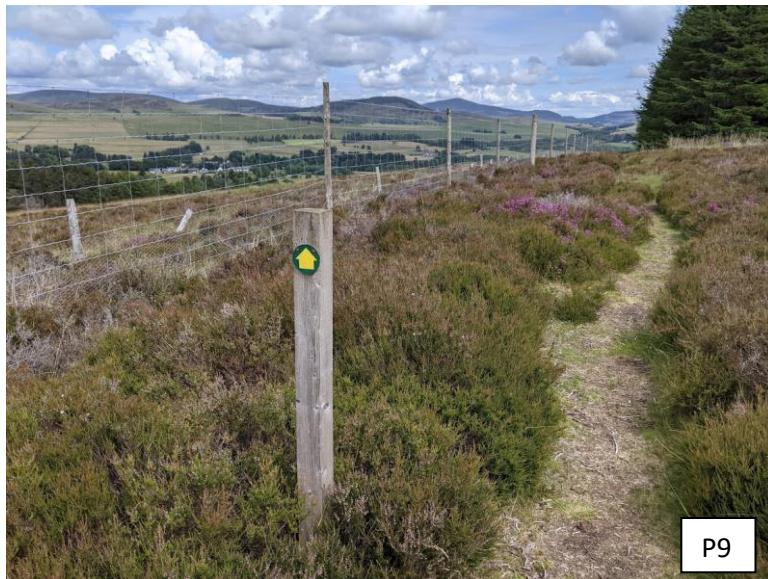
Figure 23

This section of path beyond the high deer fence towards the stone hut circles is very good, if a little narrow (see *Figure 23*). However, there are sections where heather and grass tufts are slightly overgrown and in the median of the path.

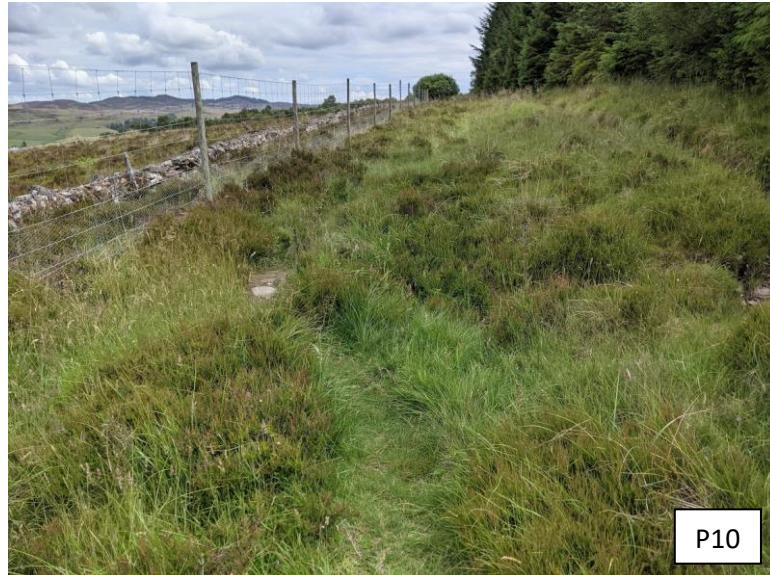
Figure 24

This section of path is less defined than the previous section and slightly more overgrown (see *Figure 24*). It is also quite narrow. However, less heather in this area would make maintaining this section much easier. A small burn runs to the west of the path (see *Figure 25*) which may be confused for the footpath, and is, in fact, arguably more defined than the actual footpath as it is, in parts, wider and more defined with rocks.

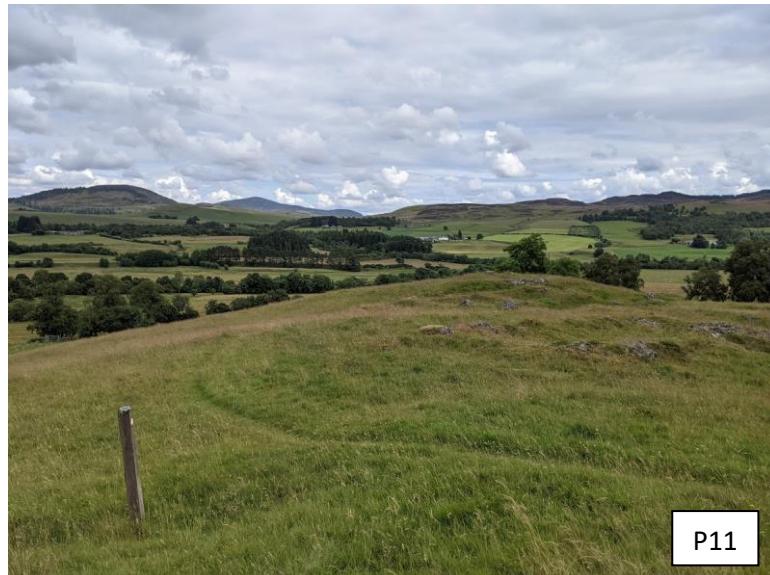
P11

The section of path down towards the Cateran Trail and past the stone hut circles goes across grassy fields with a faintly defined path. The colour of the path and the surrounding field is very similar, and thus the compressed grassy path acts as the only navigation tool next to waymarkers.

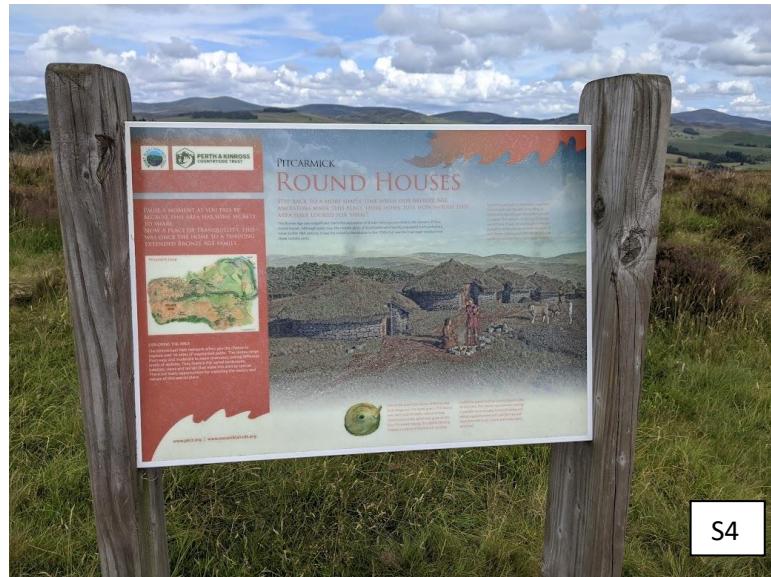
S4

The ‘Round Houses’ interpretation lectern structure is in very good condition and shows no evidence of vandalism or deterioration (see *Figure 28*). Overall, the sign is very legible and should not require cleaning. However, the protective coating on the panel (see *Figure 29*) is very cracked and uses an old PKCT logo. Moreover, the MBCDT link in the bottom left of the panel is expired.

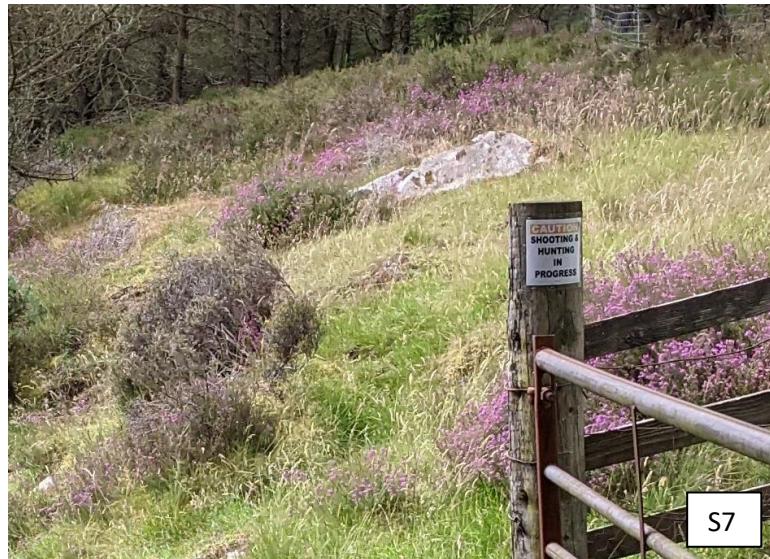
Figure 30

There is a warning sign upon leaving the lodges gravel track into the fields on the Pitcarmick Loop path regarding hunting and shooting. The sign does not reference deer stalking or grouse shooting and thus times cannot be looked up regarding hunting times. The sign shows signs of fading suggesting it remains perhaps all year round, this may greatly reduce public access (see *Figure 30*). Equally, the estate does not seem to appear on Outdoor Access Scotland's website: <https://www.outdooraccess-scotland.scot/doc/heading-scottish-hills-stalking-tables-eastern-highlands-area-5>.

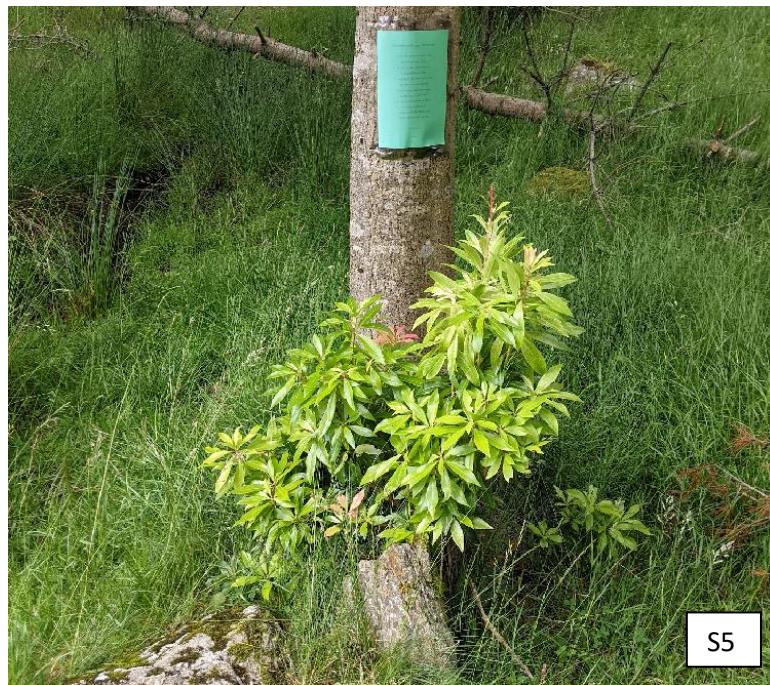
Figure 31

Towards the upper left of the lodges path there features a makeshift memorial and laminated poem stapled to a tree (see *Figure 31*).

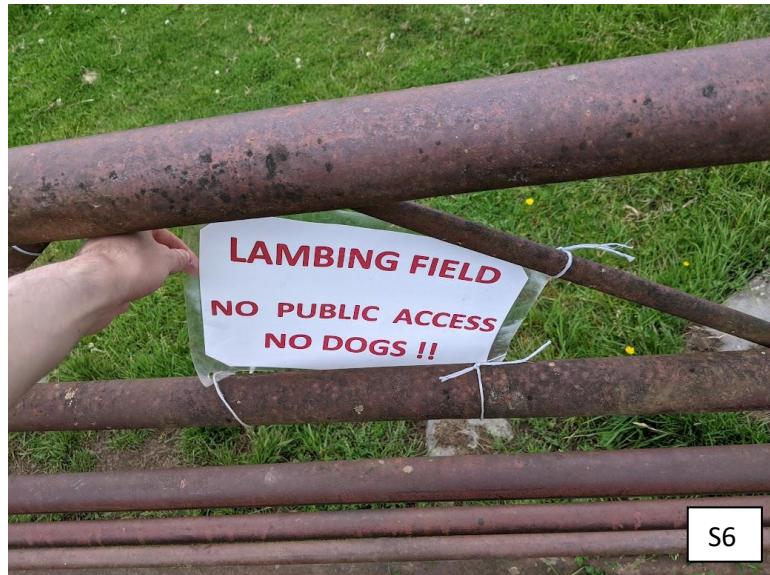
Figure 32

There is a laminated informal sign on a metal field gate near the Cateran Trail. At time of writing, the field gate was open and could be a confusing fork in the path for walkers. In such a case, the below laminated sign may assist walkers but the contents and restrictions imposed by the landowner via the sign may restrict public access (see *Figure 32*).

- Walkway, platform or ramp to be installed by dangerous drop at bridge over Balnald Burn [X3]
- High field gate to be fixed and barbed wire-hinge removed by 'Pitcarmick Round Houses' interpretation lectern [X5]
- Heavy wooden field gate to be balanced and fixed [X7]
- Toppled gate/fence on recycled plastic boardwalk to be fixed [X4]
- Outdated shooting sign potentially prohibiting public access to be removed or updated with accurate information [S7]

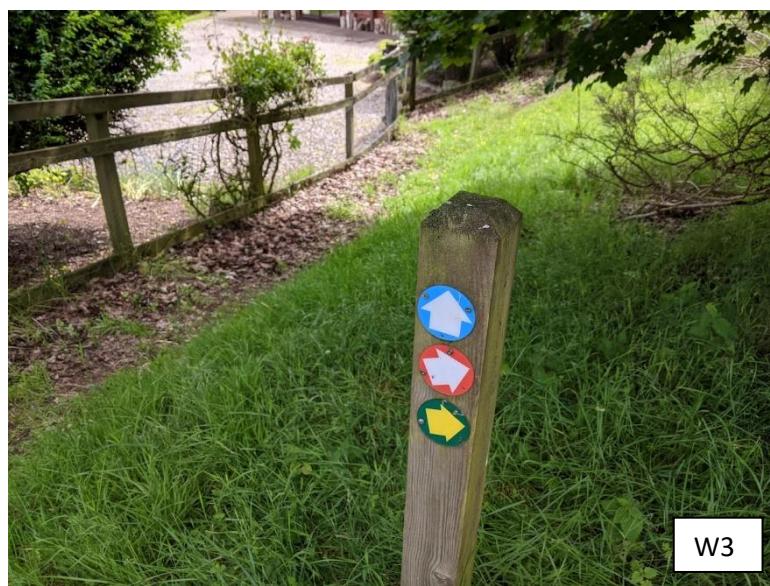
Figure 33

The first waymarking post in the lodges area on the Pitcarmick Loop is in very good condition and easily visible. It does, however, have at least one missing screw on each waymarker disc (see *Figure 33*).

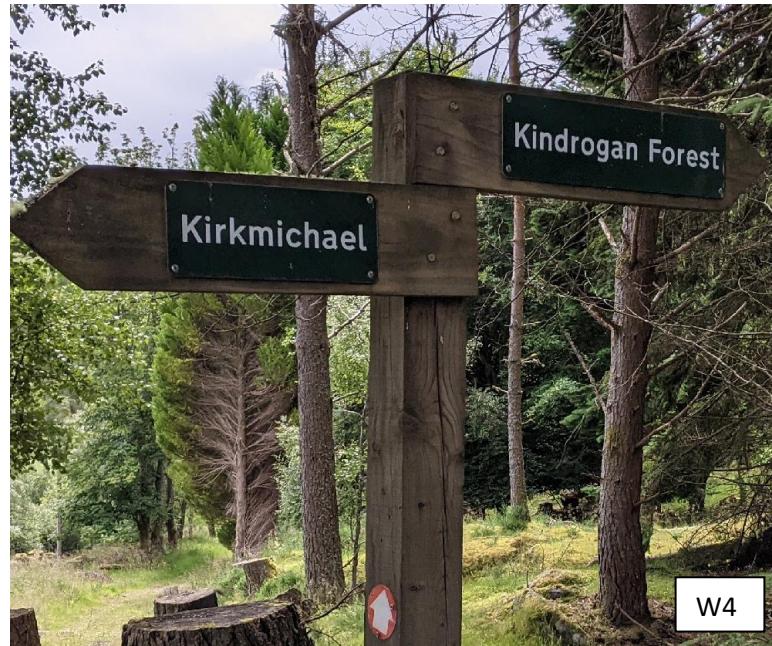
Figure 34

The first fingerpost upon entering the lodges area is in very good condition with high quality signage. There is some lichen on the fingerposts and some minor bird droppings staining on the signage panels. Moreover, at least one

screw is missing from each waymarker disc. Most importantly, however, the fingerpost comes after the fork in the path and sits under the tree canopy in the shade; whilst its direction parallel with the lodges gravel path may make it more visible to those users on the Village Loop coming to a fork in the path, it may be easily missed by those already on the lodges gravel path, but it may, however, be missed completely as it sits in the shade (see *Figure 34*).

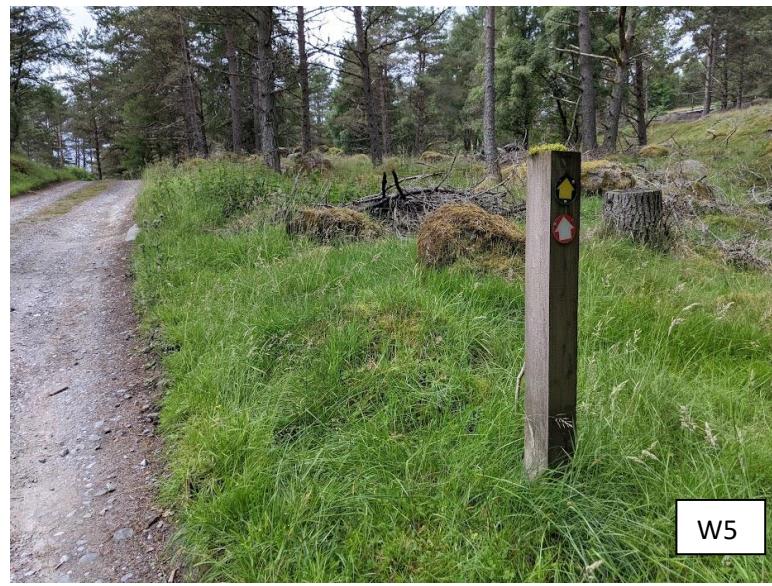
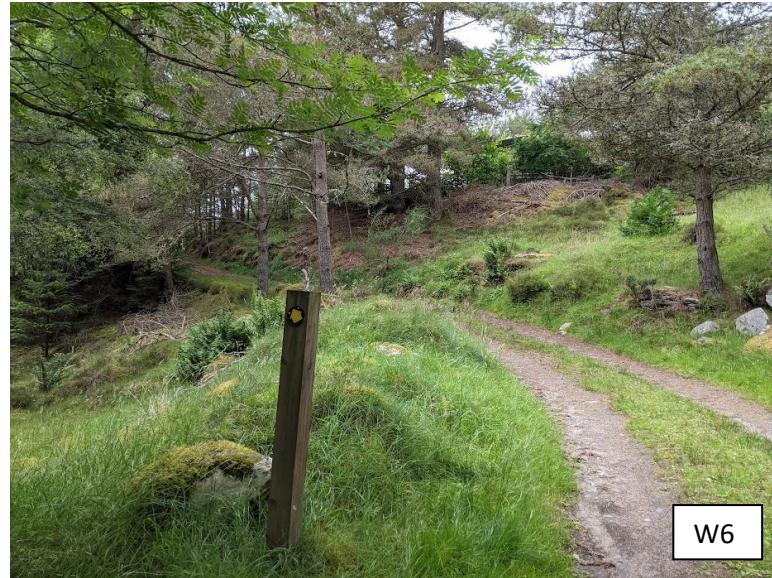
Waymarker posts throughout the lodges gravel track are in very good condition other than some missing screws on waymarker discs. There is also lichen/moss on each waymarker post (see *Figure 35* and *Figure 36*).

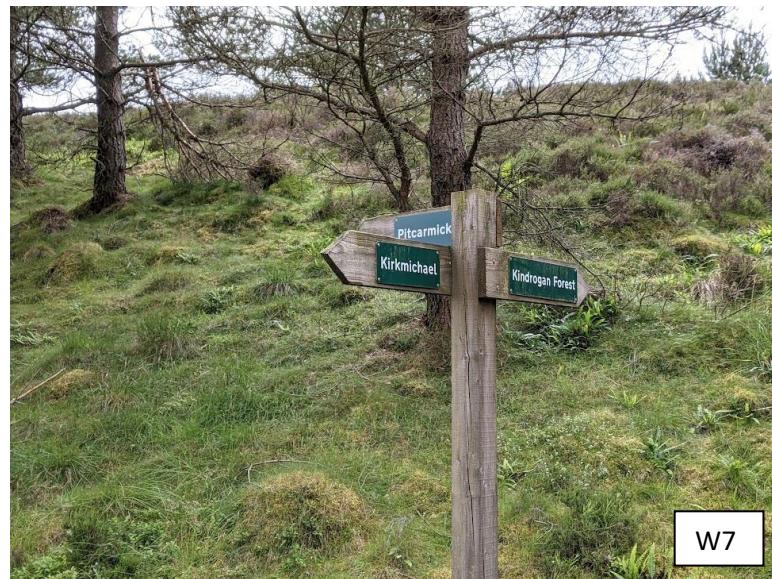
Figure 37

The fingerpost at the crossing between the Pitcarmick Loop path and the Kindrogan Forest path is in okay condition (see *Figure 37*). It is slightly stained green and features some moss and lichen. However, the cracking in the main post may soon expand and should be monitored for potential further deterioration. The graphics panels are in very good condition.

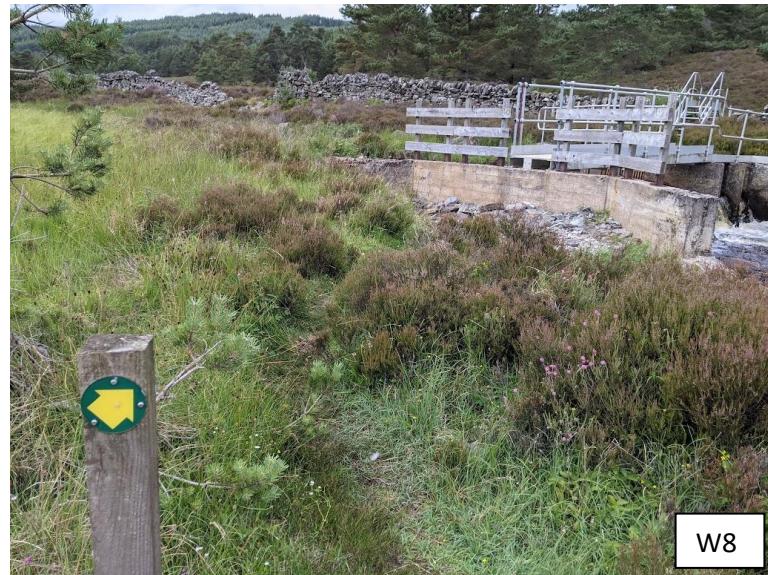
Figure 38

All remaining waymarkers on the Pitcarmick Loop are in very good condition and very sturdy (see *Figures 38–58*), apart from some missing screws (see *Figures 44, 48, and 53* for examples) some missing logo discs (see *Figure 50*) and some inconsistencies in the colour palette (see *Figures 49–53*). There is also a third-party logo disc on the waymarker closest to Kirkmichael towards the south (see *Figure 58*). Some waymarker posts also feature the Cateran Trail logo despite not being on the official Cateran Trail footpath (see *Figure 39, 46 and 51*).

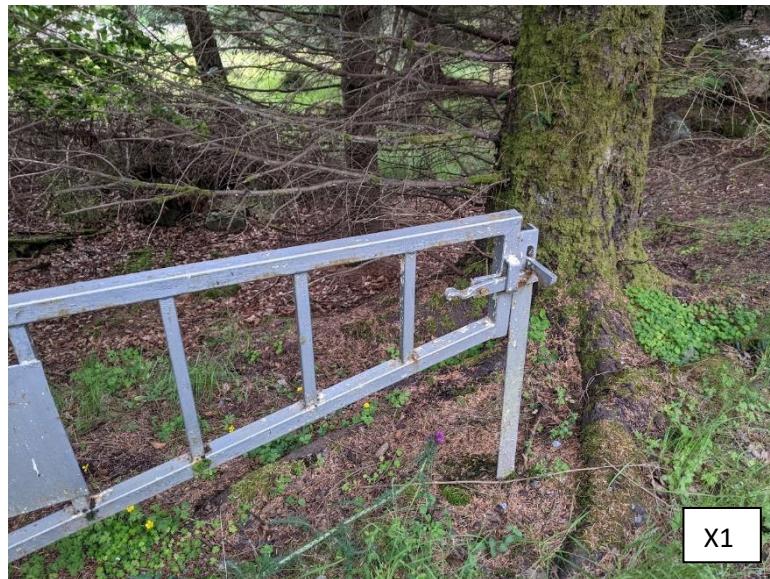
Figure 59

Near the entrance of the lodges on the Pitcarmick Loop there is a large metal road barrier (see *Figure 59*), given its poor condition (rust, peeling paint and bird droppings), it suggests that it is rarely closed and thus does not obstruct public access.

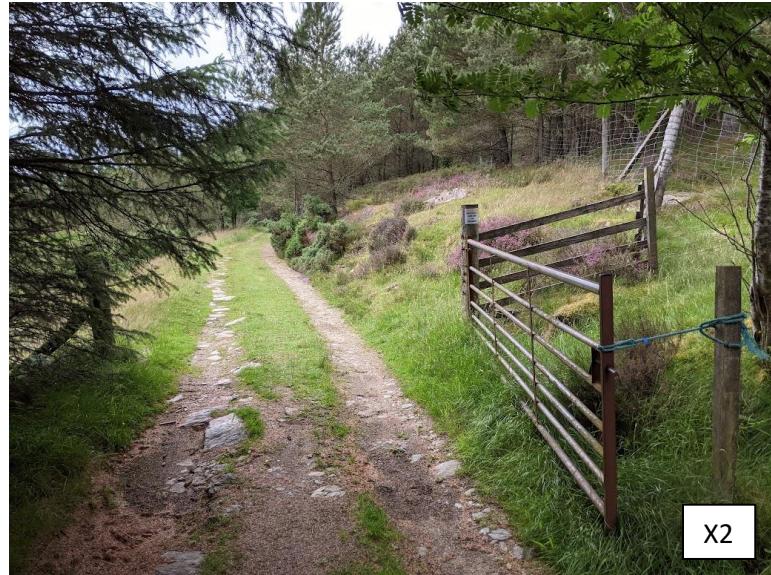
Figure 60

Towards the end of the lodges at the top of the track there is a large metal field gate (see *Figure 60*), it is tied open with blue rope. The path's overgrown branches and tall grass suggests it is rarely closed and thus does not obstruct public access.

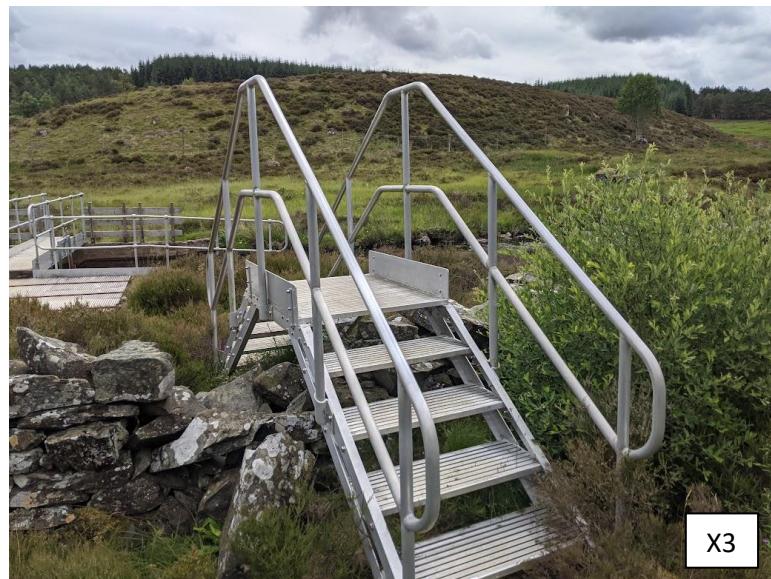
Figure 61

There is a large metal stile over a dry-stone wall near Balnald Burn (see *Figure 61*) with handrails. It is in very good condition.

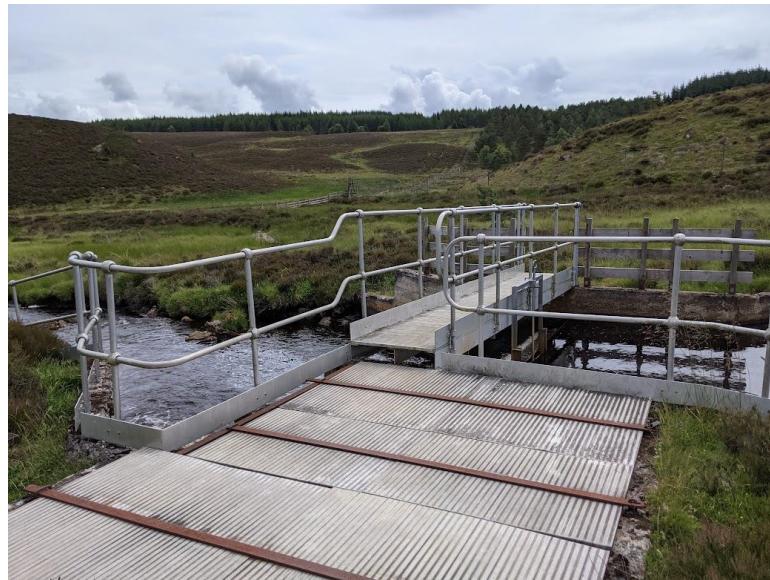
Figure 62

Similarly, the bridge and platform across Balnald Burn (see *Figure 62*) is in very good condition but may be slippery when wet.

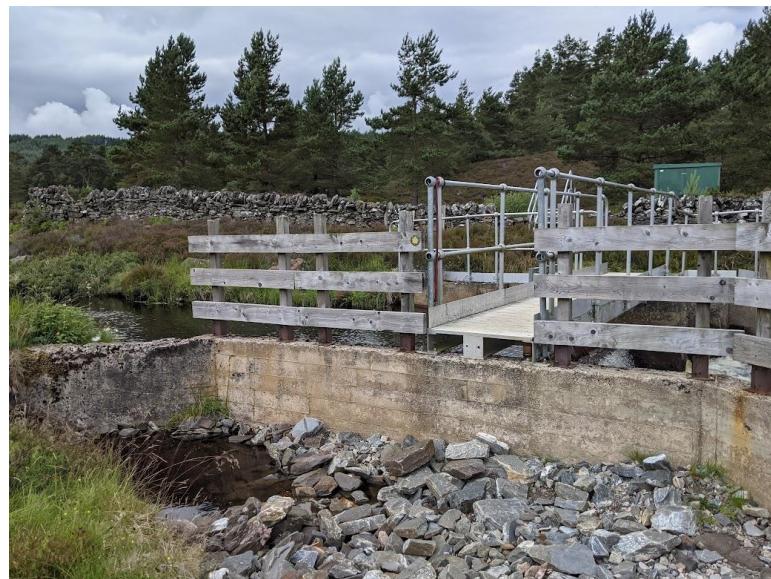
Figure 63

Beyond the bridge there is a steep and dangerous drop from the bridge onto the rocky ground (see *Figure 63*). The rocky area also appears to often flood as there was a large puddle at time of surveying. There is a dog lead attached to the railing of the bridge which may be used by walkers to ascend and descend.

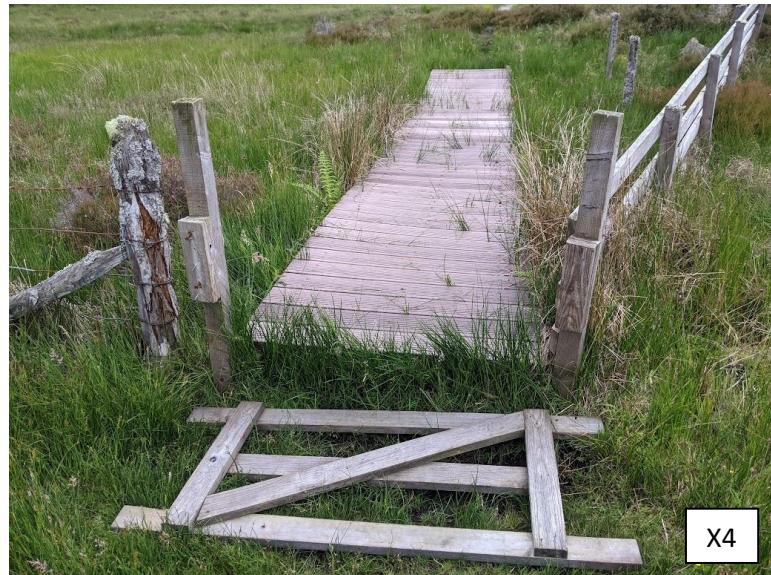
Figure 64

The start of the boardwalk begins with a toppled fence/gate (see *Figure 64*). It appears to temporarily sit on supports on the adjoining fences, but does not open and close on a hinge. Equally, there are four exposed nails (head exposed, not point) on the wooden support on the fence post to the left. The toppled fence/gate sits on a boggy section of ground so was perhaps put there by walkers.

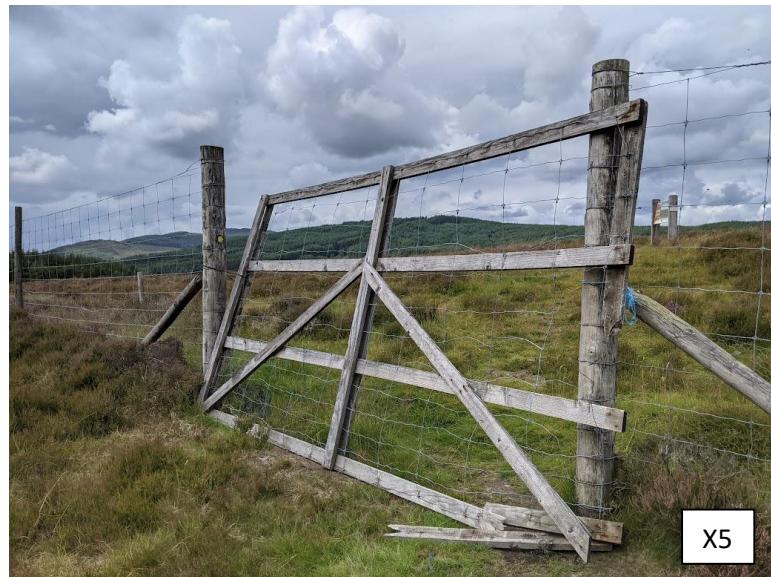
Figure 65

The high field gate beside the ‘Pitcarmick Round Houses’ interpretation lectern is in a very bad condition (see *Figure 65*). Wooden panels are broken and it does not stand up unless leaning against the adjoining fences slightly. There is an informal hinge made of metal wiring, of which the top hinge is made of barbedwire (see *Figure 66*).

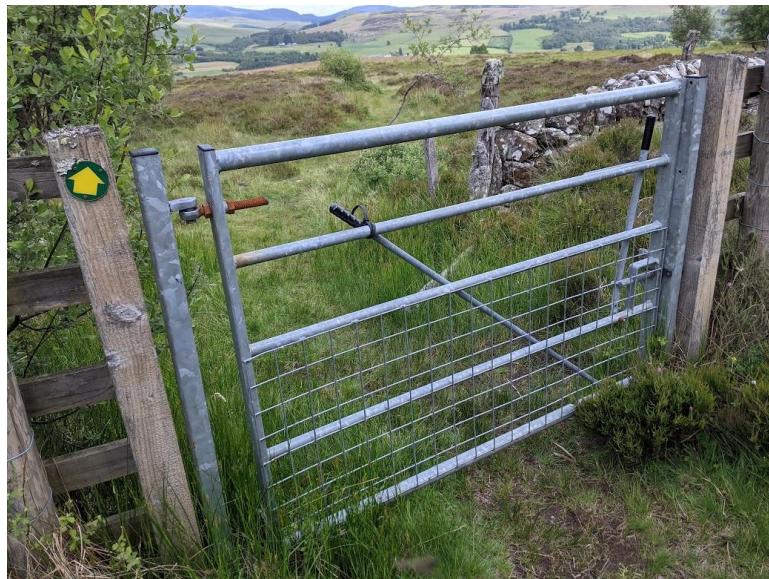
Figure 67

Towards the end of the forest plantation section of the Pitcarmick Loop there begins a series of self-closing gates. Both gates are in very good condition (see *Figure 67* and *Figure 69*), however the former has the tall lever zip tied down.
