Perth and Kinross
COUNTRYSIDE
TRUST

Kirkmichael 2023 Path Network Survey

Report

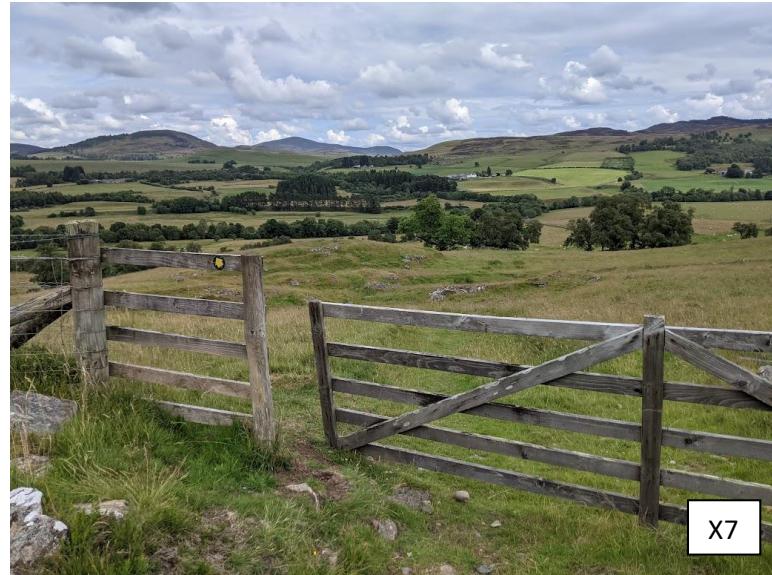
Figure 68

Between the two modern self-closing gates there is a heavy wooden field gate (see *Figure 68*). Its condition is fair, however it sits on the ground and requires the user to lift it to open and close. There is an informal metal wire hinge around the adjoining fence post which is also very close to barbedwire which sits loose off the post.

- Walkway, platform or ramp to be installed by dangerous drop at bridge over Balnald Burn [X3]
- High field gate to be fixed and barbed wire-hinge removed by 'Pitcarmick Round Houses' interpretation lectern [X5]
- Heavy wooden field gate to be balanced and fixed [X7]
- Toppled gate/fence on recycled plastic boardwalk to be fixed [X4]
- Outdated shooting sign potentially prohibiting public access to be removed or updated with accurate information [S7]

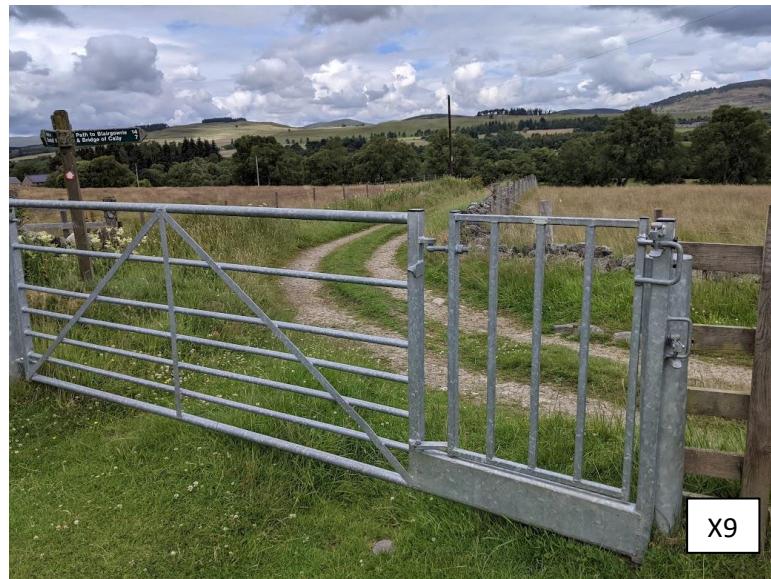
Figure 70

As the Pitcarmick Loop joins the Cateran Trail, there is a step-over self-closing gate which is in very good condition (see *Figure 70*). The large wooden farm track bridge into Kirkmichael is also in very good condition (see *Figure 71*).

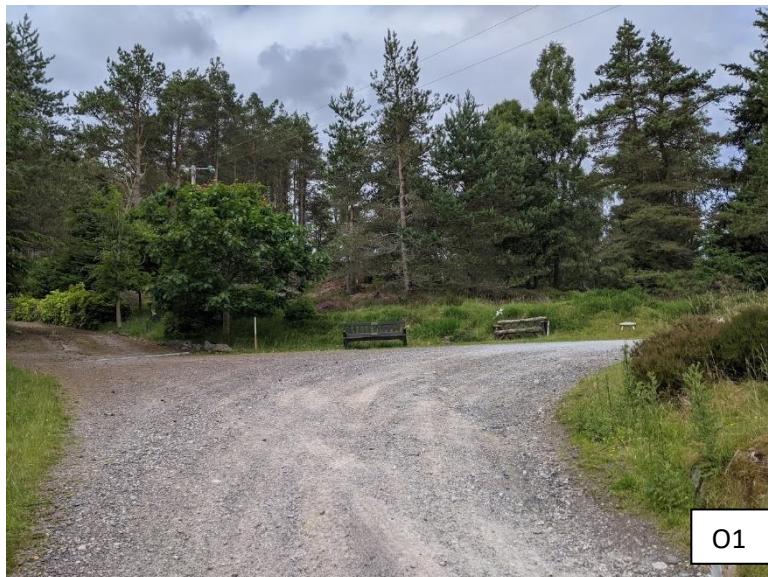
To some walkers it may be very easy to walk off of the designated path at the top section of the lodges track as it forks to the left and the right and both seemingly appear well paved and welcoming. It is at this location where there may be an opportunity for waymarking (see *Figure 72*). There is already a white thin wooden mast in the ground painted white at the top of the fork, but it is not obvious if this is a waymarker or something else installed by a third-party (see *Figure 73*).

Figure 72 - Waymarking opportunity at top of lodges gravel road

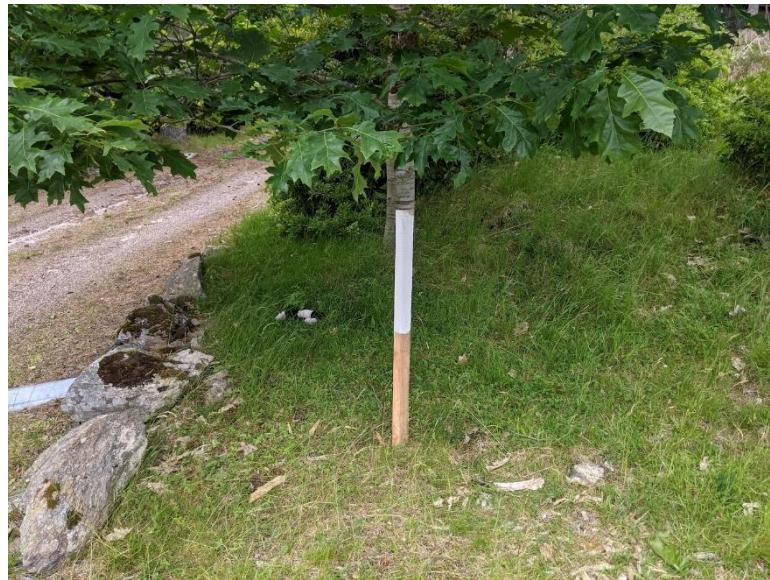
Figure 73 – Close up of post at top of lodges gravel road as above

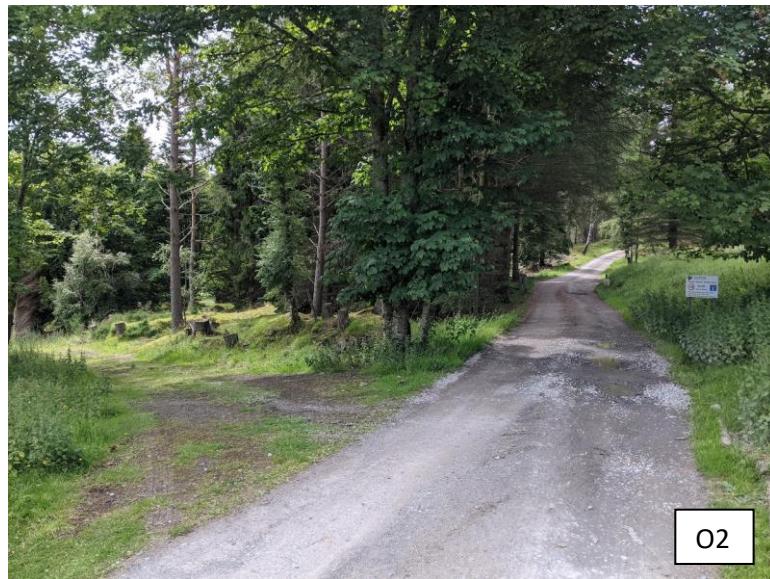
screw is missing from each waymarker disc. Most importantly, however, the fingerpost comes after the fork in the path and sits under the tree canopy in the shade; whilst its direction parallel with the lodges gravel path may make it more visible to those users on the Village Loop coming to a fork in the path, it may be easily missed by those already on the lodges gravel path, but it may, however, be missed completely as it sits in the shade (see *Figure 34*).

On the path towards the entrance to the lodges track there is an existing fingerpost waymarker for the attention of walkers on the Village Loop and Pitcarmick Loop. As it sits *after* the fork in the path and beneath the shadows of trees, it may be easily missed by walkers who instead may take the leftmost path at the fork (see *Figure 74*).

Figure 74 - Existing waymarker in shadows and after fork in path

- 'Welcome to the Bannerfield' interpretation lectern to be cleaned [S1]
- 'Kirkmichael Fairs' interpretation lectern to be replaced or fixed: cracks and scratches [S2]
- 'Pitcarmick Round Houses' interpretation lectern to have protective layer replaced: very cracked [S4]
- Convex road safety mirror to be installed by Kirkmichael carpark
- Cracked fingerpost graphics panel to be replaced [W1]
- Cracked fingerpost structure to be monitored: large cracks [W7]
- Rocky and slightly difficult to navigate path to be reviewed [P5]
- Fingerpost at entrance of lodges to be moved to a more visible area and before fork in path [P3]

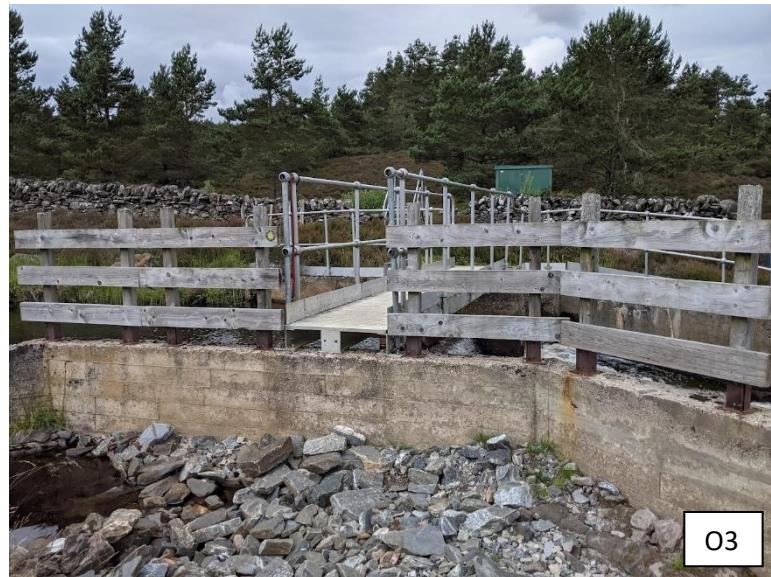
Figure 75 - Opportunity for ramp or steps onto bridge

The stand-out opportunity on the Pitcarmick Loop is at the Balnald Burn. Here, the bridge has a sharp drop on one side to a rocky, often flooded or partially flooded ground (see *Figure 76*). The viability of this walk is greatly reduced for users with limited mobility at this point in by the burn. There should be a platform and ramp installed.
