KADAK BIJLI – THE FORGE-WELDED IRON CANNON AT JHANSI FORT

R. BALASUBRAMANIAM*

The forge-welded iron cannon by name *Kadak Bijli*, located at Jhansi Fort, is described here. It measures 5.5 m in length and weighs about 5 tons. The barrel of the cannon has been constructed by hooping two iron rings over 11 longitudinal iron staves. The iron rings were hooped over such that the second layer of rings closed the gaps between the first layer of rings. Valuable information about its design and construction is available in the damaged rear portion of the cannon. The unique design of the firing mechanism in the rear portion indicates the intricate engineering of the cannon. The damaged portion reveals that the thickness of iron staves increased on progressing into the barrel of the cannon. Further, the inner rings maintain their thickness nearly constant while the external rings become progressively thicker, thereby providing the apparent tapered appearance to the barrel of the cannon.

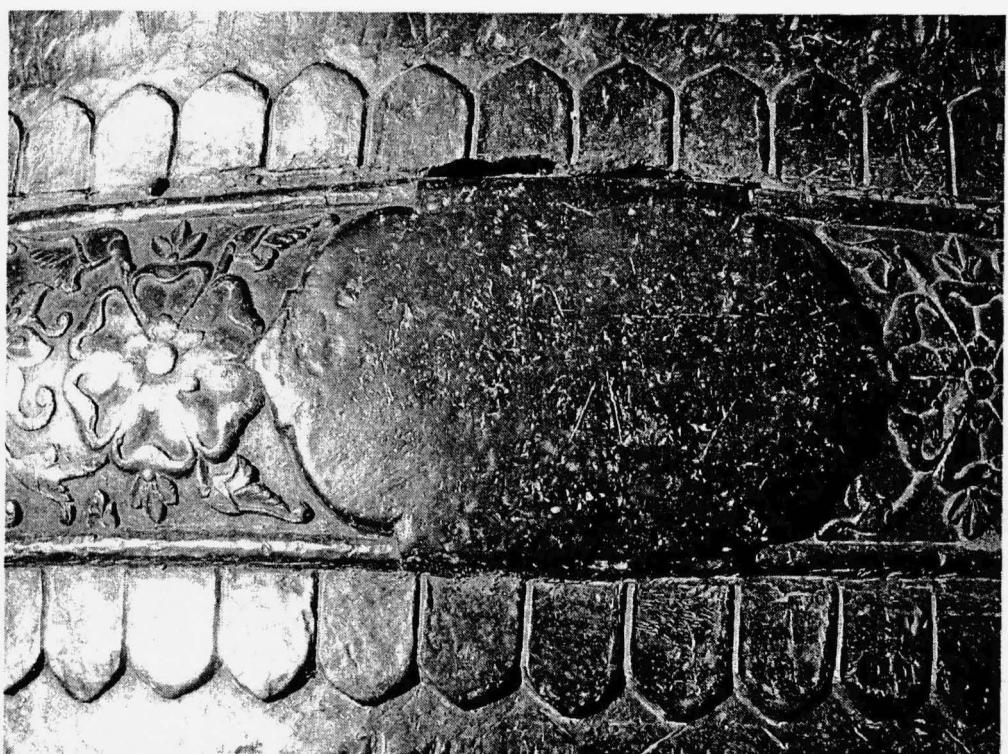
Fig. 2: Specially prepared surface on the ring that holds the trunions. This must have originally contained an inscription.

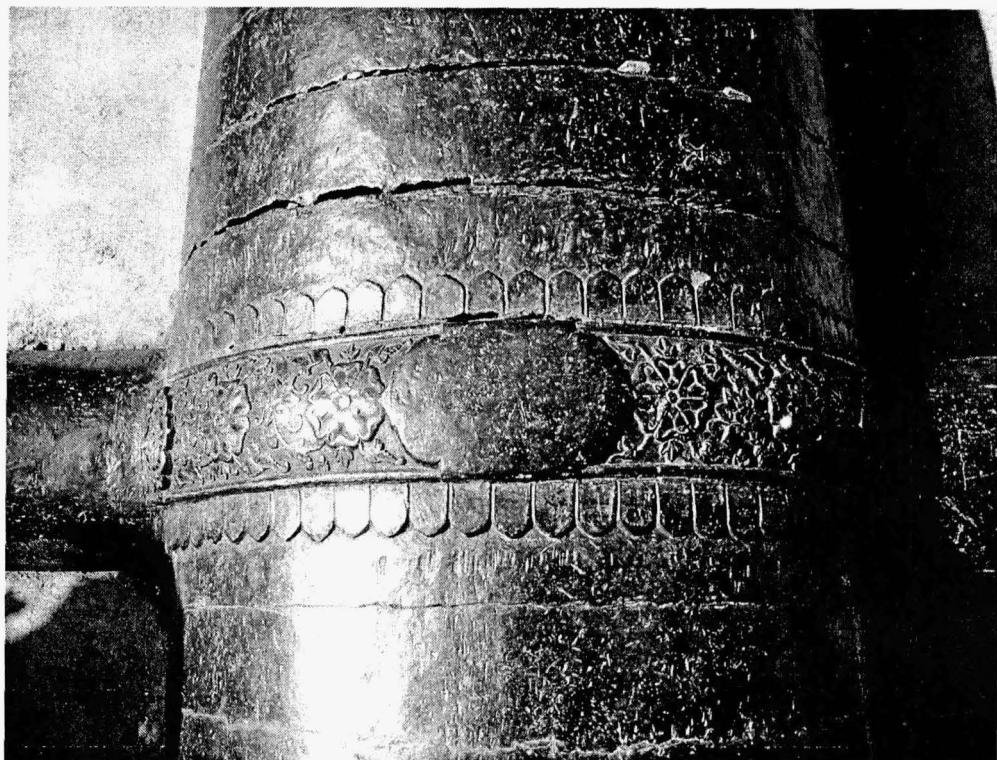
The width of the iron rings progressively increases from 6 cm to 9 cm on going up the cannon. The iron ring that supports the two trunions is 10 cm in width (Fig. 5). The excellent design inscribed on this particular ring must be noted (see also Fig. 2). The trunions are placed diametrically opposite to each other and each of these solid cylindrical masses are 28 cm long and 20 cm in diameter. These have been intelligently forge welded on to the iron ring. The iron ring containing these holding supports is counted as the 48th from the front.

Fig. 5: Details of the decorative iron ring to which the trunions are attached.
