# Physical Security Assessment and improvement of City Mall Surigao City (Common Areas)

## 1. Location and Description

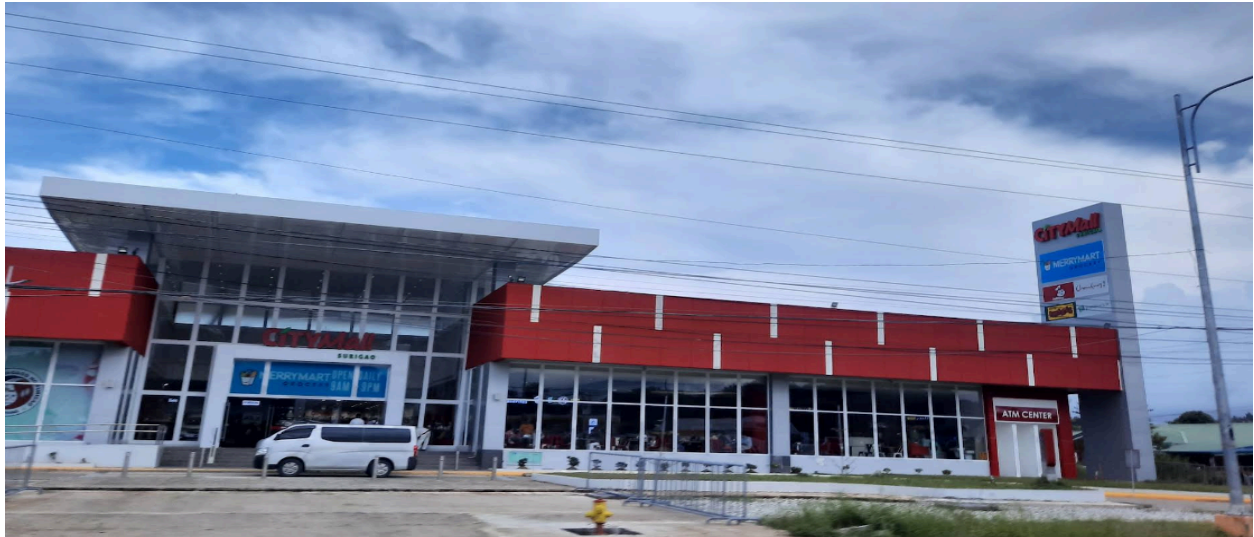
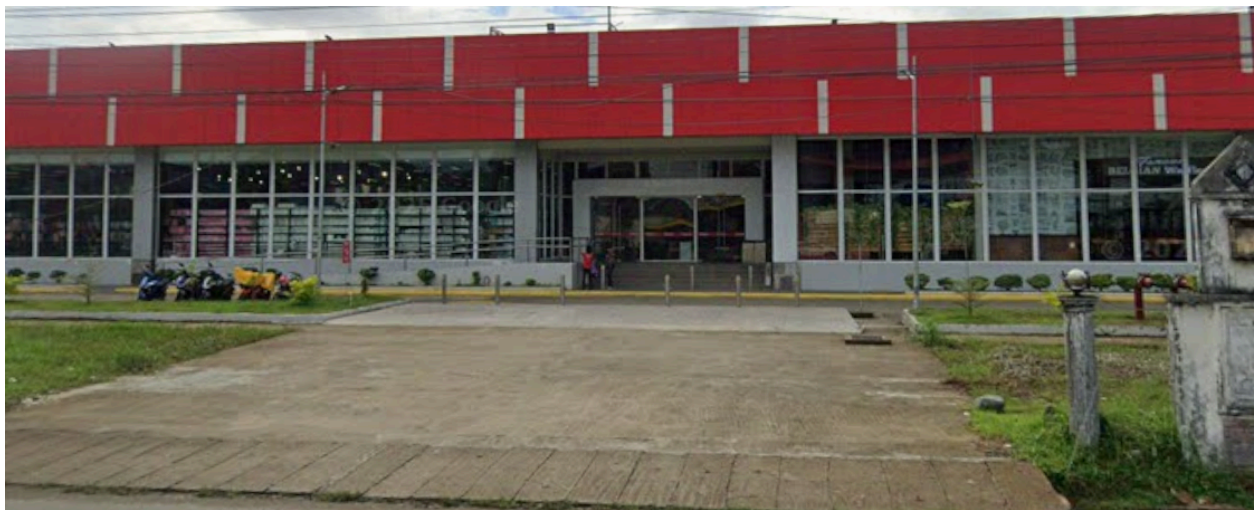
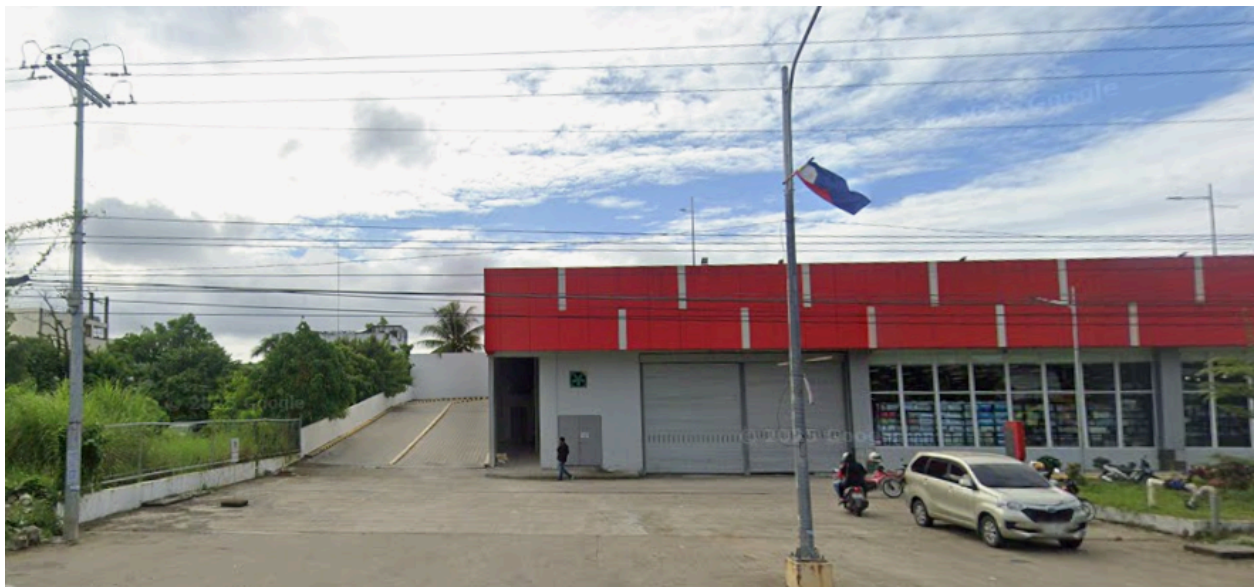
The mall has wide hallways and open spaces that allow people to move freely. During peak hours, the hallways become crowded, increasing the risk of lost wallets, accidents, or people getting bumped. Security personnel include one guard at the main entrance near Fun Prizes, two guards and one police officer at the exit gate, but some areas, like the back door behind the ATM, have no visible guard.

CCTV cameras and lighting are installed in most common areas, but some corners have blind spots. The parking area is located on top of the mall, which could be dangerous during earthquakes. Overall, CityMall provides good visibility, convenient parking, and accessible walkways. However, limited security personnel and less monitored areas highlight potential risks. These observations guide the proposed improvements to increase safety, prevent theft, and ensure better response to emergencies in the common areas.

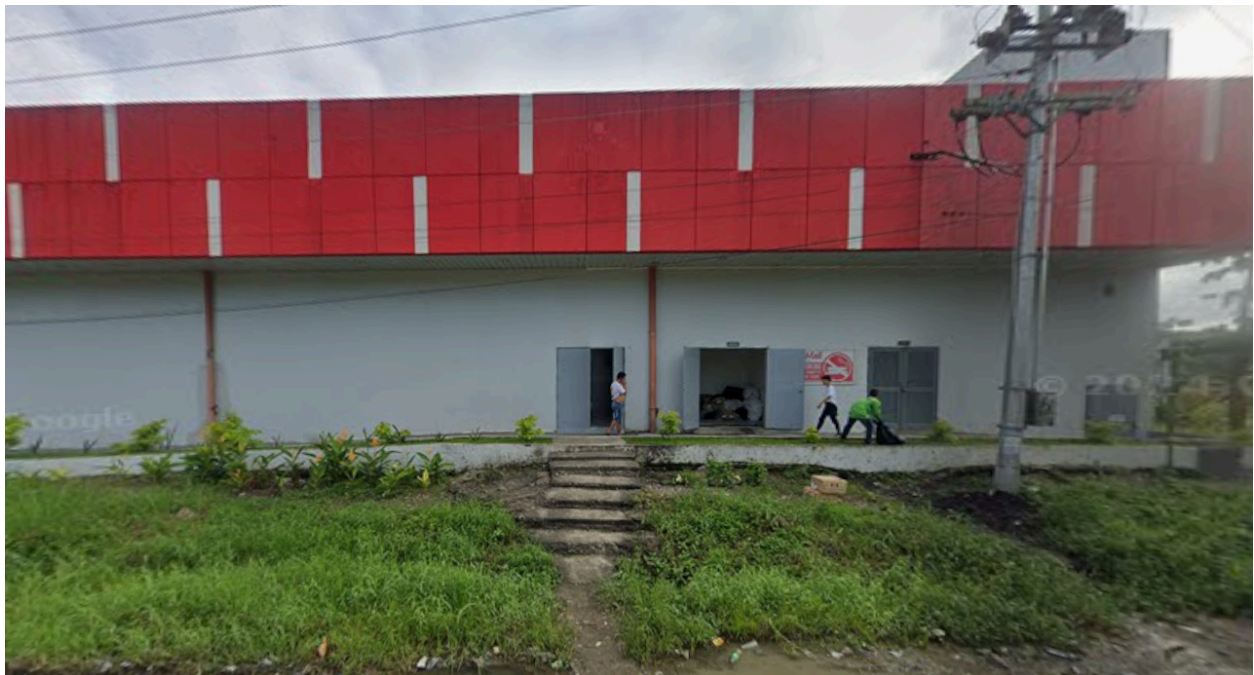
- Pickpocketing and theft during crowded hours
- Accidental pushing or hitting of people, especially children
- Limited number of security personnel during peak hours
- A back door located behind the ATM area with no visible guard outside
- This back door leads inside near the boys' and girls' comfort rooms
- Possible CCTV blind spots in corners and less visible areas

- Install warning and restricted access signage near the back door

- Install motion sensors near the ATM and back door area
- Provide backup power supply for CCTV systems
- Add alarm systems for emergency situations

- Assign additional guards during peak hours
- Include the back door in regular patrol routines
- Ensure police backup is easily available
- Conduct basic emergency response training for staff
