昇迅活动房（上海）有限公司 **SPEEDYHOUSE (SHANGHAI) CO., LTD.**

## TEST REPORT STACKING TEST

### FOR ACCOMMODATION CONTAINER MODEL MH101

Document released April 28<sup>th</sup>, 2011.

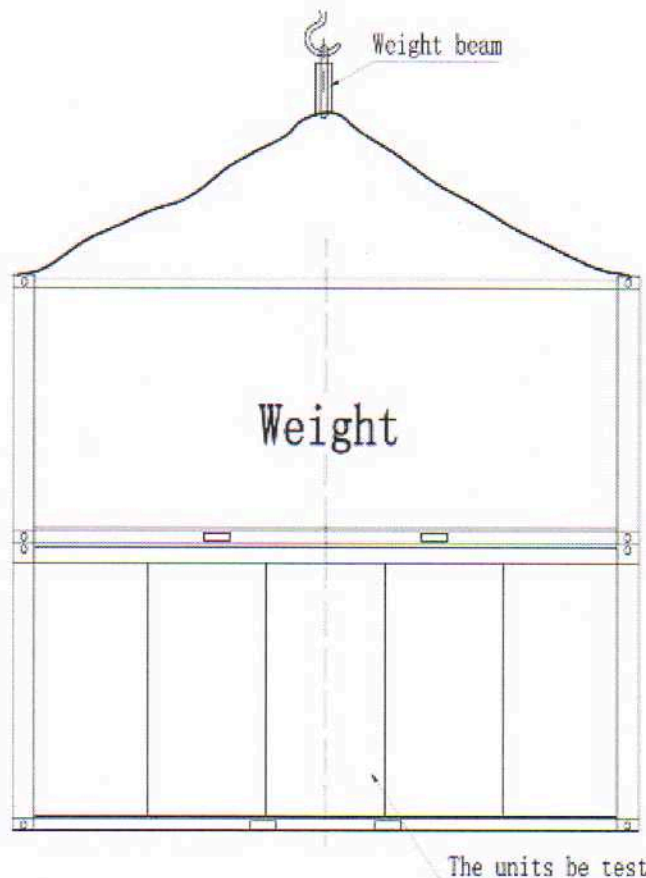
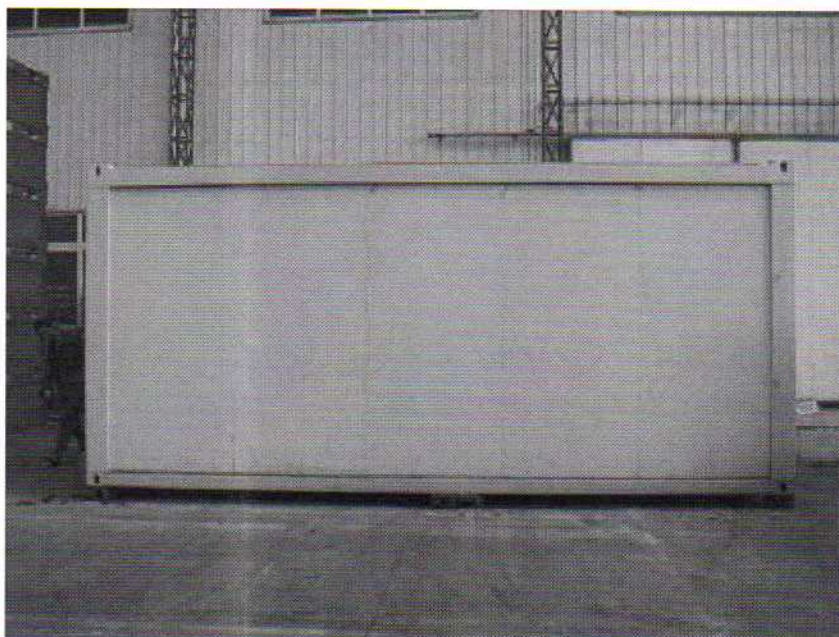
1. A standard 20' accommodation container, model MH101 has been assembled and put on the ground on 6 supports ( 4 under each corner and 2 under the middle of each long side) . The weight and put on 6 supports as the drawing.

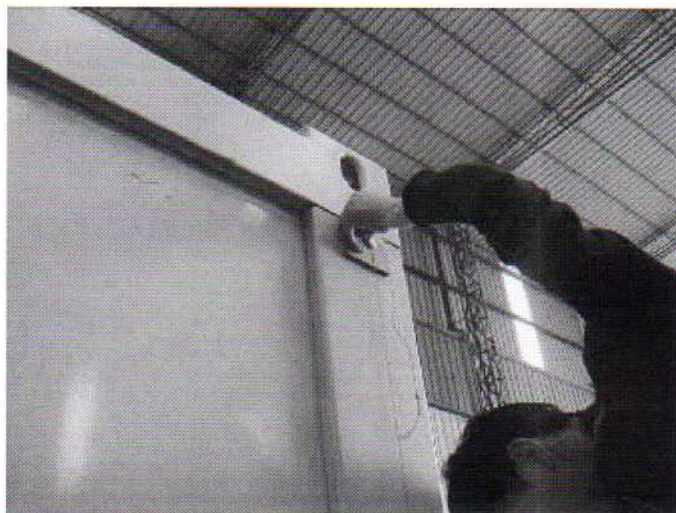
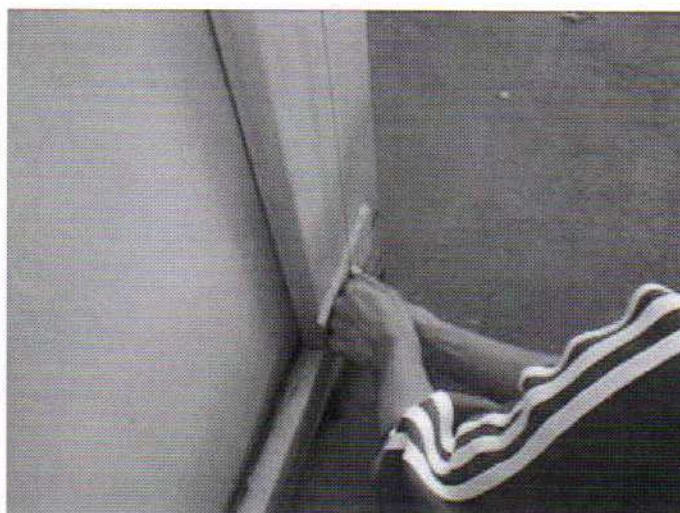
2. A cord has been fixed between the top of the corner post and bottom of the corner post, as per below images.

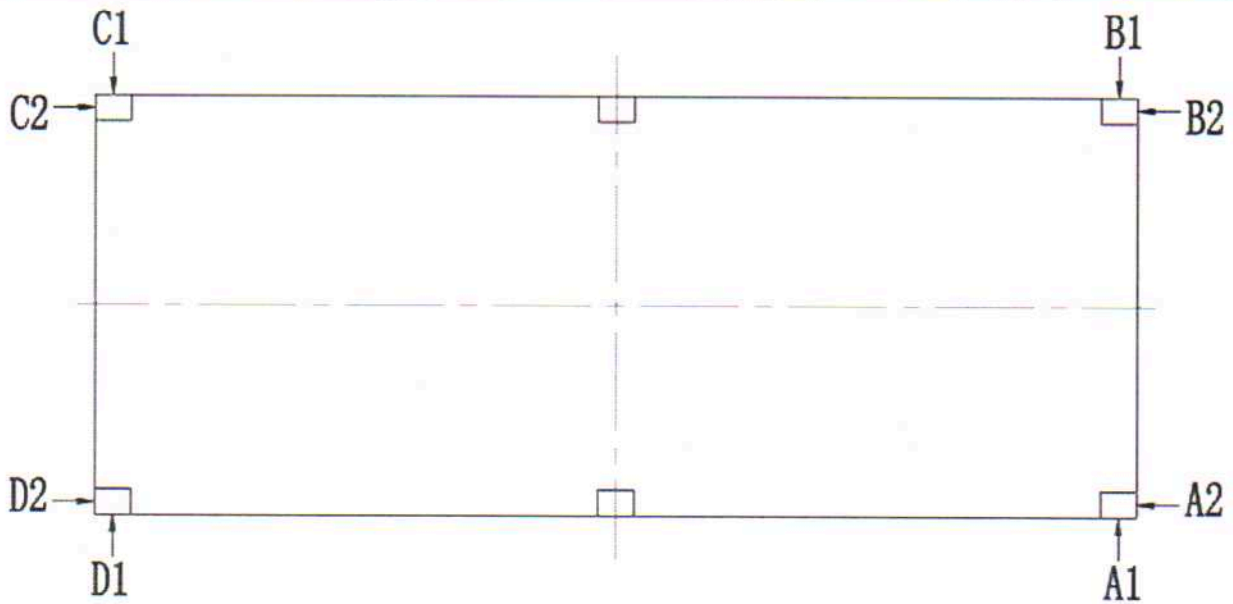
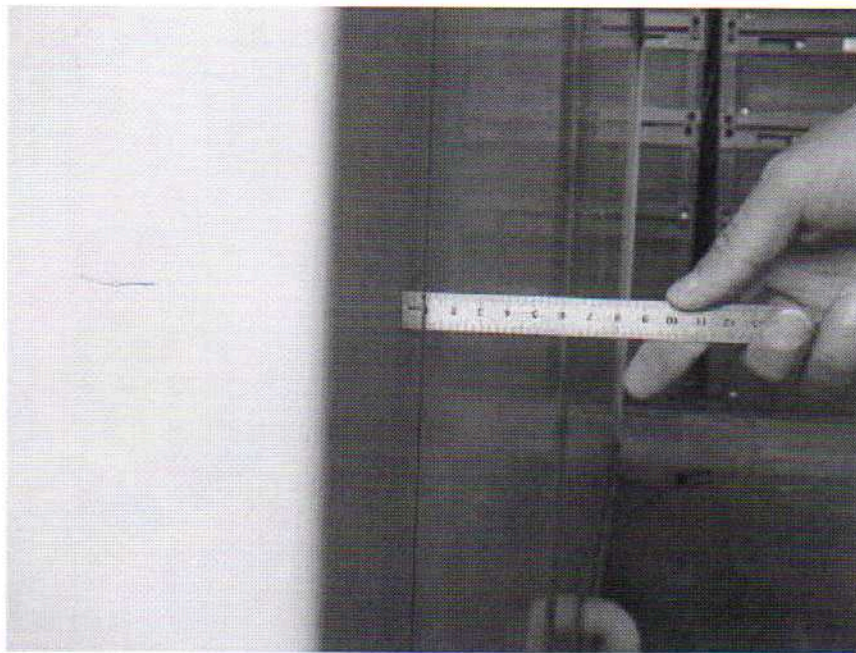
3. It has been measured the initial distance between the cord itself and the corner post surface, the details as per below images.

Measure from middle of the corner post, 8 points "A1 to D2"

- A1 = 9 mm , A2 = 9 mm , B1 = 8 mm , B2 = 9 mm , C1 = 10 mm , C2 = 9 mm , D1 = 9 mm , D2 = 7 mm ;

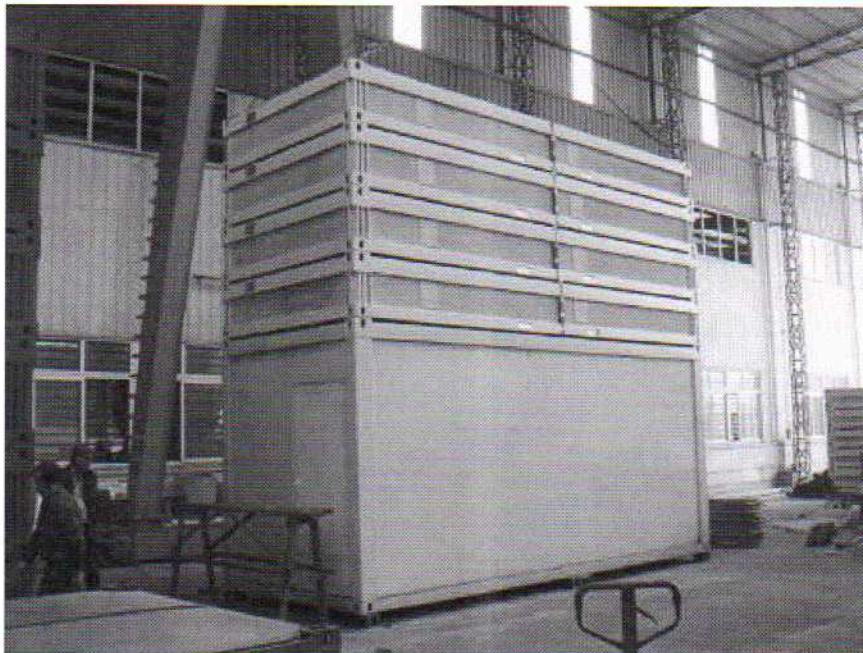
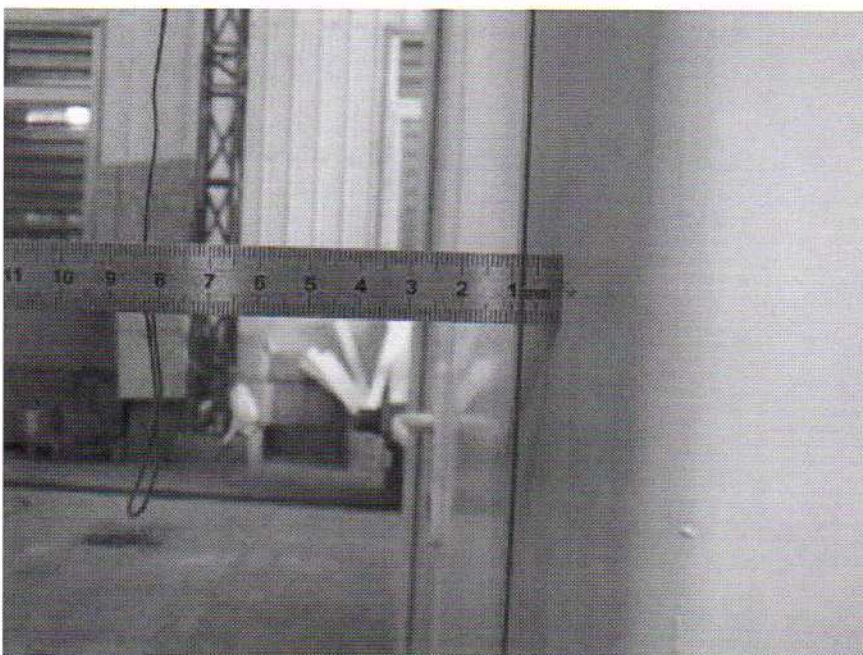
4. A weight of 8000 Kg has been put on the whole units as per below images; measurement has been repeated with the following results:

- A1 = 8 mm , A2 = 9.5 mm , B1 = 8 mm , B2 = 9 mm , C1 = 10 mm , C2 = 8.5 mm , D1 = 9 mm , D2 = 7 mm ;

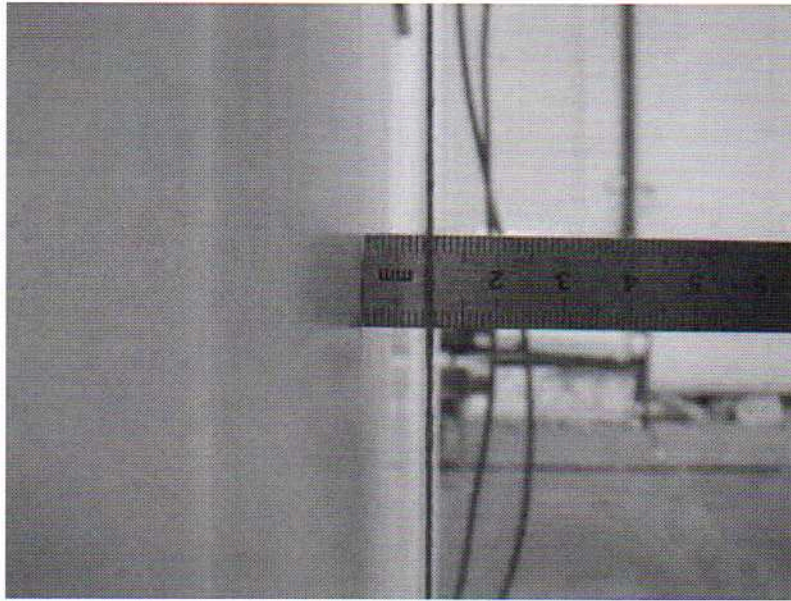
5. The weight has been kept on the unit for 5 minutes; after its removal a measurement has been made, with the following results:

A1 = 8 mm , A2 = 9 mm , B1 = 8 mm , B2 = 9 mm , C1 = 9.5 mm , C2 = 8.5 mm , D1 = 9 mm , D2 = 7 mm;

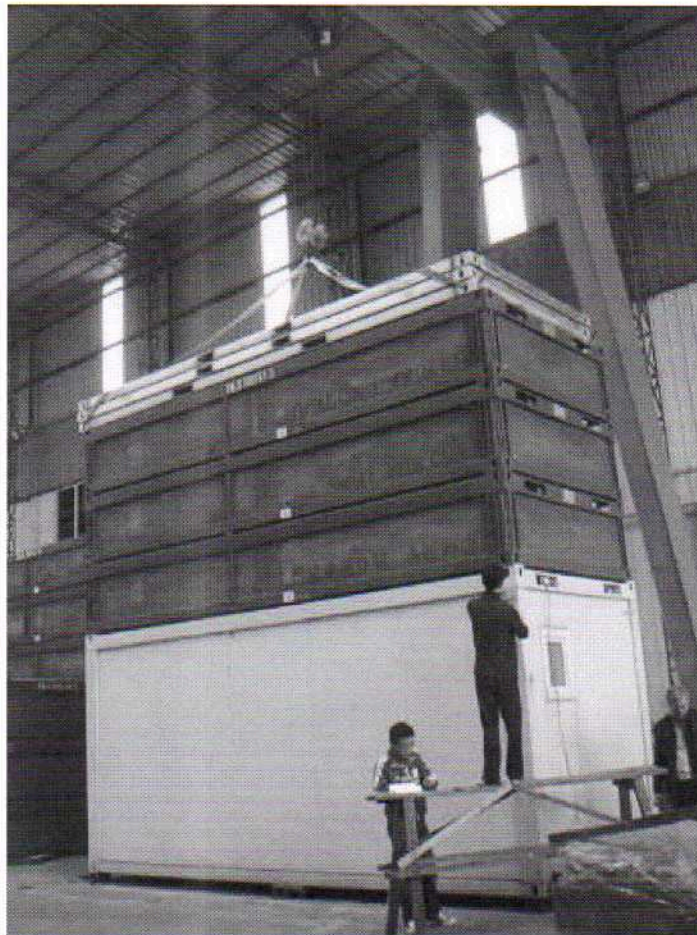
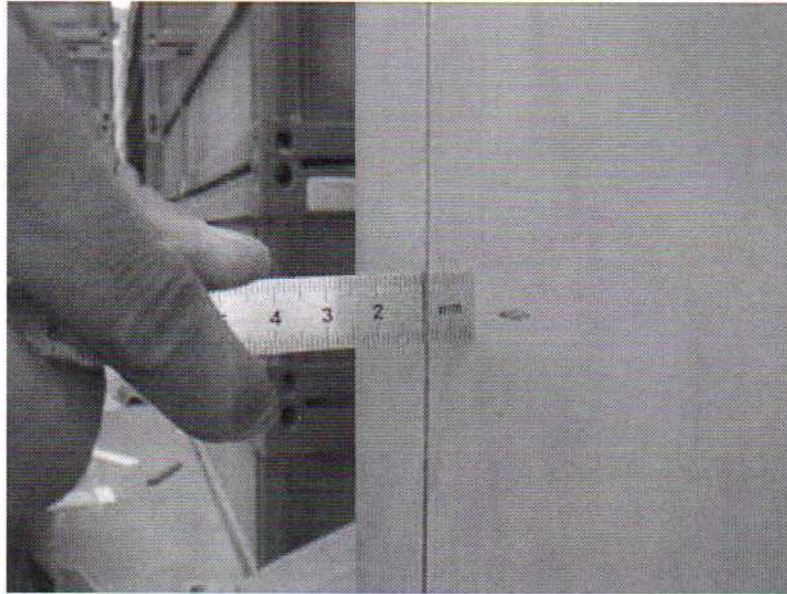
6. A weight of 10915 Kg has been put on the whole units as per pictures; a measurement has been made again with the following results:

- A1 = 9 mm , A2 = 9 mm , B1 = 8 mm , B2 = 9 mm , C1 = 10 mm , C2 = 8 mm , D1 = 9 mm , D2 = 7 mm;

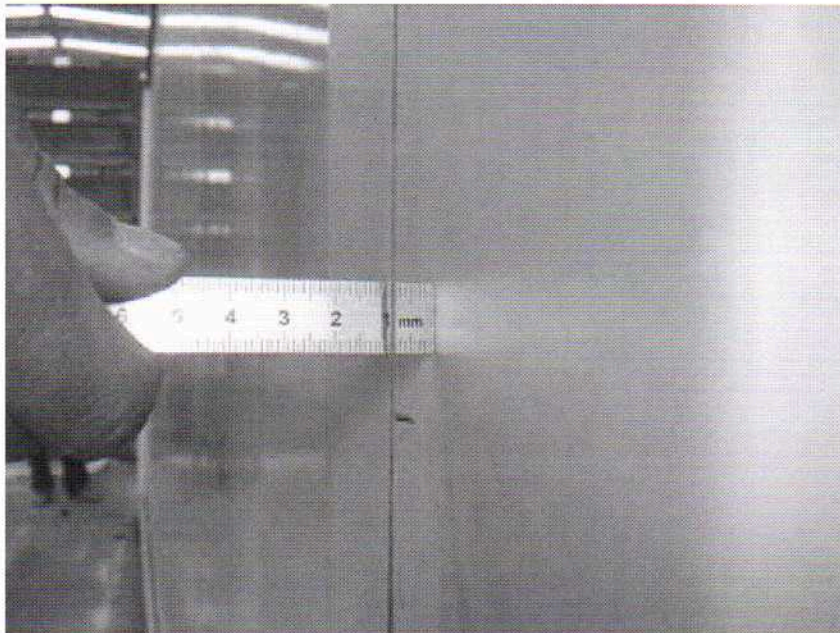
7. The weight has been kept on the panel for 5 minutes; after its removal a measurement has been made, with the following results:

A1 = 9 mm , A2 = 9 mm , B1 = 8 mm , B2 = 8.5 mm , C1 = 10 mm , C2 = 8.5 mm , D1 = 8 mm , D2 = 7.5 mm;

**So there was no major plastic deformation of the corner post under the load of 10915kg**
