UC Berkeley Space Technologies and Rocketry
Flight Readiness Review Addendum
Project U.R.S.A.¹

March 27, 2017

Appendix A Damage from March 12th Flight

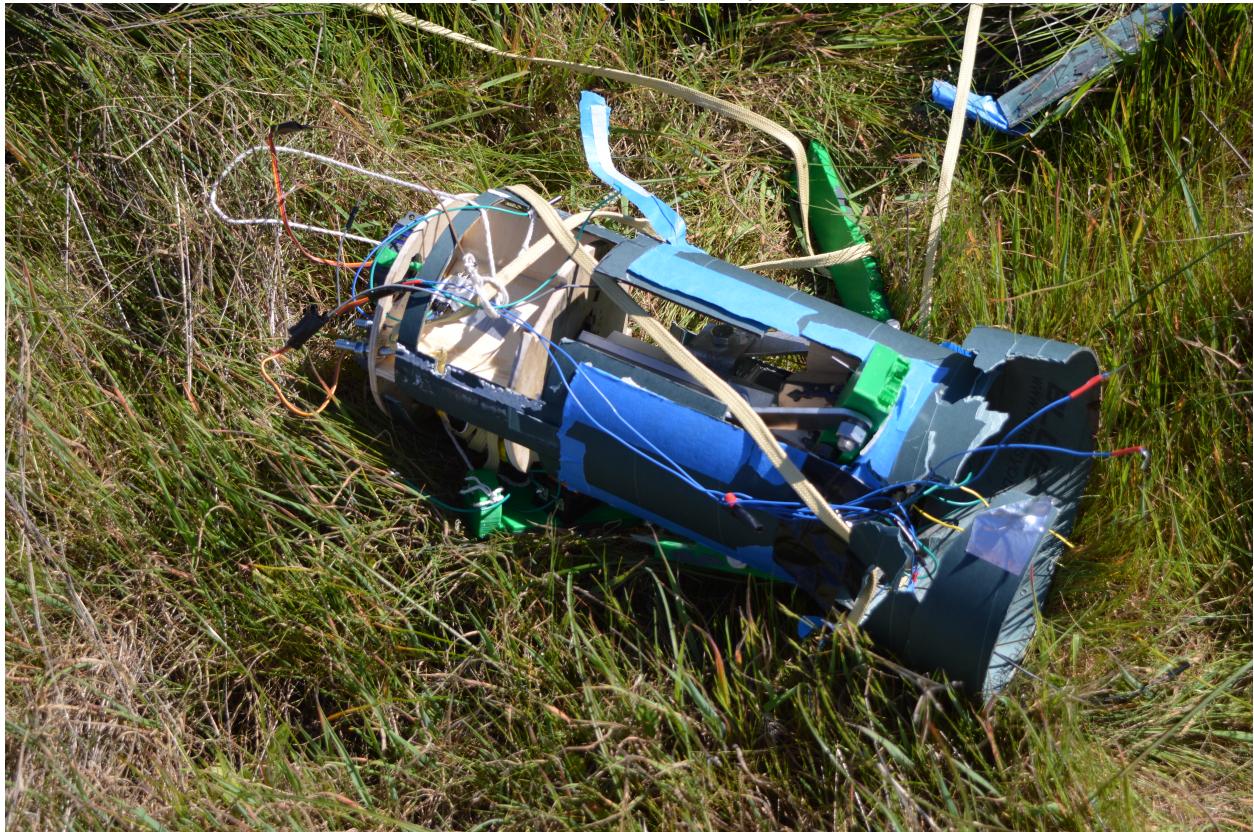
The payload section experienced the most damage. The outer blue tube was largely destroyed, having been torn apart in multiple locations. Each of the 3D printed landing legs had been torn away from the 3D printed servo arms, resulting in the destruction of both the legs and the servo arms. The bottom bulkhead was damaged in some locations. However, the support tower, consisting of the PVC column, aluminum rails, rail carriages, support legs, and parachute box, was completely undamaged (except for having separated from the damaged bottom bulkhead). The servos themselves, on top of the parachute box, were similarly undamaged. Although one payload parachute was burned during the flight, the other two parachutes had not been deployed and were undamaged.

Figure 1: Damaged Payload

In order to restore the payload section, several components were remanufactured. The outer tube and coupler reinforcement were recut from blue tube. The rebuilt payload was built to better tolerances by using 3D printing to create the entire bottom bulkhead, including the hinge posts and spring surfaces. The actual dowel pin and torsion springs were not damaged, and could be reused. This new bottom bulkhead also included a centering feature for the PVC tower, which was not damaged, and included space for a 1.25 lbs lead weight. This allowed us to replace the previous form of ballast, which consisted of individual smaller lead weights arranged throughout the payload, and concentrated the weight in a lower location so as to shift the center of gravity downward. In order to reduce the gap between the landing leg shell and the airframe in launch configuration, the landing leg shell had to be centered correctly with respect to the leg frame; in the first iteration, this was done by cutting the shell first, and then gluing it onto the leg frame. However, this resulted in a poor fit, due to human error in re-aligning the leg. In order to mitigate this, in the rebuilt iteration the leg was glued to the blue tube during initial installation of the internal payload assembly into the tube. This way, when the leg shells were cut, the leg frame would already be attached in the correct orientation. This resulted in a much better fit, and smaller gap. In addition, the new landing leg frames included features to increase the bond surface to the leg shell, ensuring that the shell retains its curvature after being cut. The support tower, parachute box, and servos were directly re-used. New servo arms were printed; the new iterations were made thicker, to resist bending by the spring-loaded leg.

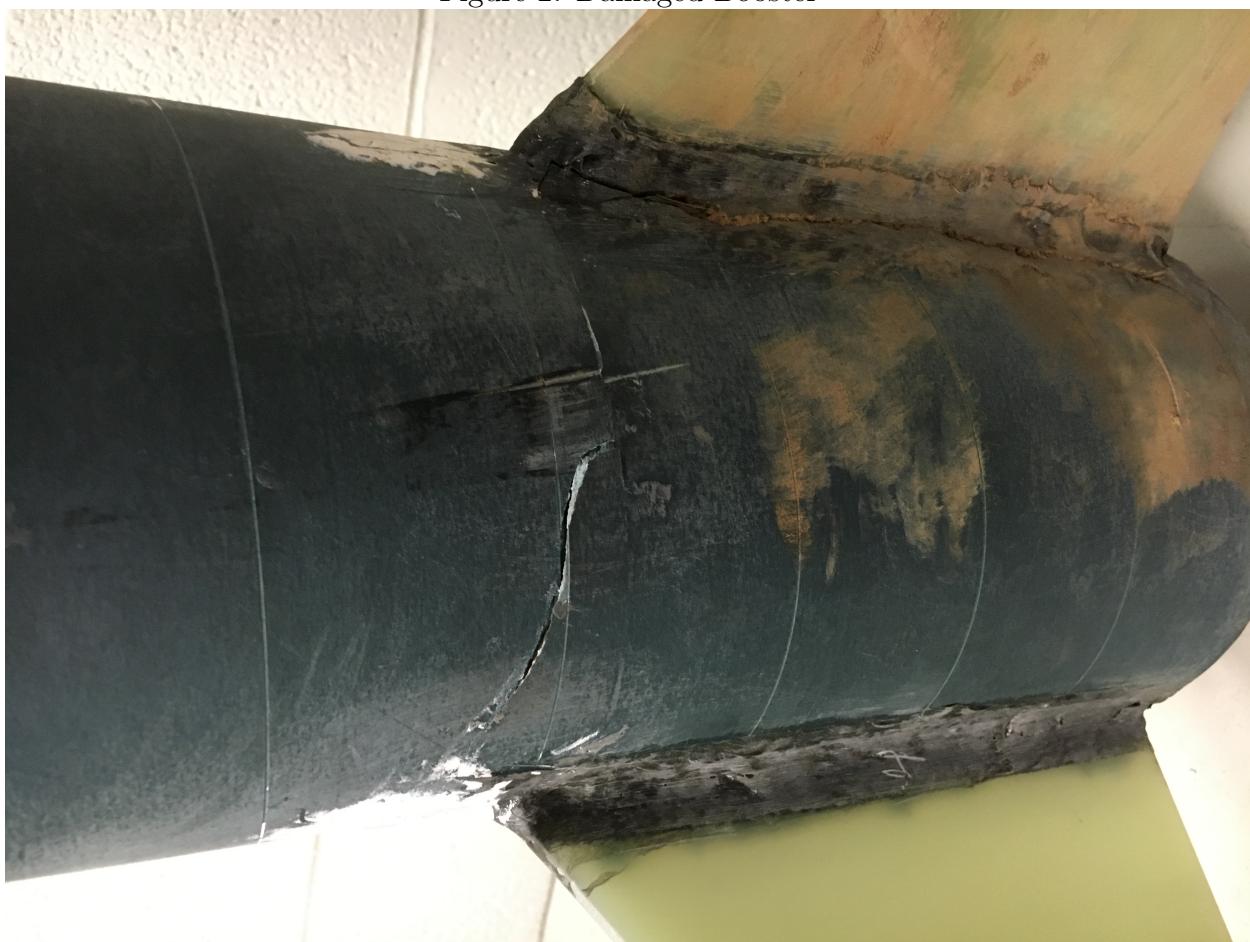
in the avionics booster, but the outer blue tube was undamaged. The 3D printed avionics sled was irreparably damaged, but the avionics electronics were intact and functional. The drogue and main parachute were also undamaged. The booster section was undamaged except for a large crack in the outer blue tube near the fins. Notably, however, the motor mount, centering rings, and fin attachments were undamaged.

Figure 2: Damaged Booster

The main launch vehicle could be largely repaired. The cracks in the booster section and avionics bay were repaired using fiberglass to reinforce the damaged areas, with carbon fiber

used to reinforce the connection between the fins and outer airframe. Thickened epoxy was then added to fill any dents and defects in the airframe, to restore the cylindrical outer shape.

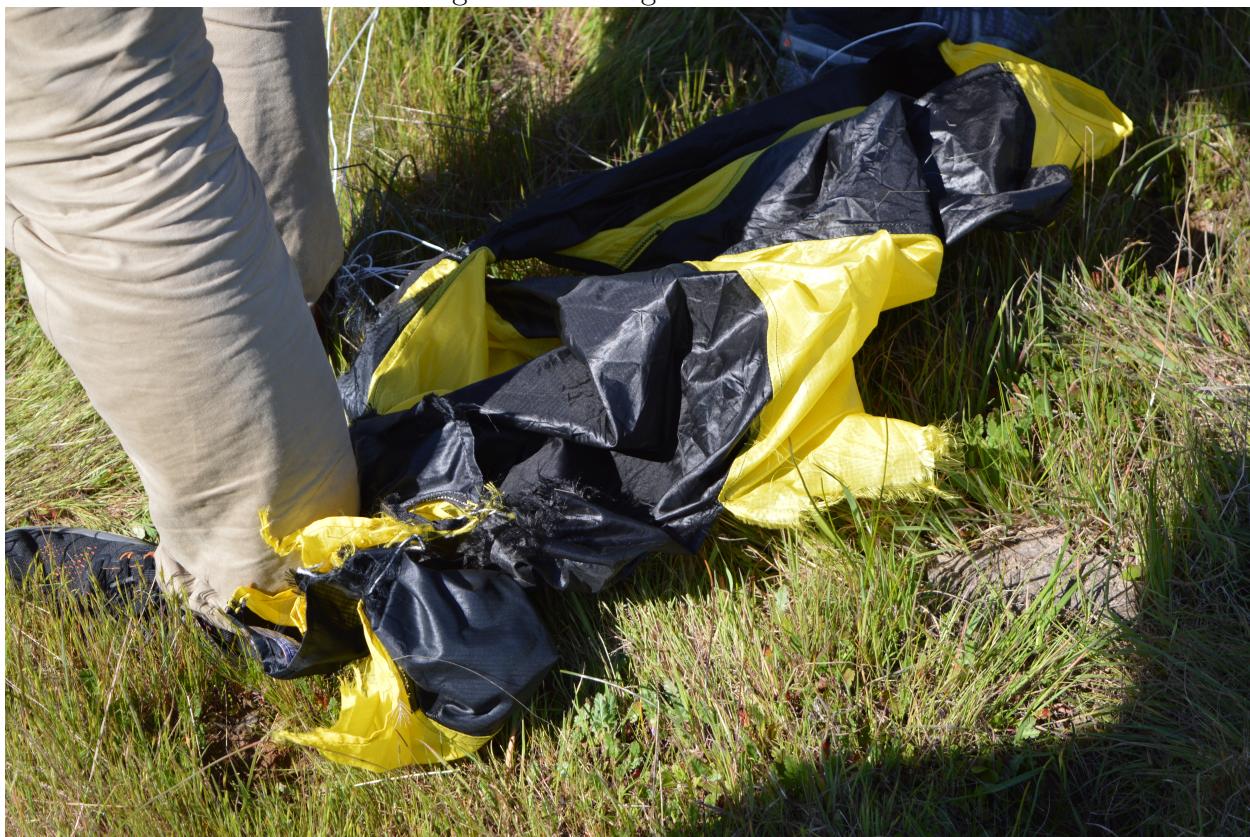
Figure 3: Damaged Parachute

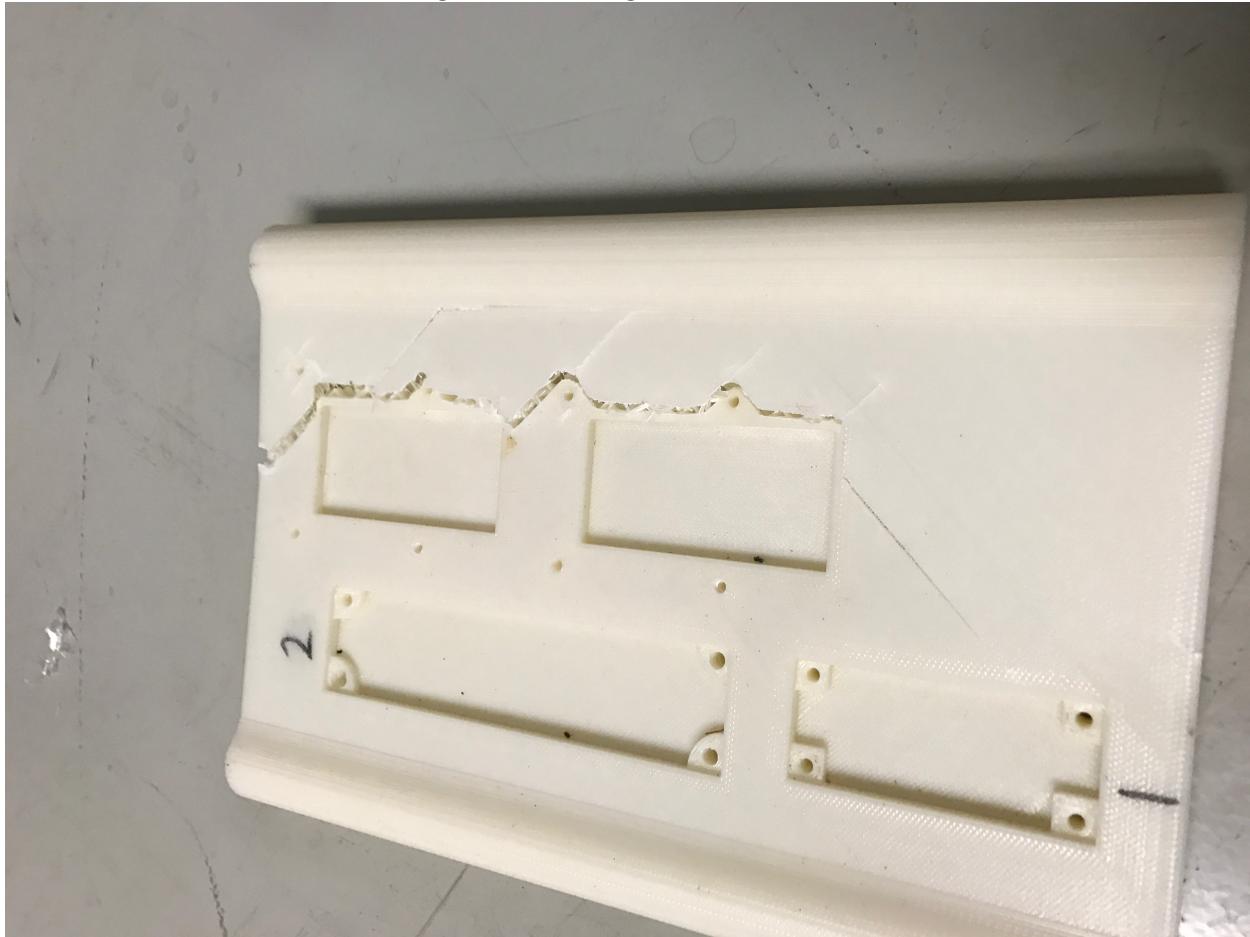
Figure 4: Damaged Avionic Sled
