**FINAL REPORT**  
**FOR**  
**POCHE BEACH URBAN RUNOFF ULTRAVIOLET LIGHT BACTERIA**  
**DISINFECTION PROJECT**  
**CBI GRANT NO. 23**  
**AGREEMENT NO. 01-236-550-1**

**PREPARED BY:**  
**JAMES R. VOLZ, P.E., SENIOR CIVIL ENGINEER**  
**WATERSHED AND COASTAL RESOURCES DIVISION**  
**RESOURCES AND DEVELOPMENT MANAGEMENT DEPARTMENT**  
**COUNTY OF ORANGE**  
**300 N. FLOWER STREET, SANTA ANA, CA 92703**

**APRIL 13, 2005**

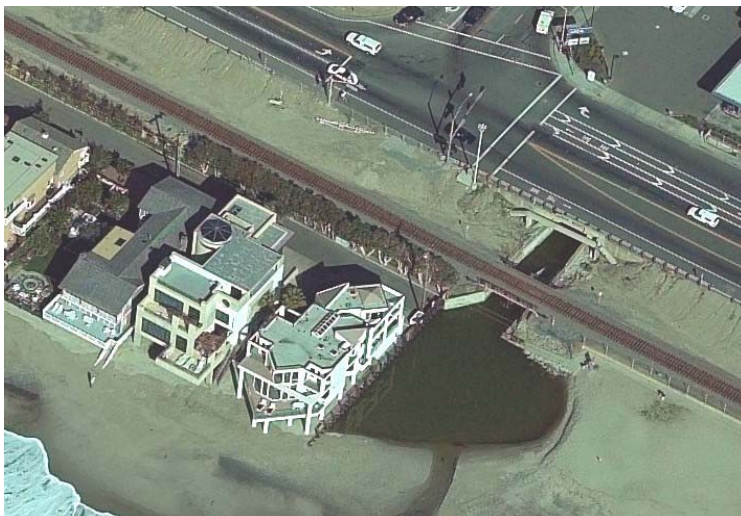
There is a natural forming scour pond on the beach at the outlet of the M01. The City of San Clemente has photos of this scour pond in the 1930s. This pond is formed from wave and tide action which deposits sand at the mouth of the creek. This scour pond is approximately the same size every year unless the shoal is mechanically breached allowing the pond to drain. Occasionally the outlet on the beach moves as much several hundred feet. The County has all required regulatory permits to shape the scour pond twice per year. Figure 4 is a photo of the scour pond.

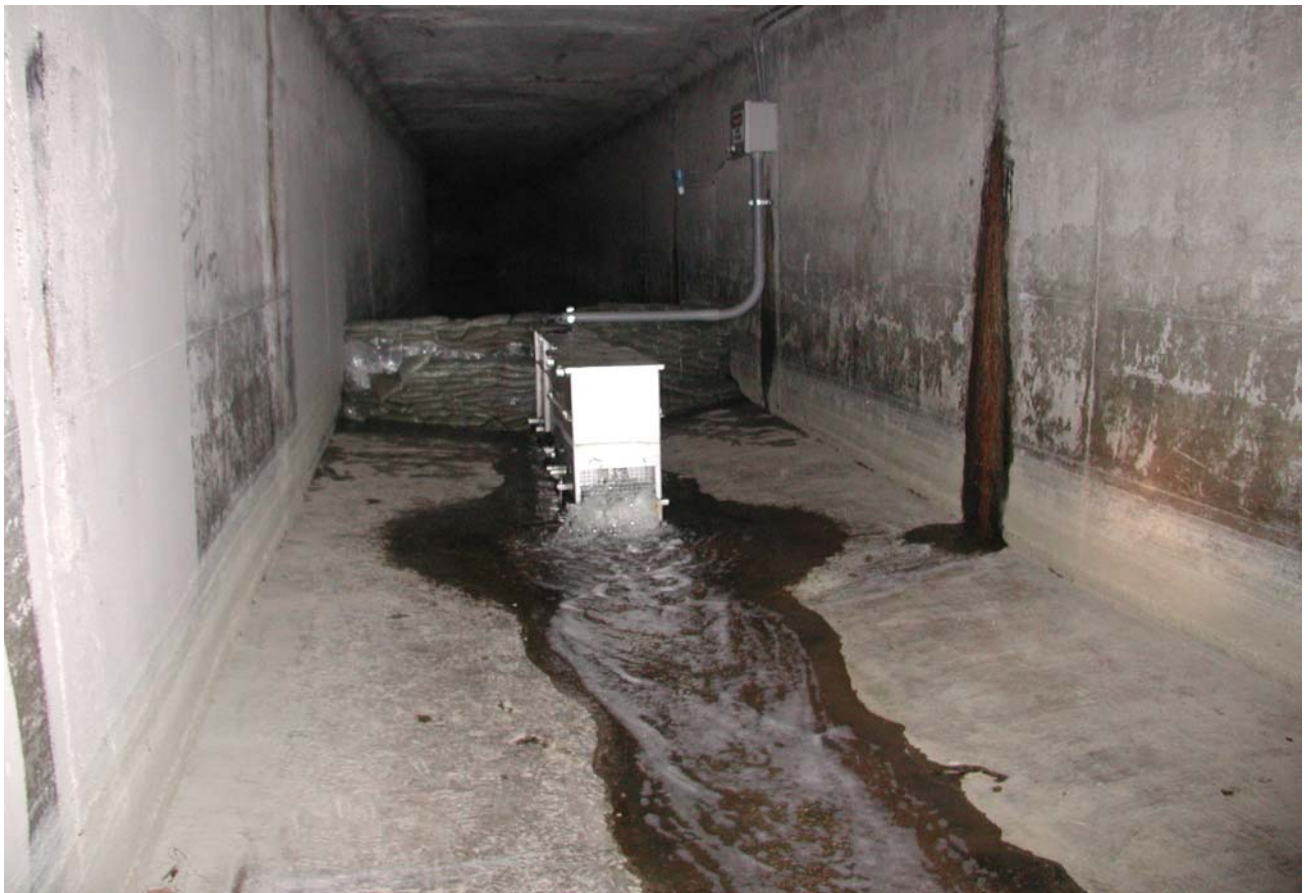
Figure 8 is a photo of the operating UV system in the south barrel of the M01 flood control box about 200-ft upstream of the beach.

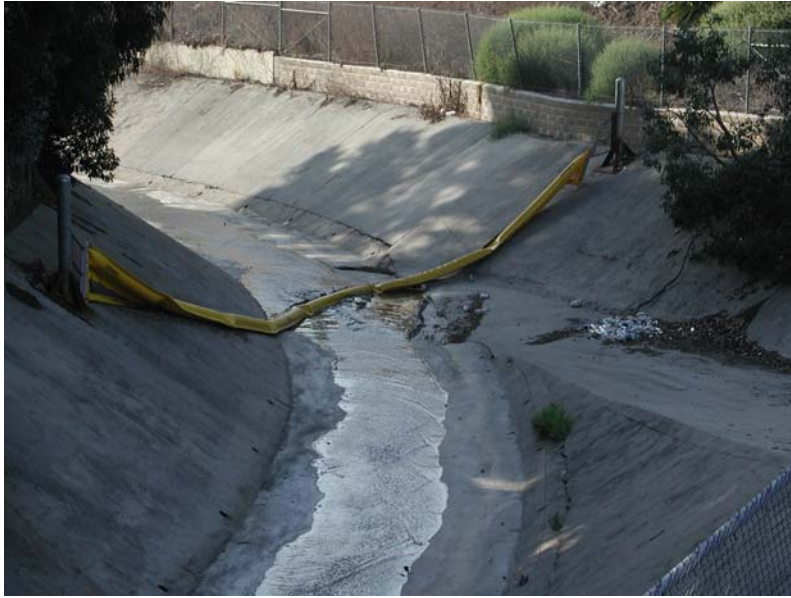
Figure 11 displays some minor leakage through the sandbag berm diverting water through the UV system.

A small amount of leakage through the sandbags occurred although it was a very minor amount.
