**Wrexham County Borough Council Section 19 Report**

**Worthenbury Community Flood Event: 16<sup>th</sup> October 2024**

# **S19 Flood Investigation Report**

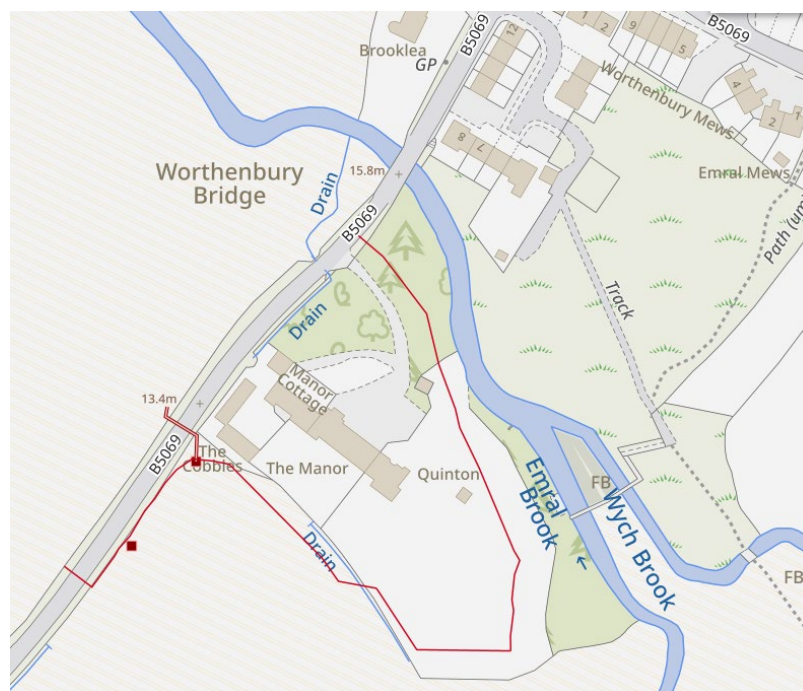
Figure 1: A map showing the location of the flood embankment maintained by Natural Resources Wales (NRW) taken from the Flood Defence Structures map on Data Map Wales.

At around 21:00, it was reported that floodwater was entering the embankment under a recent NRW repair. The likely cause of this has been identified as seepage through the root system of a felled tree which was removed.

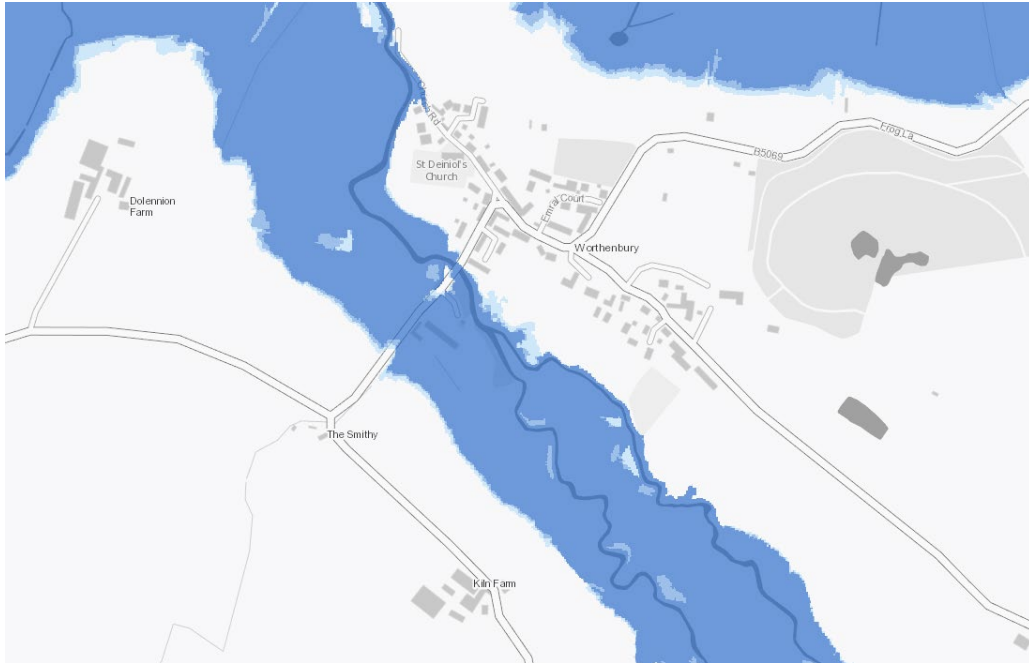
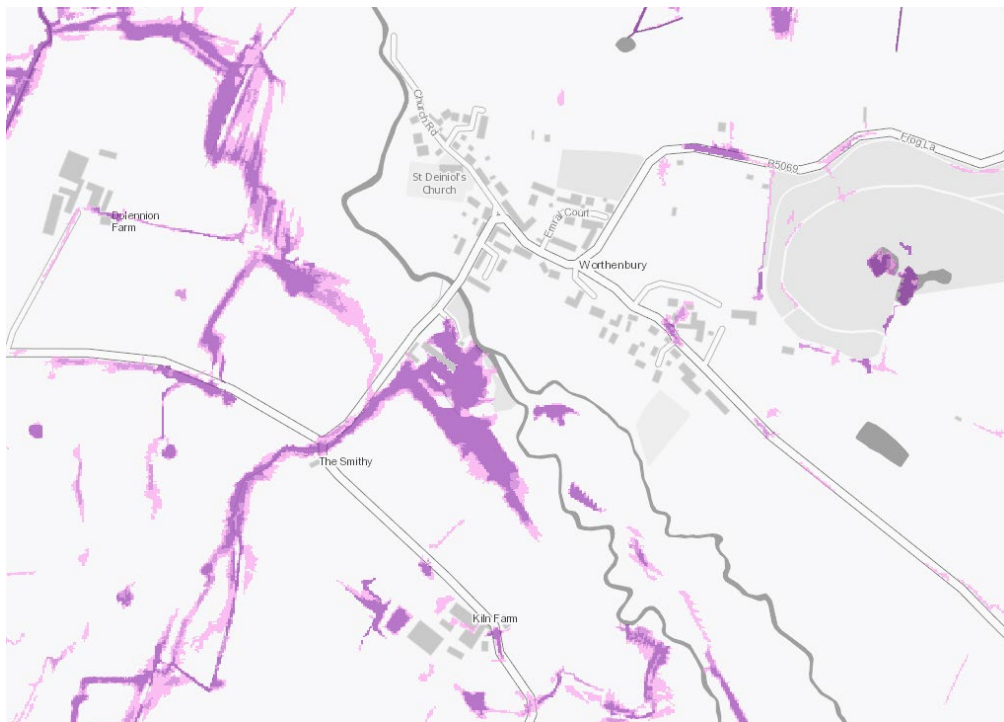
The extent of the flooding largely correlates with that shown in the undefended scenario on the NRW flood maps. The purple areas of surface water flooding indicate where the deeper flood waters collected following the overtopping of the flood embankment.

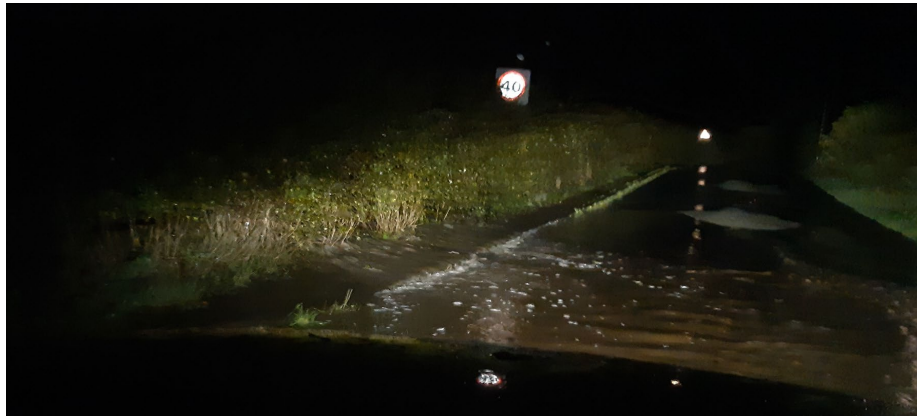
Further anecdotes from the residents suggest that the floodwater began overtopping the flood embankment to the rear of the properties around 22:00. Given the bowl-like topography inside the flood embankment, this water, combined with that from the highway, pooled and was unable to exit the defence until pumping was commenced by a local farmer.

Figure 6: A photograph of the overtopping of the flood defence onto the B5069 taken by an NRW officer who attended Worthenbury on 16<sup>th</sup> October 2024.

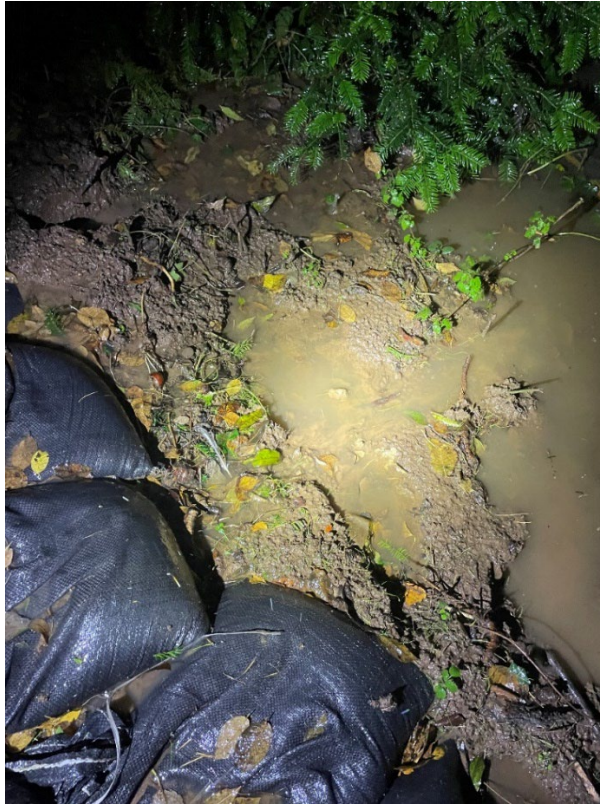
Figure 7: A photograph of the seepage under the flood embankment taken by the resident of Quinton on the night of 16<sup>th</sup> October 2024.

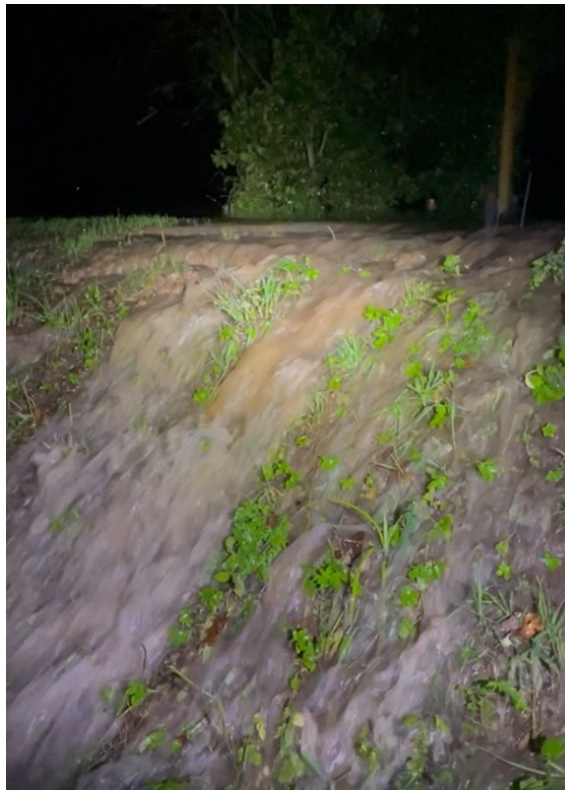
Figure 8: A video screenshot of the overtopping of the flood embankment as taken by a resident on the night of 16<sup>th</sup> October 2024.

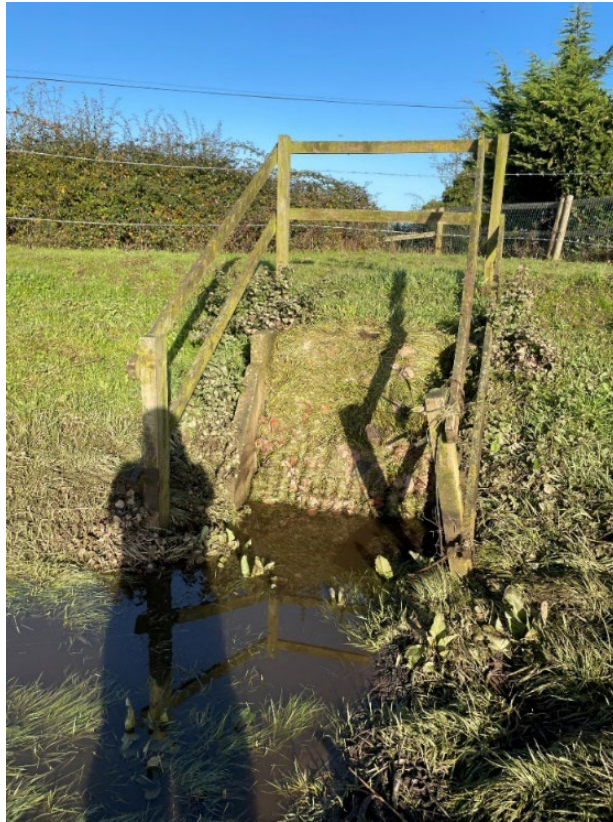
It is noted that the screen protecting the outlet in the field to the south accumulated a build up debris which was evident when the floodwater receded. It cannot be determined if this a result of suspended debris building up on the screen as the flood level decreased or if it built up during the flood event. Testimony from NRW suggests that this screen was clear before the water level rose in the late afternoon.

Figure 9: A post-event photograph showing the outfall from the field used as flood storage during the flood event. The screen protecting the outfall is largely blocked due to a buildup of vegetation. The image was taken by a resident of one of the affected properties.

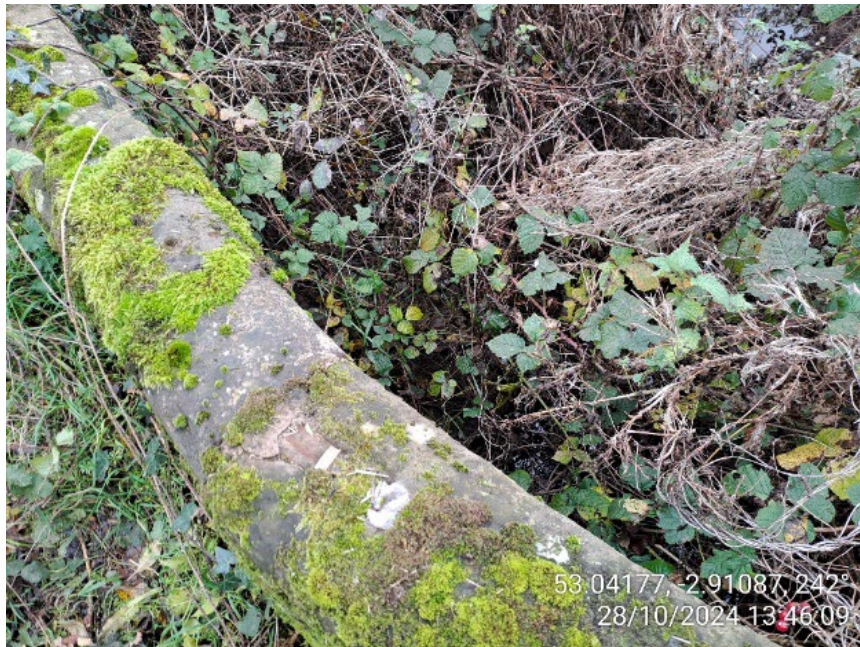
In addition to the above, the flap valve in the ownership of WCBC Highways was noted to be heavily vegetated following the flood event. The flap valve is believed to have functioned as designed despite this because the vegetation did not prevent the closure of the valve as the flood water rose in Worthenbury Brook.

Figure 10: A photograph showing the WCBC outfall at the end of the culvert system taken 12 days post flood event. The photograph was taken by a NRW operative.
