# Field observation — concrete structure near the 1948 node

Ladera Ranch vicinity, Orange County, California · recorded 2026-08-07 · LHDRS field record

## THIS IS NOT AN IDENTIFICATION.

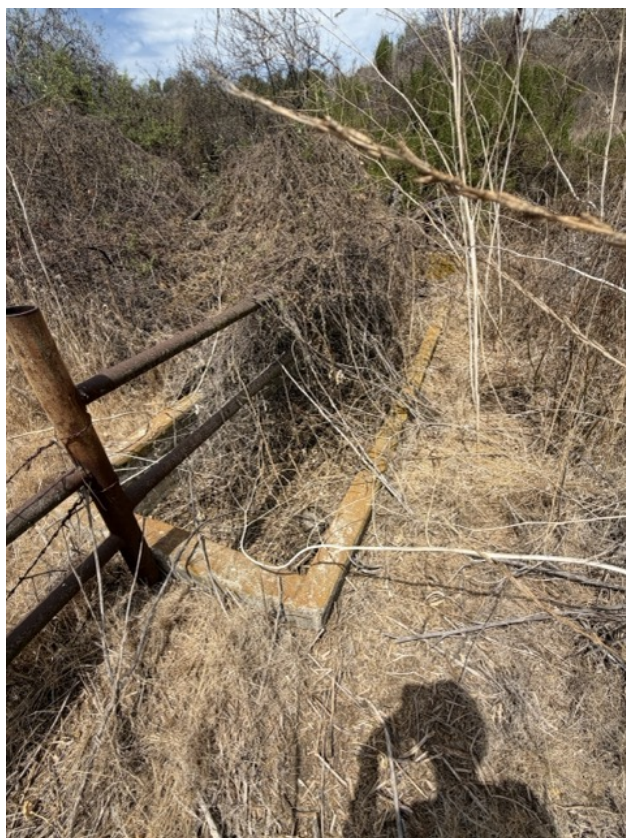
1 — Axis view. The concrete channel runs away into brush; pipe frame at the near end.

| Attribute | As reported | Confidence |
|---|---|---|
| Railing | Rusted pipe frame at the near end, one rail descending INTO the structure; further fallen/leaning pipe rails in the brush beside it | photos 1, 2, 4 |

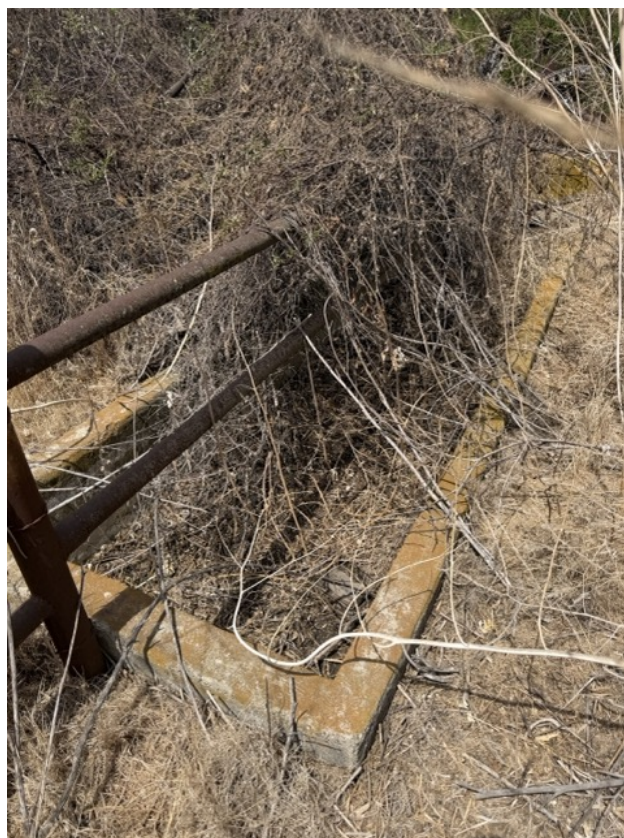
2 — End view. Clean 90° concrete corner, raised rim on both sides, pipe railing descending INTO the structure. The strongest visual argument for a discrete vessel.

| Attribute | As reported | Confidence |
|---|---|---|
| Rim & corner | Raised concrete rim on both long sides; clean 90-degree corner at the near end | photo 2 |

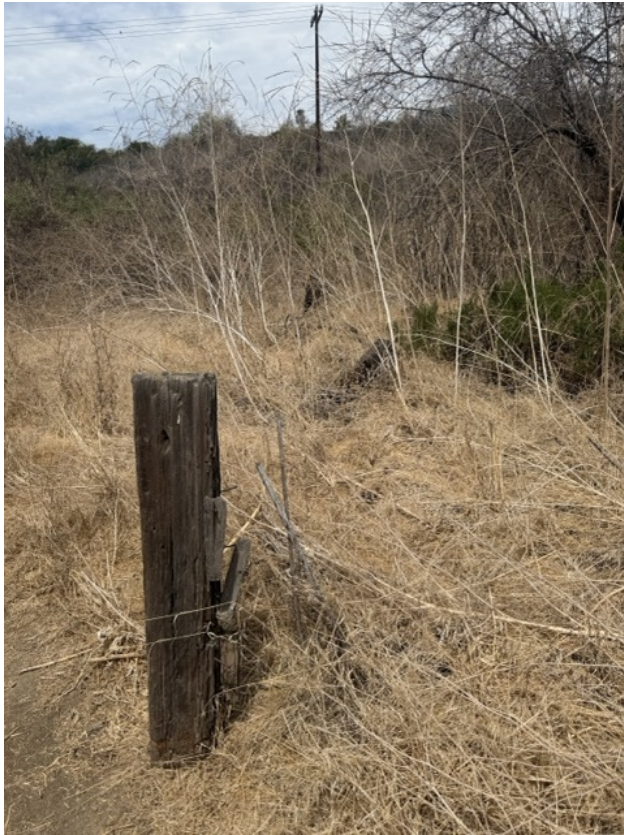
3 — Weathered timber post with WIRE still attached, standing near the structure; a second short stake beside it. Utility pole in the background.

| Attribute | As reported | Confidence |
|---|---|---|
| Timber post | Weathered squared timber post standing nearby with WIRE still attached; a second short stake beside it | photo 3 |
| Wire | Strand wire at the post, consistent with pen/fence line | photo 3 |

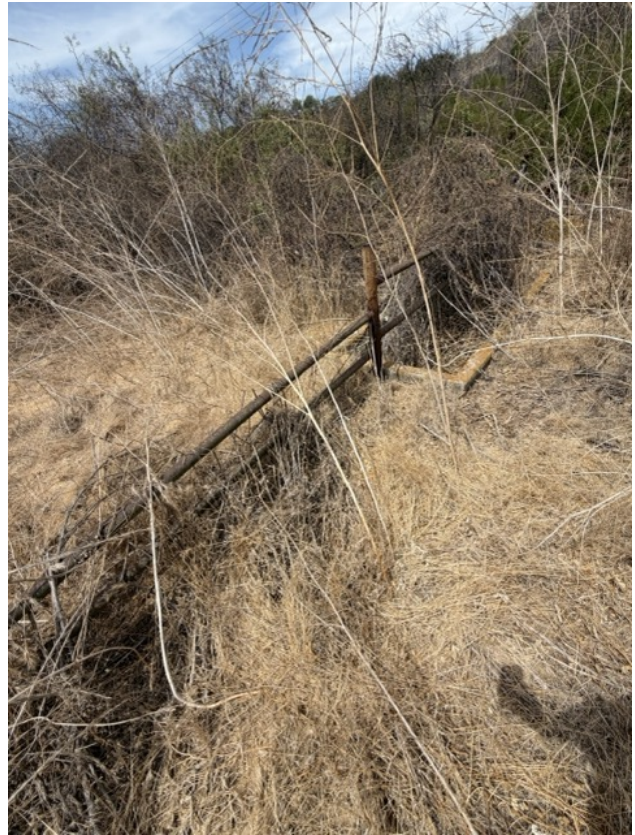
4 — Fallen and leaning pipe rails in the brush beside the structure — consistent with chute or pen railing.

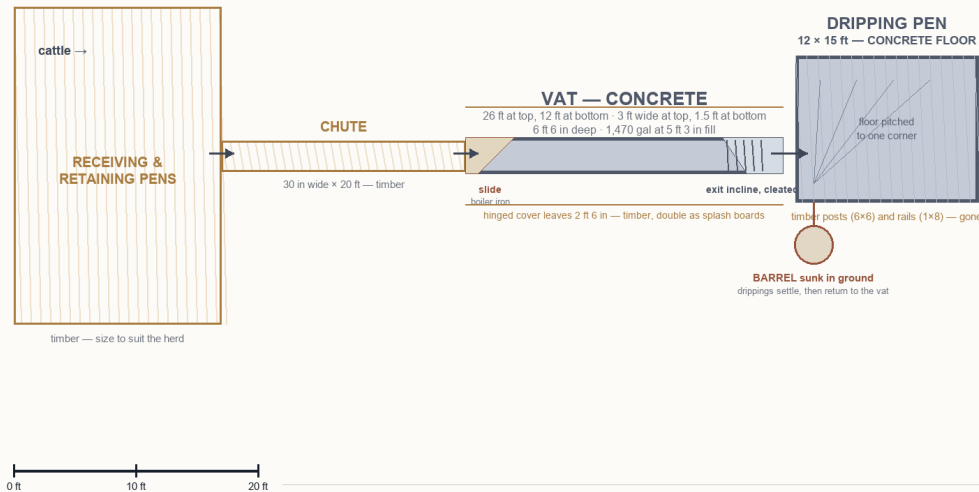
CONCRETE — the vat and the dripping-pen floor. Survives indefinitely.

TIMBER & IRON — chute, pens, rails, cover, slide. Rots and rusts away.

A century on, only the concrete is expected to remain. An isolated concrete channel in brush is what the surviving fragment of a complete station looks like — the missing pens are not evidence against.

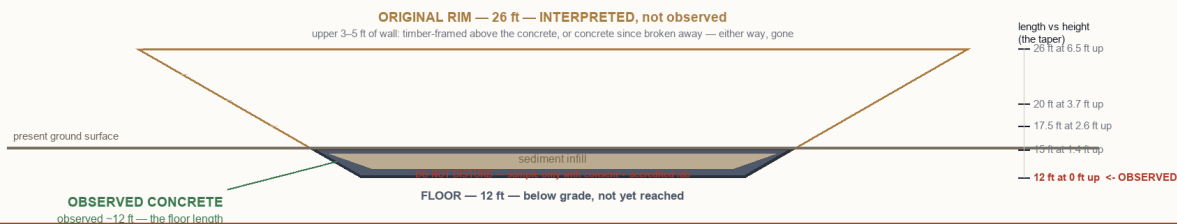
The observed ~12 ft matches the vat FLOOR exactly

Longitudinal section, to scale. Spec floor = 12 ft. An observed ~12 ft rectangle sits AT FLOOR LEVEL on the taper. Solid = observed in the field. Ghosted = INTERPRETED reconstruction from the federal spec. They are not the same kind of statement.

- Also found on site, and where they fit:
- WEATHERED TIMBER POST with wire — the spec's pens and cover posts were timber set 3 ft deep, fenced with wire and rails.
  - RUSTED PIPE RAILS — consistent with chule or pen railing at the structure's end.
  - These are remnants of exactly the perishable components the materials argument said should be missing or nearly gone.
  - Finding their traces STRENGTHENS the station reading and weakens the lone-drainage-ditch reading.

**WHAT THIS RECONSTRUCTION IS, AND IS NOT**  
An observed ~12 ft rectangle = the spec FLOOR length exactly. Solid = observed; ghosted = interpreted, testable, not established.  
DEPTH IS STILL UNMEASURED. Reading A (full concrete vat, upper walls gone/buried): probing 5–7 ft BEYOND each end should find buried rim or wall stubs.  
Reading B (hybrid): concrete base only, TIMBER upper framing rotted in place - consistent with the weathered post and wire found beside the structure.
