# Field observation — concrete structure near the 1948 node

Ladera Ranch vicinity, Orange County, California · recorded 2026-08-07 · LHDRS field record

## **THIS IS NOT AN IDENTIFICATION.**

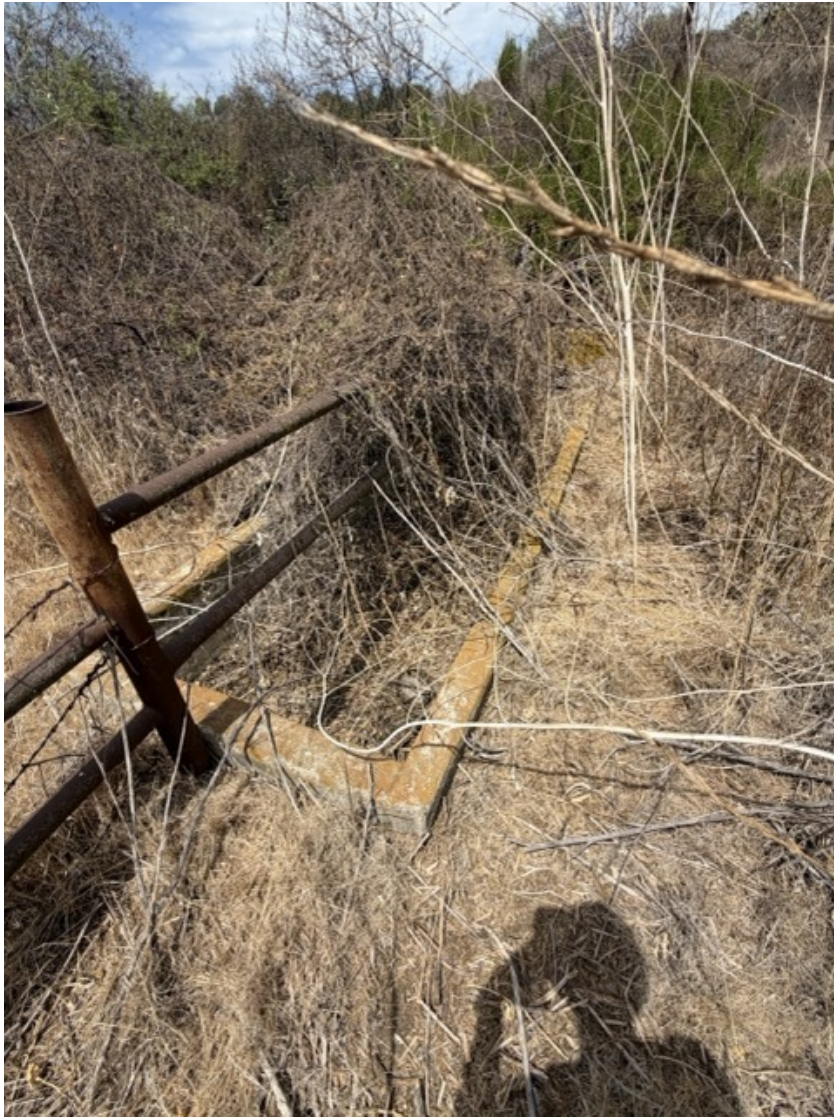
View along the axis of the structure. The concrete channel runs away from the camera into heavy brush; a rusted pipe frame crosses the near end. Depth is obscured by sediment and vegetation.

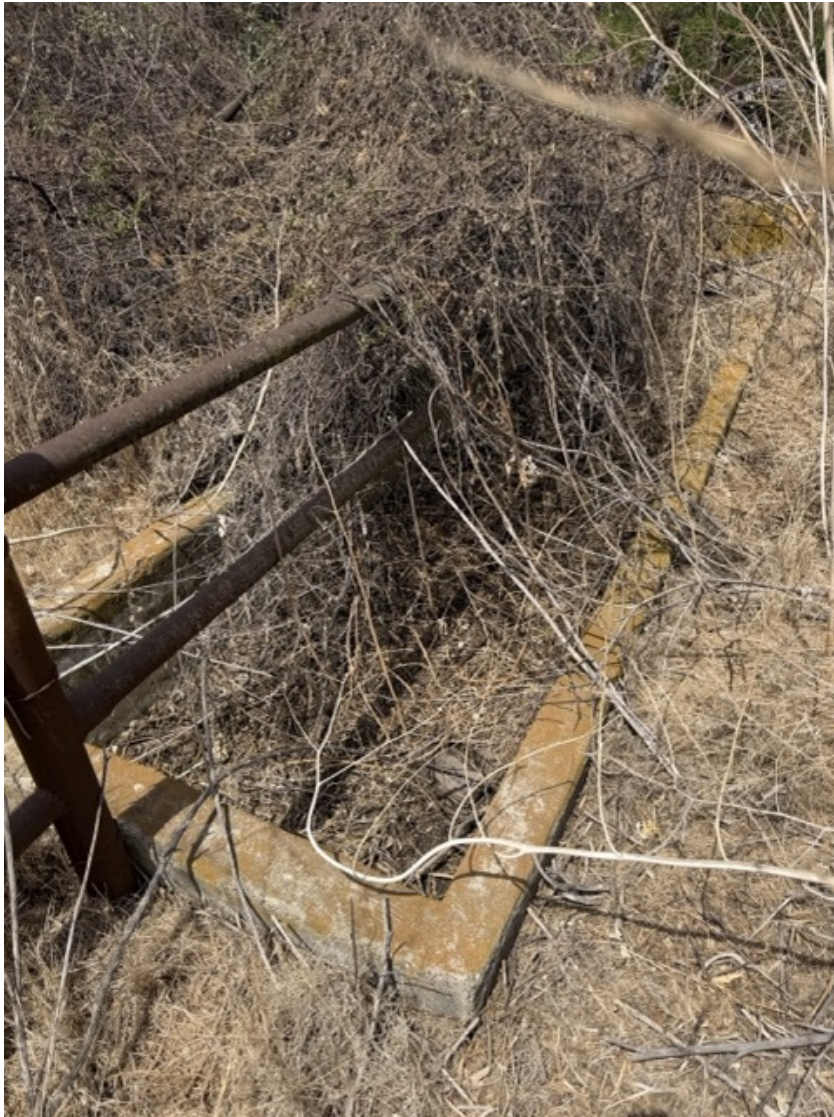
Down-angle view of the near end: a clean concrete corner with a raised rim on both sides, and the pipe railing descending into the structure. The rim-and-corner geometry is what argues for a discrete vessel rather than a continuous ditch.

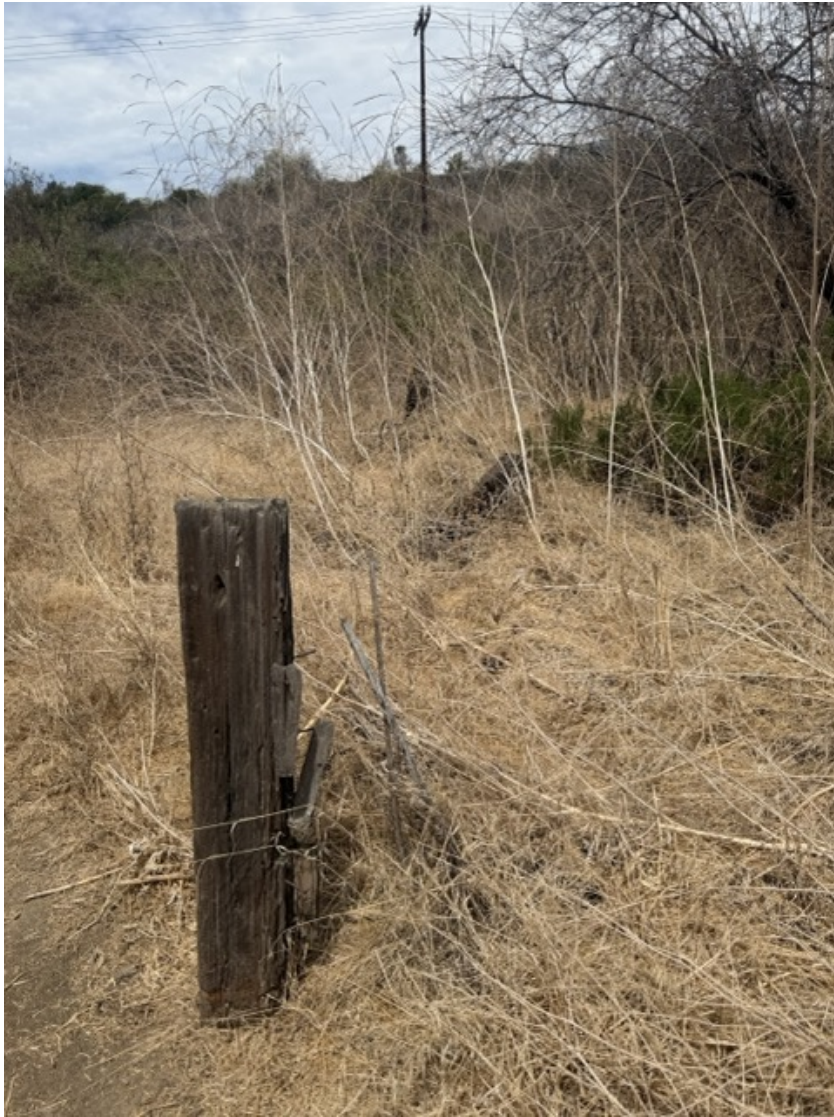
Weathered timber post with wire, standing near the structure. The 1911 specification's pen and cover posts were timber set 3 ft into the ground; wire-and-rail fencing enclosed the pens.

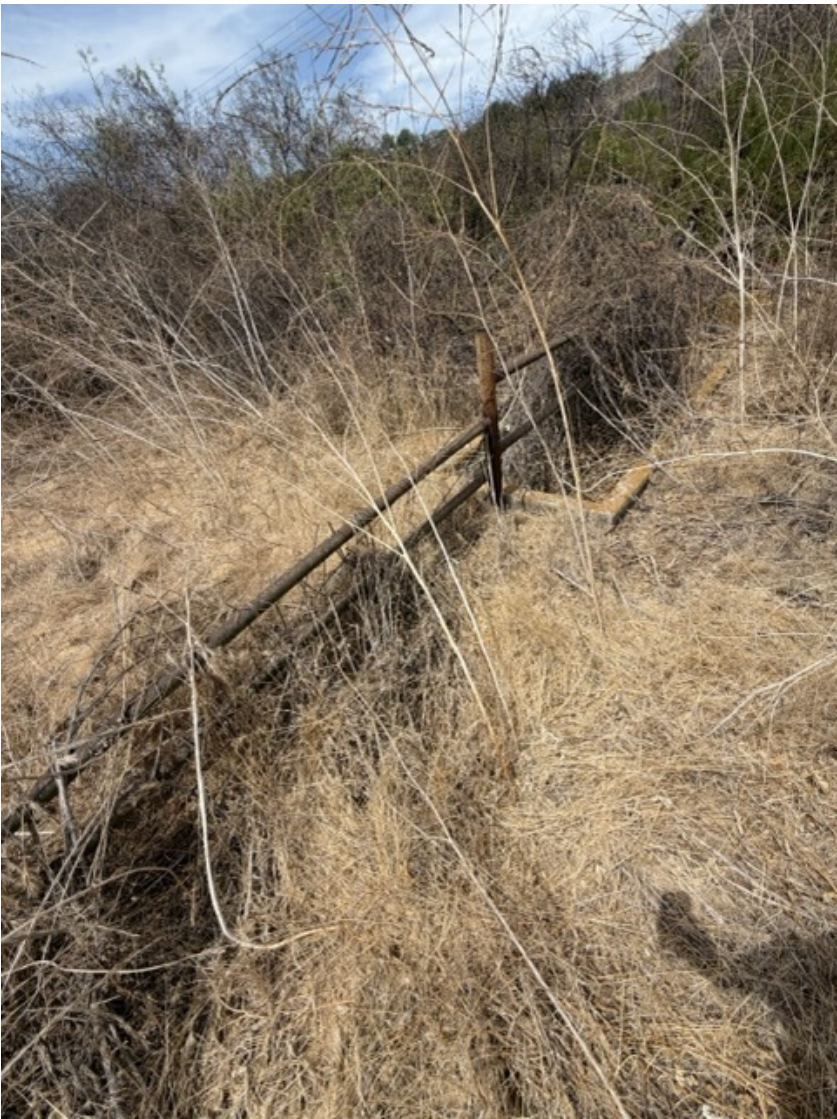
Fallen and leaning pipe rails in the brush beside the structure — consistent with chute or pen railing. Corroborating, not diagnostic.
