# Field observation — concrete structure near the 1948 node

Ladera Ranch vicinity, Orange County, California · recorded 2026-08-07 · LHDRS field record

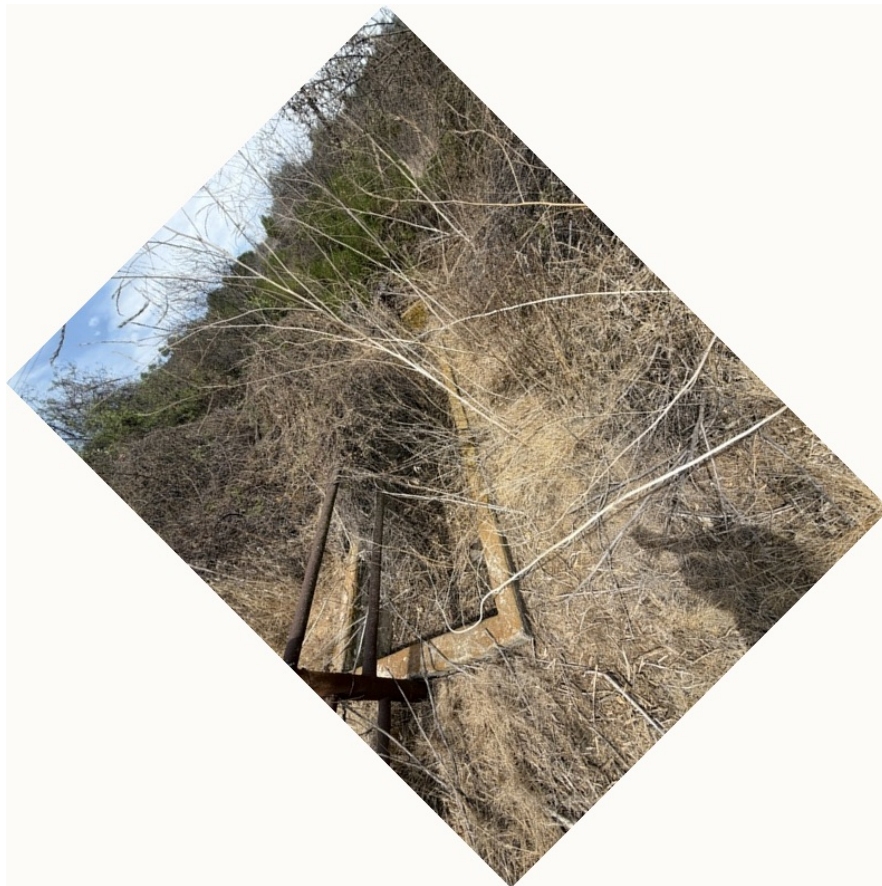
Observer photograph, source: vat\_photo.jpg, **rotated 45° clockwise** for legibility (presentational only — no content altered). Looking along the axis of the structure. A rusted metal pipe frame lies across the near end; the concrete channel runs away from the camera into heavy dry brush. Depth is obscured by accumulated sediment and vegetation.

| Attribute | As reported | Confidence |
|---|---|---|
| Form | Discrete linear channel with ends; not a continuous ditch run | observer, direct |
| Associated | Rusted pipe frame/rails at one end; weathered timber post with wire nearby (set | observer, direct |

- **Depth is unmeasured, and depth is the whole question.** A dipping vat is **6.5 ft deep** with steep sides — cattle swim through it. If this structure proves to be 1–2 ft deep it is a trough, a flume or a lined ditch, and nothing else about it matters.

- **No taper has been confirmed.** A vat narrows markedly from rim to floor. A ditch has parallel walls. This has not been checked.
- **Neither end feature has been observed.** A vat is asymmetric — a steep entry slide at roughly 25° at one end, a cleated exit ramp at the other. Their absence would be strong evidence against.

If this *is* a dipping vat, the sediment inside it is the single most concentrated place arsenic would be found anywhere in this landscape — this project's own modelling puts that compartment in the thousands of mg/kg against a California background of 1–11 mg/kg. **Do not dig in it. Do not handle or remove the sediment. Do not let children or animals into it.** Photograph and measure from outside. Arsenic does not degrade; a century has not reduced it.

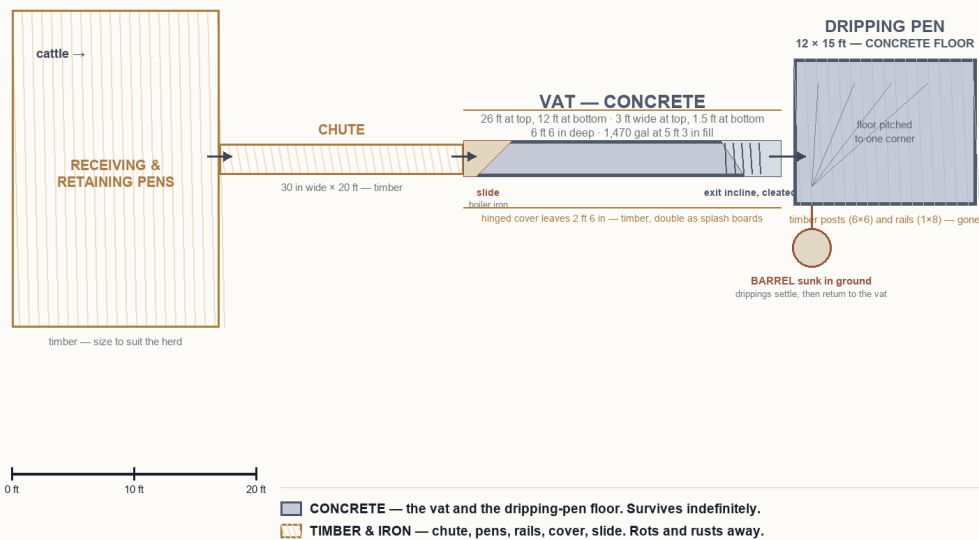
A complete 1911-specification dipping station, in plan

A century on, the timber has rotted and the ironwork has largely gone. **The concrete is the only part expected to remain by default.** So an isolated concrete channel sitting in brush, with no pens, no chute and no fencing around it, is *precisely* what the surviving fragment of a complete dipping station would look like. The absence of the other components is the predicted condition — not evidence against.

A century on, only the concrete is expected to remain. An isolated concrete channel in brush is what the surviving fragment of a complete station looks like — the missing pens are not evidence against.  
Source: USDA Bureau of Animal Industry Circular 183 (1911), repeated in Circular 207 (1912). Field locally with full text and SHA-256.

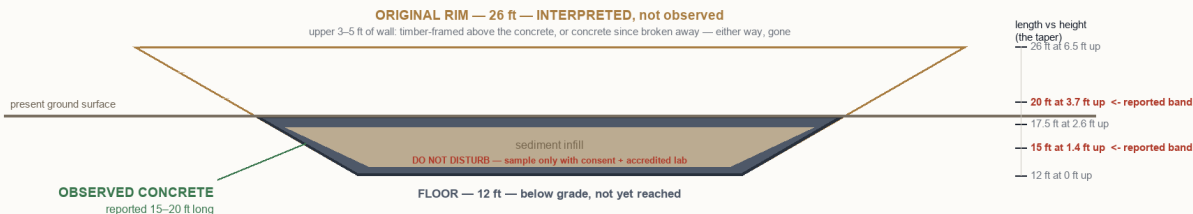
Could the observed concrete be the base of a full-size vat?

The reported 15–20 ft is not a mismatch with the 26-ft specification. It is the specification, read 1.4–3.7 ft up the taper.

That is exactly what the lower portion of a spec vat measures when the upper 3–5 ft of wall — timber-framed above the concrete, or concrete since broken away — no longer exists. Period practice included part-height concrete with timber framing above; either variant leaves this footprint. The reconstruction below draws the surviving band solid and the interpreted portion ghosted, because they are different kinds of statement.

Longitudinal section, to scale. The 1911 vat tapers, so OBSERVED LENGTH DEPENDS ON SURVIVING HEIGHT.  
Solid = observed in the field. Ghosted = INTERPRETED reconstruction from the federal spec. They are not the same kind of statement.

- Also found on site, and where they fit:
- WEATHERED TIMBER POST with wire — the spec's pens and cover posts were timber set 3 ft deep, fenced with wire and rails.
  - RUSTED PIPE RAILS — consistent with chule or pen railing at the structure's end.
  - These are remnants of exactly the perishable components the materials argument said should be missing or nearly gone.
  - Finding their traces STRENGTHENS the station reading and weakens the lone-drainage-ditch reading.

The solid band is the field observation. Everything ghosted is INTERPRETED from USDA Circular 183 and is testable, not established.  
DEPTH IS STILL UNMEASURED. A probe finding concrete floor 3–4 ft below present grade CONFIRMS this reading; a floor at under 2 ft REFUTES it.  
Reported width (3–4 ft) runs slightly wide of the taper's 1.8–2.4 ft at this height - stated, not hidden. Widths were estimates, not measurements.

**Falsifiable, both ways:** a probe finding concrete floor 3–4 ft below present grade CONFIRMS this reading. A floor at under 2 ft REFUTES it. One caveat is stated on the figure: reported width (3–4 ft) runs slightly wide of the taper's 1.8–2.4 ft at that height — widths were estimates, not measurements.
