# Field observation — concrete structure near the 1948 node

Ladera Ranch vicinity, Orange County, California · recorded 2026-08-07 · LHDRS field record

## THIS IS NOT AN IDENTIFICATION.

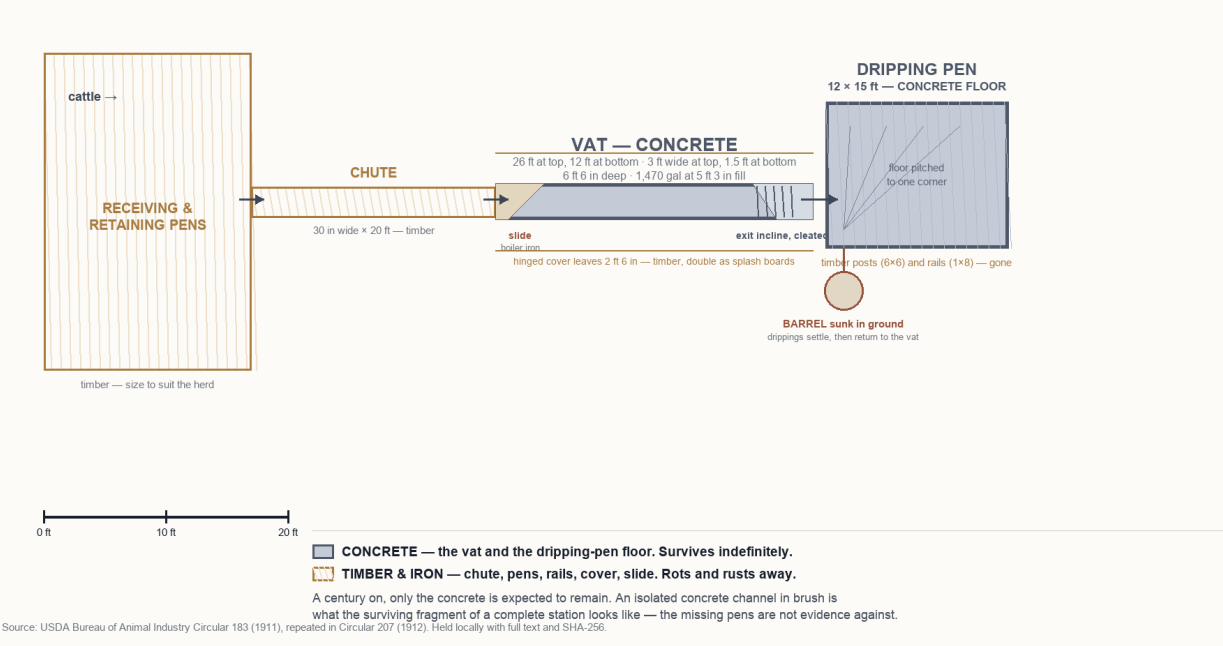
A century on, the timber has rotted and the ironwork has largely gone. **The concrete is the only part expected to remain by default.** So an isolated concrete channel sitting in brush, with no pens, no chute and no fencing around it, is *precisely* what the surviving fragment of a complete dipping station would look like. The absence of the other components is the predicted condition — not evidence against.

This cuts the other way too, and should be said: the same argument means a surviving concrete fragment carries **less** corroborating context than an intact site would. There is no chute or pen left to confirm the interpretation. That is why the measurements in the next section carry so much weight — the structure has to identify itself.

Scale plan of a complete 1911-specification station, drawn from the federal instructions. Every dimension is quoted from USDA Bureau of Animal Industry Circular 183 (1911), repeated in Circular 207 (1912). Solid = concrete; hatched = timber and iron.
