# Field observation — concrete structure near the 1948 node

Ladera Ranch vicinity, Orange County, California · recorded 2026-08-07 · LHDRS field record

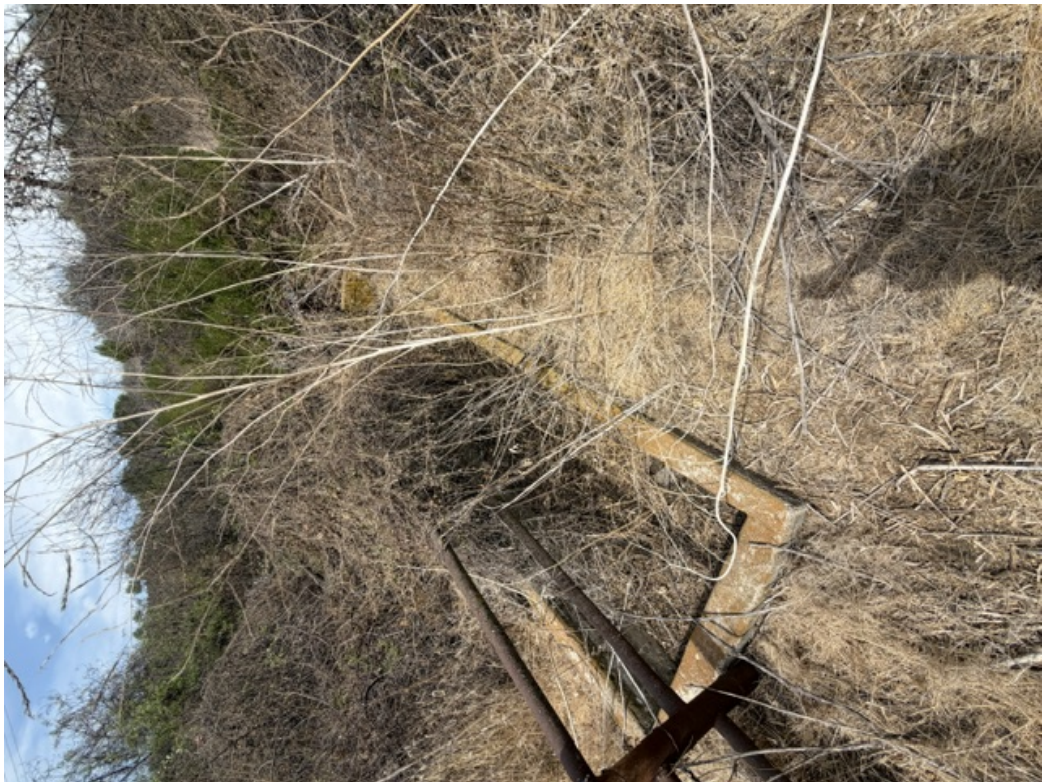
Observer photograph, source: vat\_photo.jpg. Looking along the axis of the structure. A rusted metal pipe frame lies across the near end; the concrete channel runs away from the camera into heavy dry brush. Depth is obscured by accumulated sediment and vegetation.

- **Depth is unmeasured, and depth is the whole question.** A dipping vat is **6.5 ft deep** with steep sides — cattle swim through it. If this structure proves to be 1–2 ft deep it is a trough, a flume or a lined ditch, and nothing else about it matters.

- **No taper has been confirmed.** A vat narrows markedly from rim to floor. A ditch has parallel walls. This has not been checked.
- **Neither end feature has been observed.** A vat is asymmetric — a steep entry slide at roughly 25° at one end, a cleated exit ramp at the other. Their absence would be strong evidence against.

- **No drip pen or chute has been seen.** These are large, concrete, and adjacent. Their absence is not conclusive — they may be buried or demolished — but their presence would be near decisive.

If this *is* a dipping vat, the sediment inside it is the single most concentrated place arsenic would be found anywhere in this landscape — this project's own modelling puts that compartment in the thousands of mg/kg against a California background of 1–11 mg/kg. **Do not dig in it. Do not handle or remove the sediment. Do not let children or animals into it.** Photograph and measure from outside. Arsenic does not degrade; a century has not reduced it.
