## DETAILS OF CRACK MONITORING

| GHG Reference | S2520891 |
| Risk Address | Mapletree Cottage, Kings Mead, Pebmarsh, Halstead, CO9 2NA, United Kingdom |

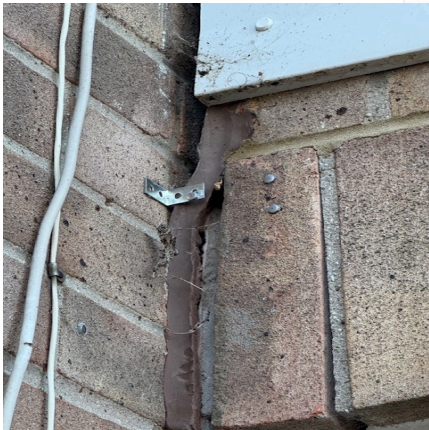
| Location | External RH elevation where outrigger meets main house |

| Crack Width | 25.00 |
| Alignment | Vertical |

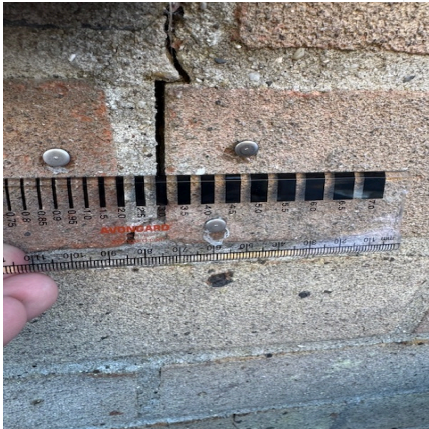
| Location | External Front Porch Below RHS of window |

| Crack Width | 3.00 |
| Alignment | Vertical |
