**Insurance Company:** Ageas

**Insurer Claim Number:** 6866220H

H Thomas And R Thomas Mapletree Cottage, Kings Mead, Pebmarsh, HALSTEAD, CO9 2NA

Ongoing subs claim, Defects noticed to the drainage system.

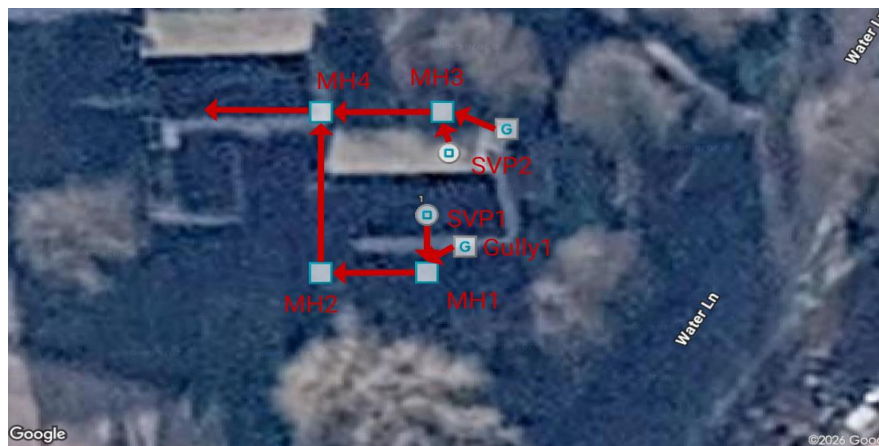
### Site Plan

Attended property to carry out a CCTV survey of the drains as there is a subsidence investigation ongoing, MH1 U/S SVP1 there is a displacements which will require a patch repair MH1 D/S to MH2 we found multiple root intrusions which will require root cutting and 3 patch repairs to this one line to clear issues, the roots are congesting around 50% of the diameter MH3 U/S to Gully2 there is a medium displaced joint which will require a structural liner repair Also MH3 D/S to MH4 there were roots and a displaced joint which will require 2 structural lining repairs

Root ingress /displaced joints

MH1 U/S SVP1 - Require a patch repair

MH1 D/S to MH2 will require root cutting and 3 patch repairs to this one line to clear issues

MH3 U/S to Gully2 there is a medium displaced joint which will require a structural liner repair

MH3 D/S to MH4 will require 2 structural lining repairs
