## CCTV REPORT

Mapletree Cottage  
Pebmarsh  
Halstead  
CO9 2NA  
GHG

06/03/2026

# RECOMMENDATION SHEET

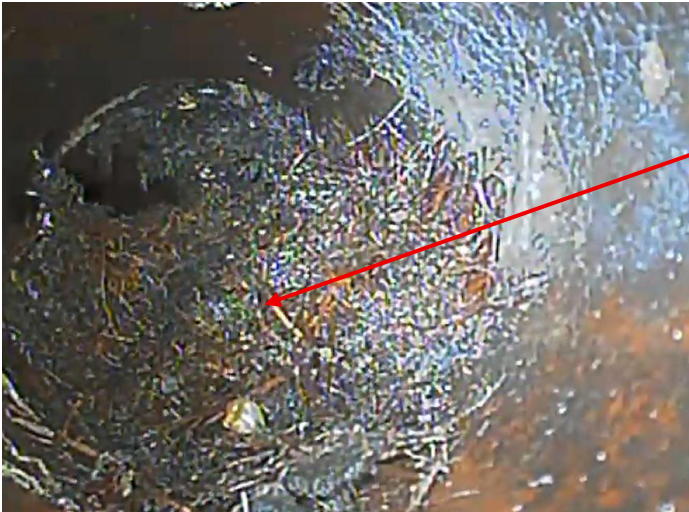
| Run 1 | Heads upstream to SVP/1. The run is 100% blocked with root. The camera could not be pushed pasted the obstruction. We would advise the run is root cut to allow for a liner to be inverted upstream to the rest bend. | £2,167.58 |

Root Mass

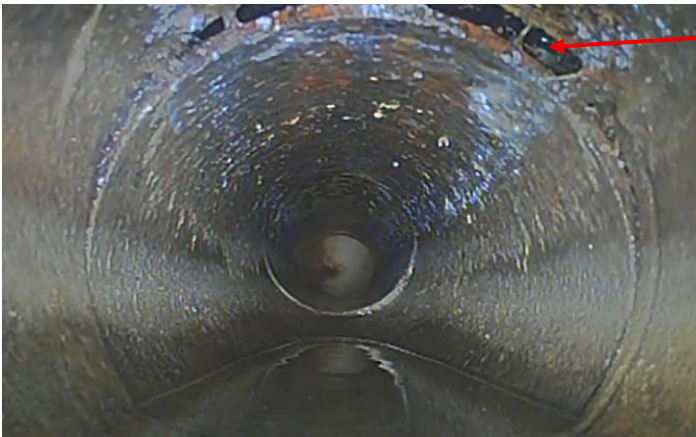
| Run 2 | Heads upstream to DSWC/1. There are displacements noted within the run. We would advise the run is lined upstream to the rest bend. | £208.12 |

Root Mass

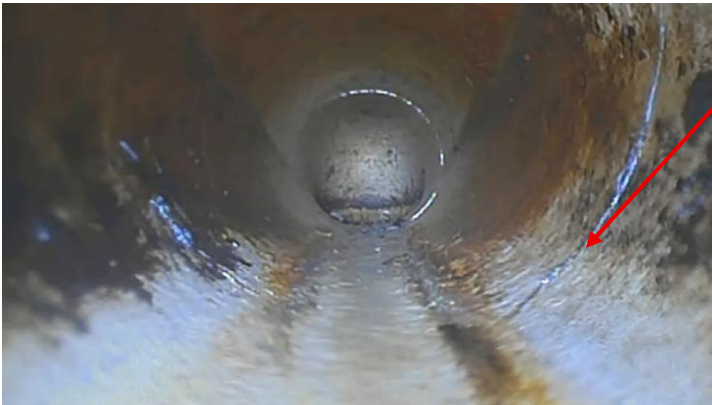
| Run 3 | Heads upstream to WG/1. There is a slight crack within the run. We would advise a patch is inverted. | £407.33 |

Crack

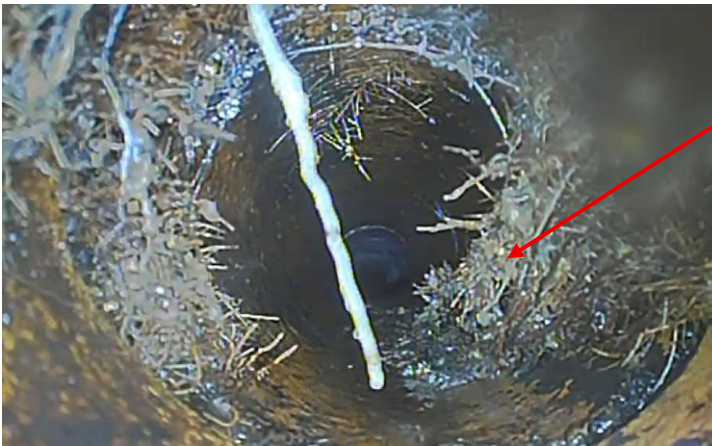
| Run 4 | Heads downstream to MH/2. The run then heads downstream off boundary and joins MH/3 which is then back on boundary. Roots have began to penetrate the run. We would advise the run is HPWJ and a liner inverted downstream to MH/2. Then x2 patches inverted from MH/3 upstream to cover defects noted at 8m and 14m (see coding sheet). | £1,543.08 |

Root Mass

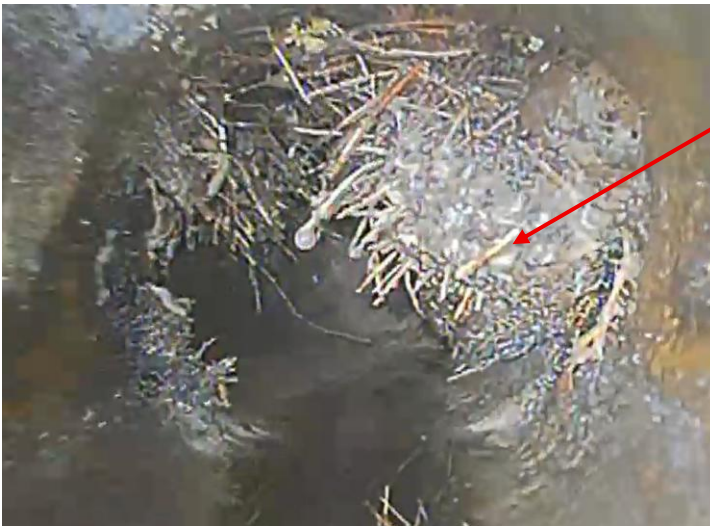
Root Mass

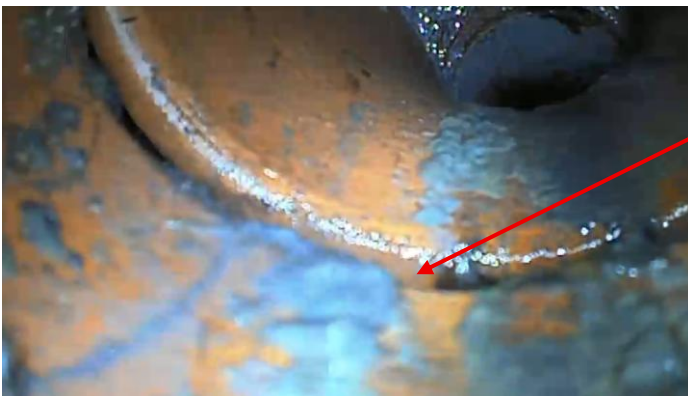
### Run 5

| Run 5 | Heads upstream to RWWG/1. There is a displaced joint noted at 4.80m. We would advise a patch is inverted over the defect. | £407.33 |

JDM

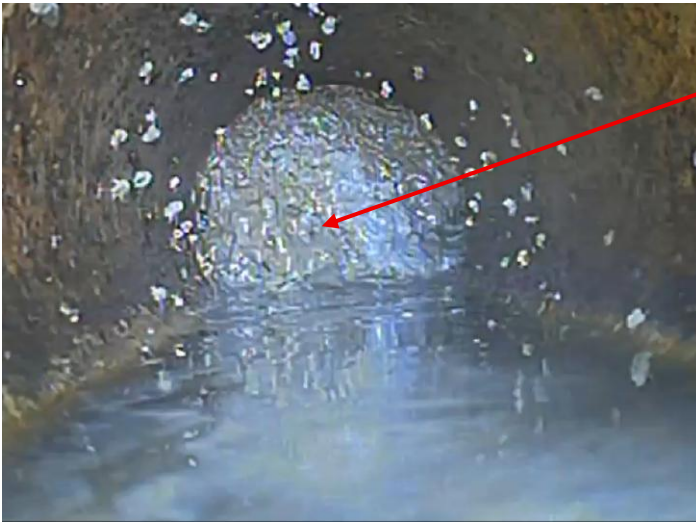
| Run 6 | Heads upstream to WG/2. The gully is blocked and could not be cleared. The survey showed mass root at 0.80m. Due to the line up the gully will need to be removed to allow for the cutter to be deployed to remove the root ingress which will also clear the gully. On completion a super flexi liner to be inverted downstream to the gully. (Pump required to clear gully). | £2,089.23 |

Root Mass

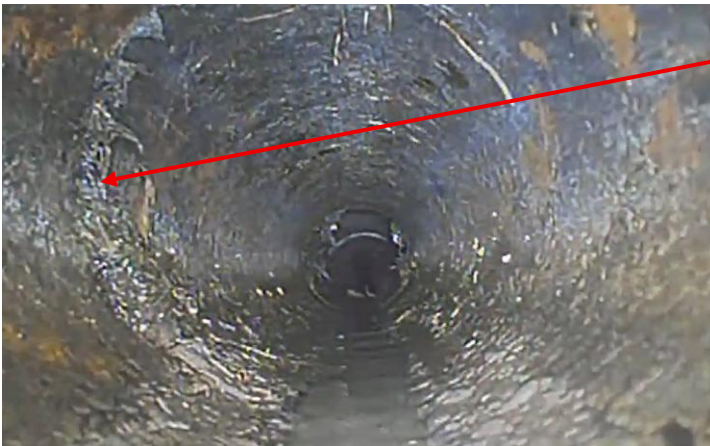
| Run 8 | Heads downstream off boundary. There is root ingress within the run. We would advise the run is HPWJ and a patch inverted upstream from MH/3 and downstream from MH/3. | £1,221.99 |

Root

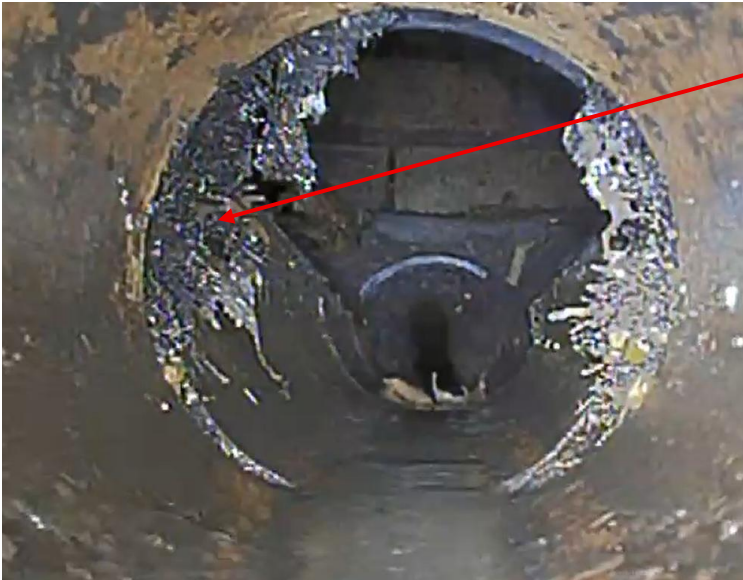
Root

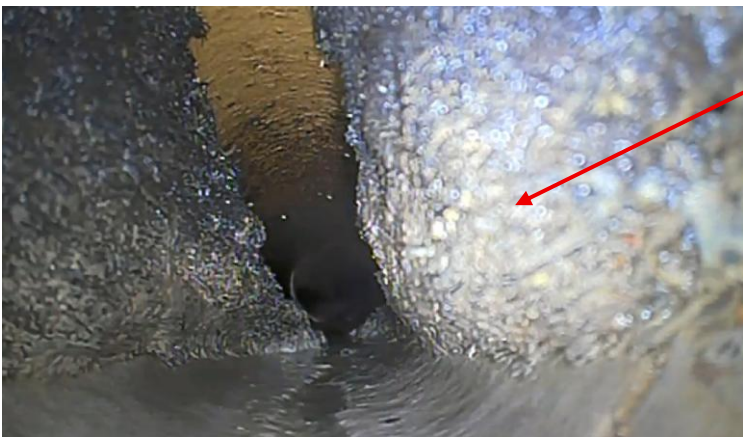
Root Mass

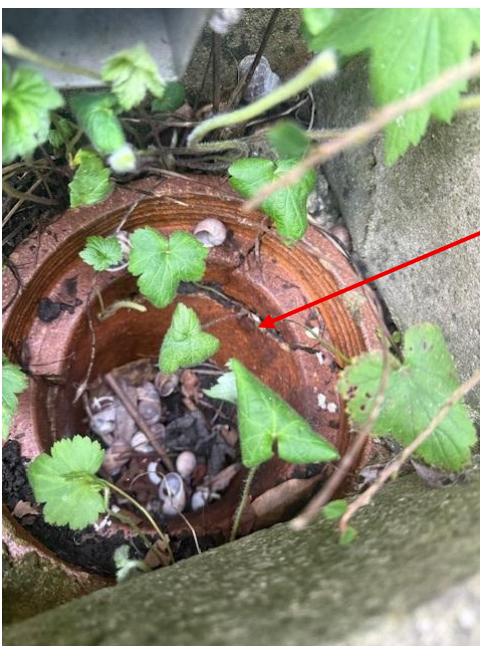
| RWG/1 | Located on front left off boundary. The gully is off boundary within the neighbour's flower bed. Both the homeowner and neighbour spoke to. The gully is cracked and blocked. Neighbour believed they found a pipe when laying a new drive way. We would advise the LWA are contacted. | £0 |

Cracked Gully
