## DETAILS OF CRACK MONITORING

| GHG Reference | S2520891 |
| Risk Address | Mapletree Cottage, Kings Mead, Pebmarsh, Halstead, CO9 2NA, United Kingdom |

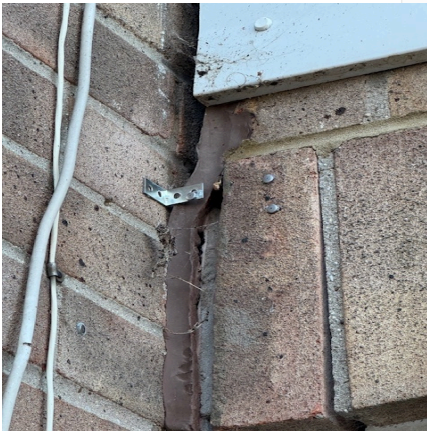
| Location | Monitoring station - side left |

| Crack Width | 25.00 |
| Alignment | Vertical |

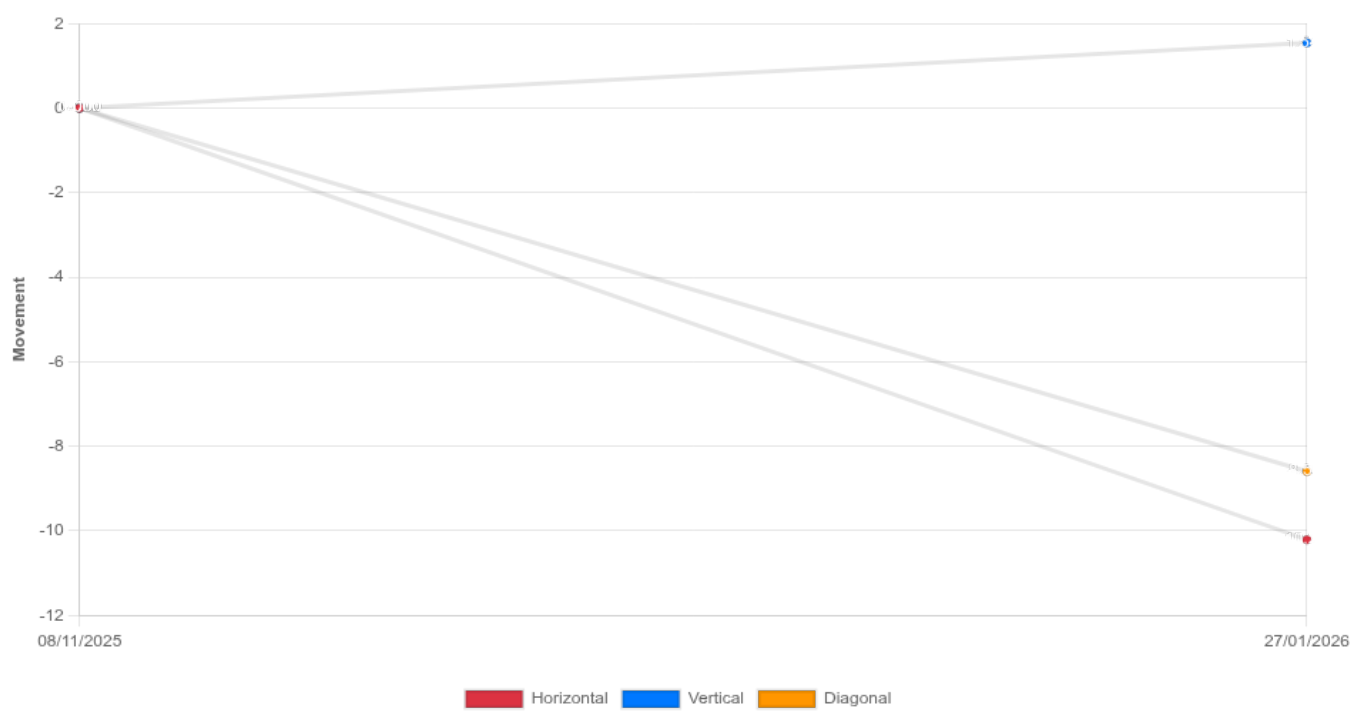
GRAPH OF CRACK MOVEMENT

| 08/11/2025 | Notes | Segment | Alignment | Value | +/-Initial | +/-Previous |
|---|---|---|---|---|---|---|
| SML | | A-B | Horizontal | 35.930 | -10.210 | -10.210 |
| | | B-C | Vertical | 26.780 | 1.547 | 1.547 |
| | | A-C | Diagonal | 43.310 | -8.593 | -8.593 |

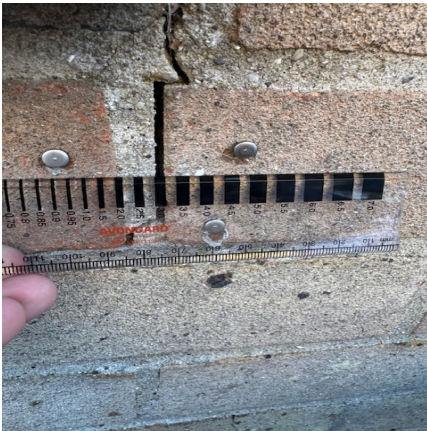
| Location | Monitoring Station Front |

| Crack Width | 3.00 |
| Alignment | Vertical |

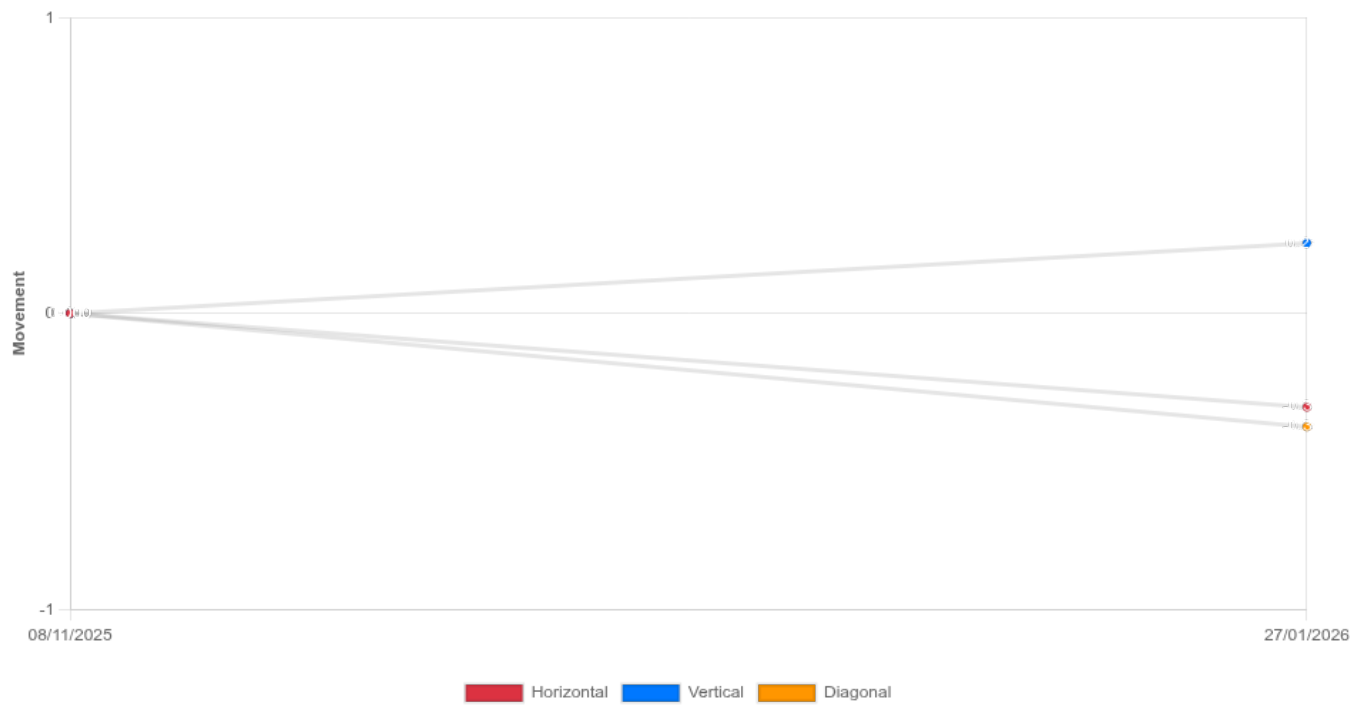
GRAPH OF CRACK MOVEMENT

| 08/11/2025 | Notes | Segment | Alignment | Value | +/-Initial | +/-Previous |
|---|---|---|---|---|---|---|
| SML | | A-B | Horizontal | 48.853 | -0.317 | -0.317 |
| | | B-C | Vertical | 34.590 | 0.237 | 0.237 |
| | | A-C | Diagonal | 52.630 | -0.383 | -0.383 |
