Energy Procedia 88 (2016) 422 - 428

CUE2015-Applied Energy Symposium and Summit 2015: Low carbon cities and urban energy systems

Power degradation caused by snail trails in urban photovoltaic energy systems

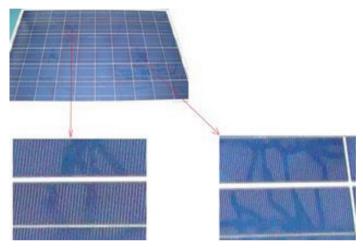
Fig. 4. Module with snail trails. All the snail trails appear on solar cells. There is no snail trails discoloration in the gap areas

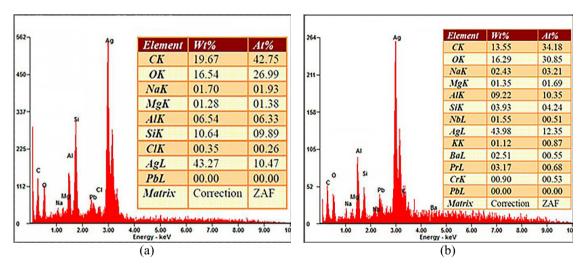
EDS (Energy Dispersive x-ray Spectrometry) is used to exam the elements and relevant content in cell fingers. In the finger areas of cell, the key elements C, O, and Ag were detected in both affected and non-affected silver lines areas. There is no striking difference in the content of silver in both fingers. This result implies that the silver element of snail trails didn't come from silver finger. The result is shown in figure 6.

Fig. 6. EDS analysis for affected cell finger areas (a) and non-affected cell finger areas (b)
