## Fusion reactor component failures

While magnetic confinement fusion facilities cannot undergo a runaway thermonuclear chain reaction or a Chernobyl-style core meltdown, they operate under extreme thermodynamic, structural, and electromagnetic conditions. An experimental fusion reactor is a complex process facility storing gigajoules of magnetic energy, managing volatile cryogenic fluids, operating at kilovolt-scale electrical potentials, and utilizing high-speed kinetic machinery to pulse its systems.

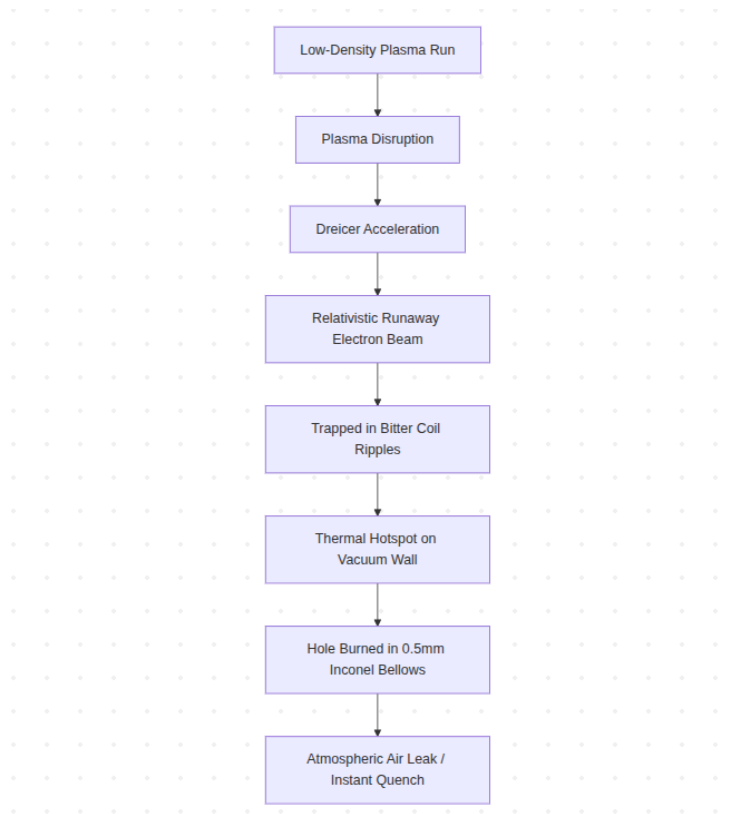
1973 TFR incident

The runaway electron beam concentrated its thermal energy on a sub-centimeter spot of the inner vacuum vessel wall. The localized heat flux melted a hole directly through the 0.5 mm Inconel bellows, resulting in an immediate atmospheric air in-leak that quenched the remaining plasma [2].

The primary cause was the generation of a high-current relativistic electron beam in a low-density, impurity-laden plasma regime [2]. This was exacerbated by a significant toroidal magnetic field ripple that directed the runaway electron beam into the thin bellows of the vacuum chamber.

The incident required disassembly of the tokamak and fabrication of a replacement vacuum vessel. This event warned the global fusion community of the destructive potential of runaway electron beams, initiating decades of research into neoclassical transport, magnetic ripple transport, and active disruption mitigation techniques.

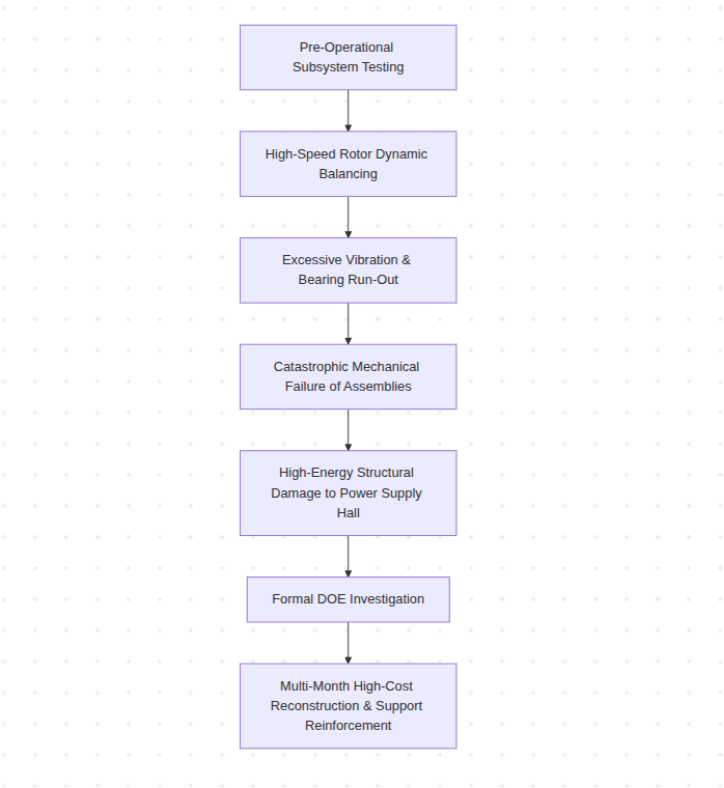
1980 TFTR incident

The rotating components experienced mechanical instability, leading to a structural breakdown of the generator's bearing housings, shaft alignments, and balancing assemblies [4].

The resulting release of kinetic energy caused extensive physical damage to the power-supply hall. Because this incident occurred during pre-operational subsystem testing, no plasma was active, and no radioactive materials were present in the facility [4].

An investigation by the Department of Energy (DOE) identified that high-speed rotor dynamic imbalances, combined with bearing run-out and insufficient structural dampening of the generator's foundation brackets, led to the mechanical failure under cyclic operational loads [4].

The incident delayed TFTR operations and required a multi-month reconstruction of the pulsing power systems [4]. Engineers redesigned the rotor support structures, modified the liquid rheostats, and integrated supplementary bearings to manage vibration and bearing run-out at high speeds [5]. This repair process allowed TFTR to safely begin its plasma operations in December 1982.

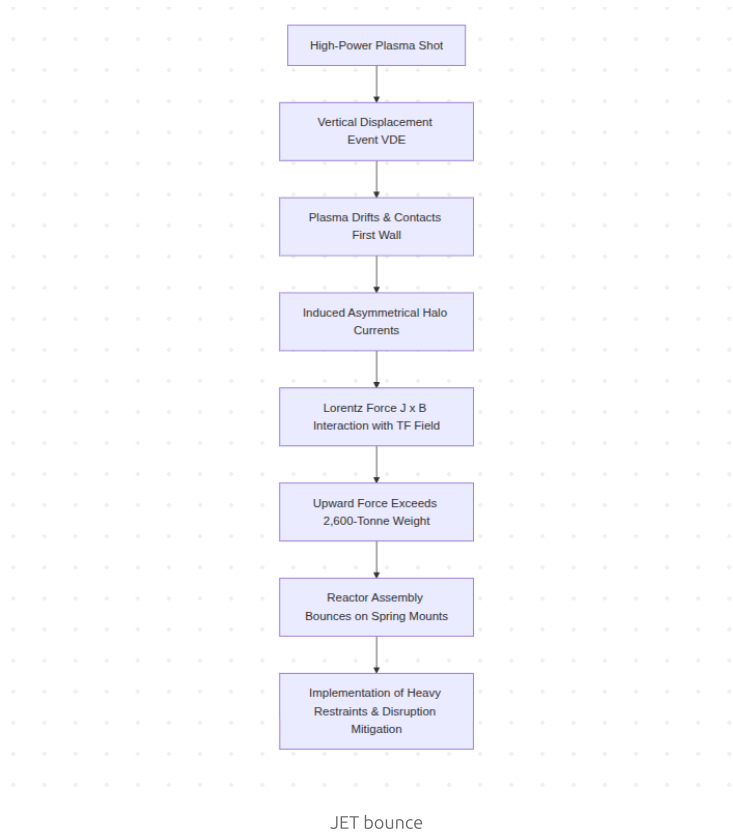
These transient halo currents ( $J$ ) interacted with the main toroidal magnetic field ( $B$ ), generating massive, instantaneous, upward Lorentz forces ( $J \times B$ ) [8]. In several high-power disruptions, the upward mechanical force exceeded the gravitational weight of the entire 2,600-tonne machine, physically lifting the reactor assembly and causing it to "bounce" several centimeters on its structural, shock-absorbing spring mounts [8]. The vertical and lateral shear forces strained structural weldments, diagnostic ports, and vacuum bellows [6].

The rapid vertical drift of a highly energetic, elongated plasma column during a disruption led to the generation of large, asymmetric, and unmitigated halo currents [8]. The interaction of these currents with the strong background toroidal magnetic field created transient global forces that exceeded the design limits of the original structural supports.

JET engineers implemented a mechanical upgrade of the facility, installing heavy external mechanical restraints, radial keys, and reinforced vacuum vessel supports [8]. This experience also catalyzed the development of active disruption mitigation systems—including massive gas injection (MGI) and shatter pellet injection (SPI)—designed to quickly dissipate plasma thermal and magnetic energy before asymmetric halo currents can develop [7].

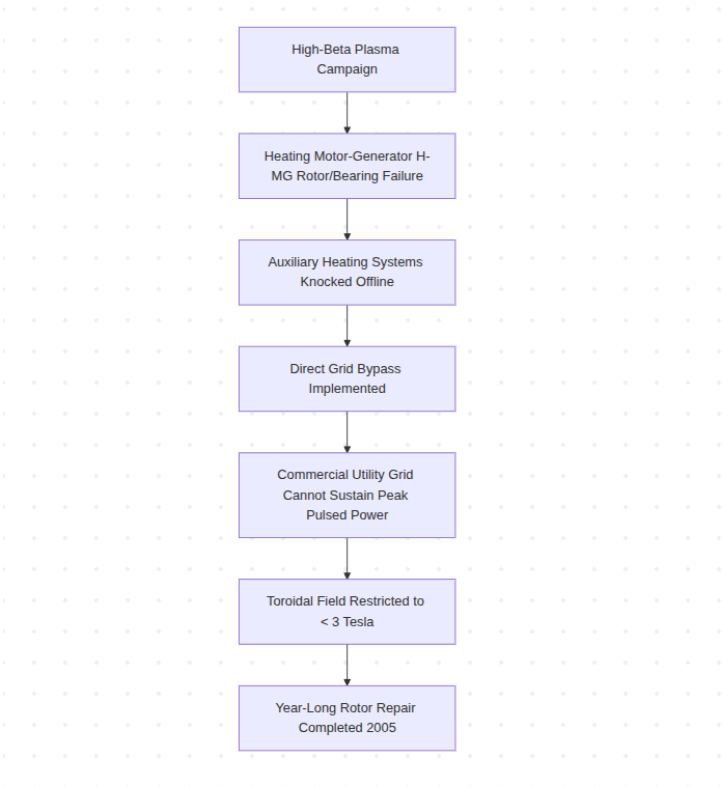
2004 JT-60U rotor failure

In February 2004, during a high-power plasma campaign designed to investigate high-beta plasma profiles, the H-MG system suffered a mechanical breakdown of its internal rotor and bearing assemblies while spinning at peak operating speed [9].

The mechanical failure disabled the H-MG, immediately taking the auxiliary heating systems offline [10]. Because manufacturing and installing a new rotor had a lead time of over a year, engineers executed a bypass [9].

The mechanical failure was attributed to severe shaft vibrations and rotor winding stress caused by the highly cyclic, fast-pulsing duty cycles required for high-power plasma heating [9, 10].

As a result, the reactor's maximum magnetic field had to be restricted to under 3 Tesla (down from its 4 T design capacity) for the remainder of that operational campaign [9, 10]. The H-MG was repaired and returned to service in late 2005, restoring full-field capability.

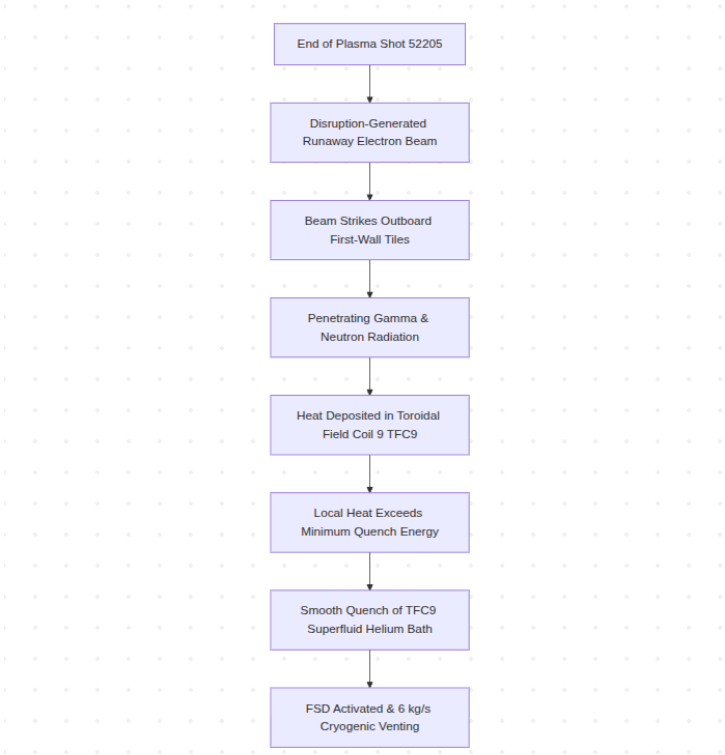
2017 Tore Supra incident

The collision of these highly energetic electrons with the first-wall tiles produced a localized flux of hard gamma-ray and neutron radiation [11]. This radiation penetrated the thermal shielding and deposited heat directly into Toroidal Field Coil 9 (TFC9).

The sudden localized heat deposition exceeded the Minimum Quench Energy (MQE) of the superconducting winding, triggering a "smooth quench" in TFC9 [11]. The QDS responded correctly, triggering the FSD system to dump the magnet's stored energy into external series resistors [12]. The cryogenic relief system managed an expelled helium mass flow rate of nearly 6 kg/s over 5 seconds through its safety valves and rupture discs [12].

The quench was caused by secondary radiation heating from an unmitigated runaway electron beam colliding with first-wall structures [11]. This highlighted the vulnerability of low-temperature superconducting coils to the penetrating radiation generated by runaway electrons, even when the coils are physically shielded behind thick vacuum vessel walls.

Because the QDS and FSD systems functioned as designed, the magnet was successfully discharged without permanent damage and returned to nominal current operations [11]. The incident underscored the need for sensitive, secondary thermohydraulic monitoring (such as helium liquid level and pressure sensors) to detect "smooth" or slow-growing quenches in low-field regions of superconducting magnets [12].

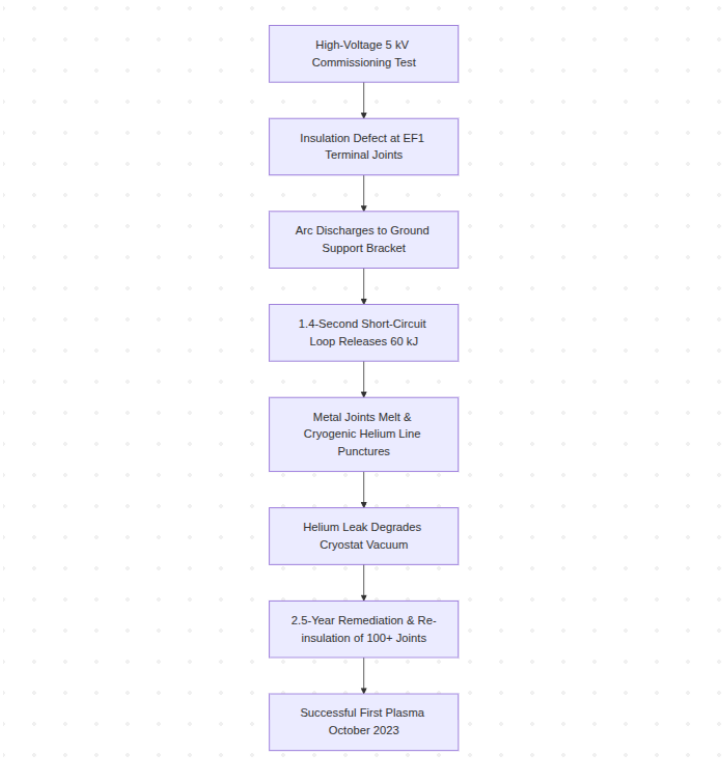
2021 JT-60SA incident

An insulation defect where a diagnostic cable emerged from the coil terminal joints allowed a high-current path to form [14]. An electrical arc discharge formed between the positive terminal joint and its grounded support bracket, followed immediately by a second arc on the neighboring negative terminal joint [13]. These two arcs created a short-circuited loop that discharged for approximately 1.4 seconds, releasing an estimated 60 kJ of energy [13].

The electrical arc melted several holes into the cylindrical metal joint of the coil, puncturing the pressurized helium cooling pipe [13]. Pressurized cryogenic helium leaked directly into the insulating vacuum cryostat, causing the vacuum to degrade from  $10^{-3}$  Pa to 7000 Pa and triggering a thermal quench of the magnet system [13]. A rupture disc on the helium cooling line released the venting helium gas safely into the torus hall [14].

The investigation determined the root cause to be insufficient local electrical insulation at the terminal joints of the EF1 coil [14]. The factory-applied insulation technique was unable to withstand the high-voltage test conditions under vacuum, leading to electrical breakdown under high voltage stress [13, 14].

The incident required a 2.5-year shutdown to warm the reactor, open the cryostat, repair the damaged joints, and redesign the insulation [15]. Engineers reinforced and re-insulated more than 100 electrical connections across the magnet systems [14, 15].

They also implemented extensive "Global Paschen Tests" (GPT) at varying vacuum levels within the cryostat to verify electrical insulation integrity before cooling the magnets back down [15]. The lessons learned from this remediation work were shared with the ITER project, and JT-60SA successfully achieved first plasma in October 2023 [16].
