# Fusion reactor component failures

Lars Warren Ericson<sup>1</sup>

<sup>1</sup>Catskills Research Company

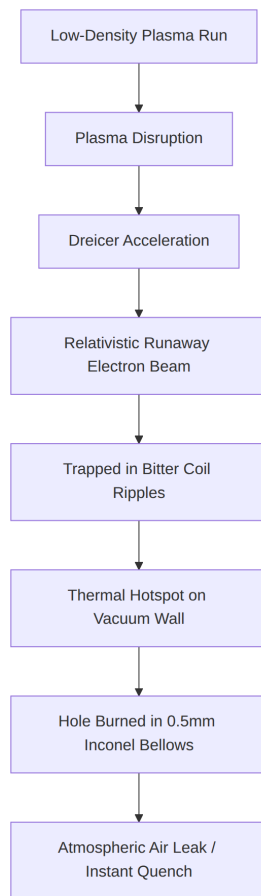
Figure 1: Tfr Runaway Electron

The runaway electron beam concentrated its thermal energy on a sub-centimeter spot of the inner vacuum vessel wall. The localized heat flux melted a hole directly through the 0.5 mm Inconel bellows, resulting in an immediate atmospheric air in-leak that quenched the remaining plasma [2].

The primary cause was the generation of a high-current relativistic electron beam in a low-density, impurity-laden plasma regime [2]. This was exacerbated by a significant toroidal magnetic field ripple that directed the runaway electron beam into the thin bellows of the vacuum chamber.

The incident required disassembly of the tokamak and fabrication of a replacement vacuum vessel. This event warned the global fusion community of the destructive potential of runaway electron beams, initiating decades of research into neoclassical transport, magnetic ripple transport, and active disruption mitigation techniques.

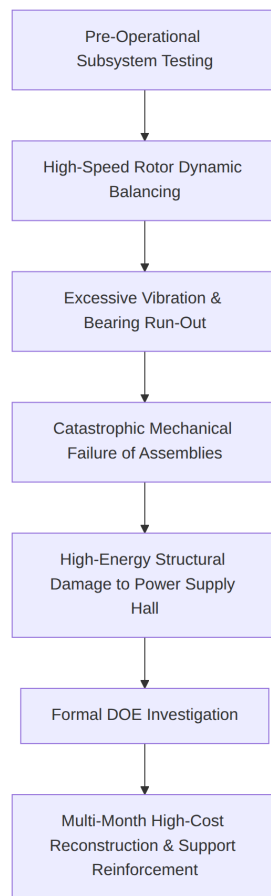
Figure 2: Tfr Motor Generator

The rotating components experienced mechanical instability, leading to a structural breakdown of the generator’s bearing housings, shaft alignments, and balancing assemblies [4].

The resulting release of kinetic energy caused extensive physical damage to the power-supply hall. Because this incident occurred during pre-operational subsystem testing, no plasma was active, and no radioactive materials were present in the facility [4].

An investigation by the Department of Energy (DOE) identified that high-speed rotor dynamic imbalances, combined with bearing run-out and insufficient structural dampening of the generator’s foundation brackets, led to the mechanical failure under cyclic operational loads [4].

The incident delayed TFTR operations and required a multi-month reconstruction of the pulsing power systems [4]. Engineers redesigned the rotor support structures, modified the liquid rheostats, and integrated supplementary bearings to manage vibration and bearing run-out at high speeds [5]. This repair process allowed TFTR to safely begin its plasma operations in December 1982.

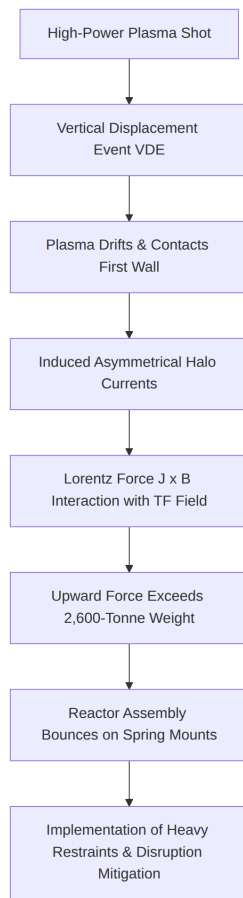
Figure 3: Jet Reactor Bounce

These transient halo currents ( $J$ ) interacted with the main toroidal magnetic field ( $B$ ), generating massive, instantaneous, upward Lorentz forces ( $J \times B$ ) [8]. In several high-power disruptions, the upward mechanical force exceeded the gravitational weight of the entire 2,600-tonne machine, physically lifting the reactor assembly and causing it to “bounce” several centimeters on its structural, shock-absorbing spring mounts [8]. The vertical and lateral shear forces strained structural weldments, diagnostic ports, and vacuum bellows [6].

The rapid vertical drift of a highly energetic, elongated plasma column during a disruption led to the generation of large, asymmetric, and unmitigated halo currents [8]. The interaction of these currents with the strong background toroidal magnetic field created transient global forces that exceeded the design limits of the original structural supports.

JET engineers implemented a mechanical upgrade of the facility, installing heavy external mechanical restraints, radial keys, and reinforced vacuum vessel supports [8]. This experience also catalyzed the development of active disruption mitigation systems—including massive gas injection (MGI) and shatter pellet injection (SPI)—designed to quickly dissipate plasma thermal and magnetic energy before asymmetric halo currents can develop [7].

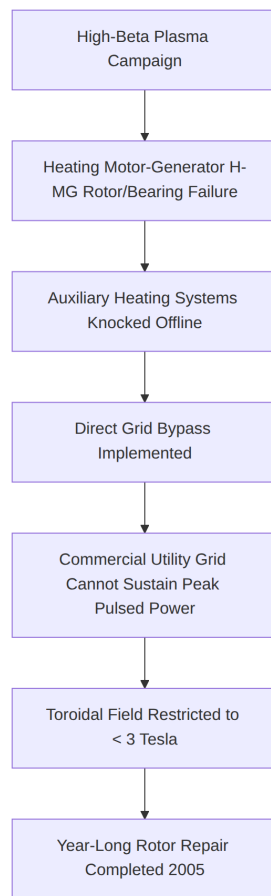
Figure 4: Jt60U Mg Rotor

The mechanical failure disabled the H-MG, immediately taking the auxiliary heating systems offline [10]. Because manufacturing and installing a new rotor had a lead time of over a year, engineers executed a bypass [9].

The mechanical failure was attributed to severe shaft vibrations and rotor winding stress caused by the highly cyclic, fast-pulsing duty cycles required for high-power plasma heating [9, 10].

Although the bypass allowed JT-60U to resume operations, the commercial utility grid could not sustain the peak power surges required to operate the Toroidal Field coils at their full design strength [9].

As a result, the reactor's maximum magnetic field had to be restricted to under 3 Tesla (down from its 4 T design capacity) for the remainder of that operational campaign [9, 10]. The H-MG was repaired and returned to service in late 2005, restoring full-field capability.

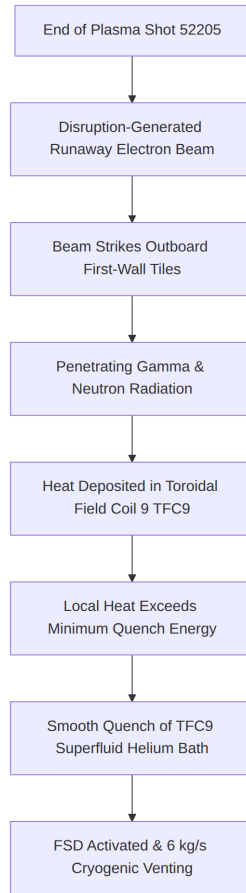
Figure 5: Tore Supra Quench

The collision of these highly energetic electrons with the first-wall tiles produced a localized flux of hard gamma-ray and neutron radiation [11]. This radiation penetrated the thermal shielding and deposited heat directly into Toroidal Field Coil 9 (TFC9).

The sudden localized heat deposition exceeded the Minimum Quench Energy (MQE) of the superconducting winding, triggering a “smooth quench” in TFC9 [11]. The QDS responded correctly, triggering the FSD system to dump the magnet’s stored energy into external series resistors [12]. The cryogenic relief system managed an expelled helium mass flow rate of nearly 6 kg/s over 5 seconds through its safety valves and rupture discs [12].

The quench was caused by secondary radiation heating from an unmitigated runaway electron beam colliding with first-wall structures [11]. This highlighted the vulnerability of low-temperature superconducting coils to the penetrating radiation generated by runaway electrons, even when the coils are physically shielded behind thick vacuum vessel walls.

Because the QDS and FSD systems functioned as designed, the magnet was successfully discharged without permanent damage and returned to nominal current operations [11]. The incident underscored the need for sensitive, secondary thermohydraulic monitoring (such as helium liquid level and pressure sensors) to detect “smooth” or slow-growing quenches in low-field regions of superconducting magnets [12].

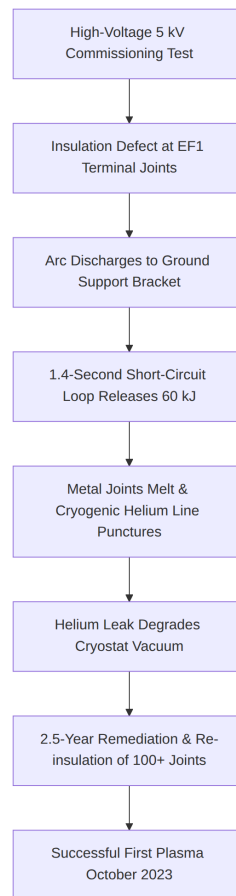
Figure 6: Jt60Sa Hv Arc

An insulation defect where a diagnostic cable emerged from the coil terminal joints allowed a high-current path to form [14]. An electrical arc discharge formed between the positive terminal joint and its grounded support bracket, followed immediately by a second arc on the neighboring negative terminal joint [13]. These two arcs created a short-circuited loop that discharged for approximately 1.4 seconds, releasing an estimated 60 kJ of energy [13].

The electrical arc melted several holes into the cylindrical metal joint of the coil, puncturing the pressurized helium cooling pipe [13]. Pressurized cryogenic helium leaked directly into the insulating vacuum cryostat, causing the vacuum to degrade from  $10^{-3}$  Pa to 7000 Pa and triggering a thermal quench of the magnet system [13]. A rupture disc on the helium cooling line released the venting helium gas safely into the torus hall [14].

The investigation determined the root cause to be insufficient local electrical insulation at the terminal joints of the EF1 coil [14]. The factory-applied insulation technique was unable to withstand the high-voltage test conditions under vacuum, leading to electrical breakdown under high voltage stress [13, 14].

The incident required a 2.5-year shutdown to warm the reactor, open the cryostat, repair the damaged joints, and redesign the insulation [15]. Engineers reinforced and re-insulated more than 100 electrical connections across the magnet systems [14, 15].

They also implemented extensive “Global Paschen Tests” (GPT) at varying vacuum levels within the cryostat to verify electrical insulation integrity before cooling the magnets back down [15]. The lessons learned from this remediation work were shared with the ITER project, and JT-60SA successfully achieved first plasma in October 2023 [16].
