# Fusion Reactor Component Failures: A Review of Historical Non-Thermonuclear Energetic Excursions

Lars Warren Ericson<sup>1</sup>

June 16, 2026

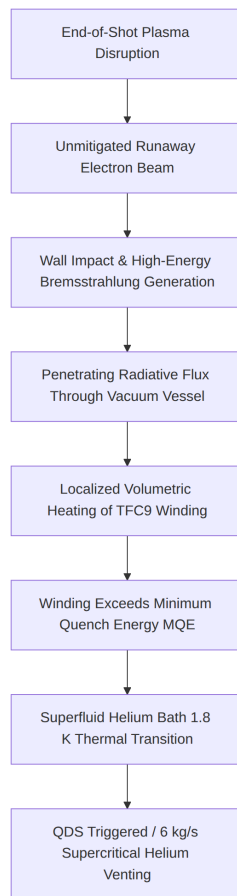
Figure 5: Tore Supra Quench

The high-energy electron impact generated a localized flux of hard gamma-ray and neutron radiation via Bremsstrahlung [11]. This penetrating radiation bypassed the thermal shielding and deposited energy directly into the winding pack of Toroidal Field Coil 9 (TFC9).

The sudden localized heat deposition exceeded the Minimum Quench Energy (MQE) of the superconducting winding, initiating a quench in TFC9 [11].

The quench was driven by secondary radiation heating from an unmitigated runaway electron beam, demonstrating that superconducting coils are vulnerable to radiative energy deposition even when physically shielded by the vacuum vessel structure [11].

The magnet system was discharged without permanent damage and returned to nominal operations. The incident highlighted the necessity of integrated thermohydraulic and nuclear shielding models when designing magnet protection systems for steady-state tokamaks [12].
