# Fusion Reactor Component Failures: A Review of Historical Non-Thermonuclear Energetic Excursions

Lars Warren Ericson<sup>1</sup>

**Resource type:** Technical report

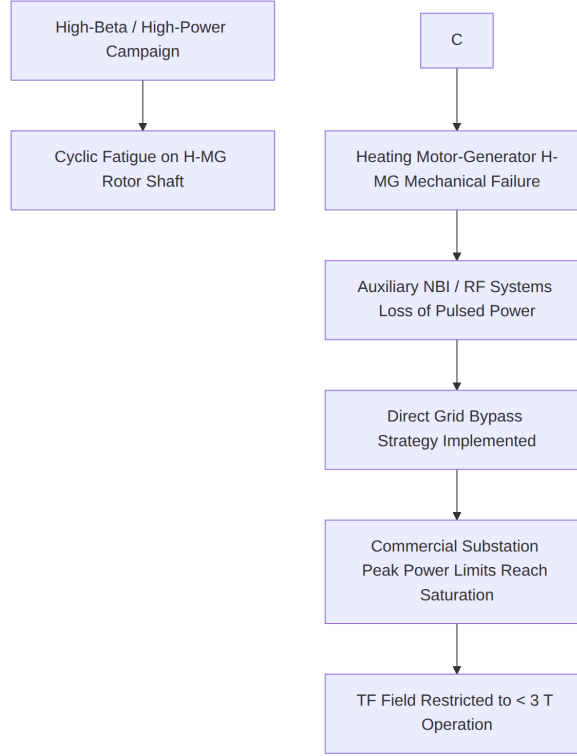
Figure 4: Jt60U Mg Rotor

In February 2004, during a high-beta plasma campaign, the H-MG system suffered a mechanical breakdown of its internal rotor and bearing assemblies while operating at peak rotational speed [9]. The mechanical failure immediately disabled the auxiliary heating systems, halting the operational campaign [10].

The mechanical failure was localized within the generator facility, but repairing the 300-ton rotor and bearing system had an estimated lead time of over a year [9].

The failure was caused by mechanical fatigue and rotor winding stress under the highly cyclic, fast-pulsing duty cycles required for high-power plasma heating [9].

To avoid a prolonged shutdown, engineers bypassed the H-MG, re-routing the auxiliary heating systems to the Toroidal Field Motor-Generator (T-MG) and connecting the Toroidal Field coils directly to the local 275 kV commercial utility grid [9, 10].

Although the bypass successfully restored auxiliary heating, the local commercial utility grid could not sustain the peak power surges required to run the Toroidal Field coils at full design strength [9]. Consequently, the reactor's maximum magnetic field had to be restricted to under 3 Tesla (down from its 4 T design capacity) for the remainder of the campaign [10]. The H-MG was repaired and returned to service in late 2005.

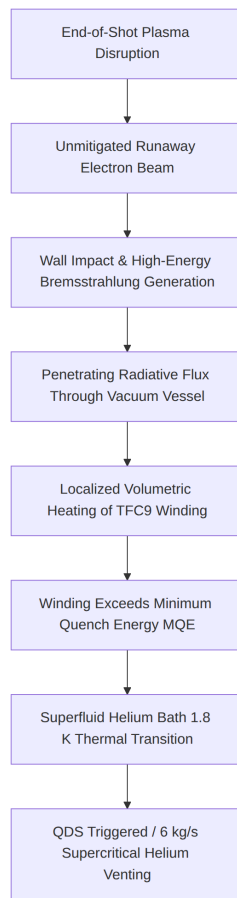
Figure 5: Tore Supra Quench

The high-energy electron impact generated a localized flux of hard gamma-ray and neutron radiation via Bremsstrahlung [11]. This penetrating radiation bypassed the thermal shielding and deposited energy directly into the winding pack of Toroidal Field Coil 9 (TFC9).

The sudden localized heat deposition exceeded the Minimum Quench Energy (MQE) of the superconducting winding, initiating a quench in TFC9 [11].

The quench was driven by secondary radiation heating from an unmitigated runaway electron beam, demonstrating that superconducting coils are vulnerable to radiative energy deposition even when physically shielded by the vacuum vessel structure [11].

The magnet system was discharged without permanent damage and returned to nominal operations. The incident highlighted the necessity of integrated thermohydraulic and nuclear shielding models when designing magnet protection systems for steady-state tokamaks [12].

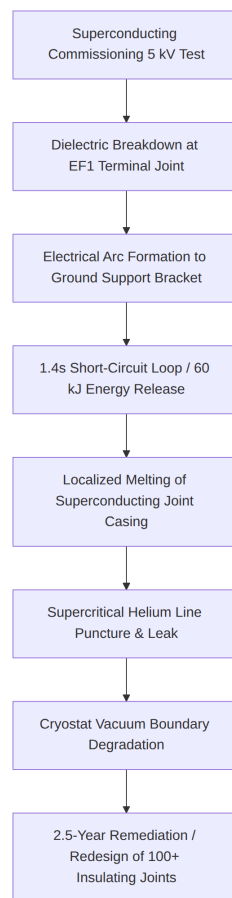
Figure 6: Jt60Sa Hv Arc

An insulation defect where a diagnostic cable emerged from the coil terminal joints allowed a high-current path to form [14]. An electrical arc discharge formed between the positive terminal joint and its grounded support bracket, followed immediately by a second arc on the neighboring negative terminal joint [13]. These arcs created a short-circuited loop that discharged for approximately 1.4 seconds, releasing an estimated 60 kJ of energy [13].

The electrical arc melted several holes into the cylindrical metal joint of the coil, puncturing the pressurized helium cooling pipe [13]. Pressurized cryogenic helium leaked directly into the insulating vacuum cryostat, degrading the vacuum from  $10^{-3}$  Pa to 7000 Pa and triggering a thermal quench of the magnet system [13]. A rupture disc on the helium cooling line released the venting helium gas into the torus hall [14].

The investigation determined that the root cause was insufficient local electrical insulation at the terminal joints of the EF1 coil, which was unable to withstand the high-voltage test conditions under vacuum [14].

The incident required a 2.5-year shutdown to warm the reactor, open the cryostat, repair the damaged joints, and redesign the insulation [15]. Engineers reinforced and re-insulated more than 100 electrical connections across the magnet systems [14, 15].

They also implemented “Global Paschen Tests” (GPT) at varying vacuum levels within the cryostat to verify electrical insulation integrity before cooling the magnets back down [15]. The lessons learned from this remediation work were shared with the ITER project, and JT-60SA successfully achieved first plasma in October 2023 [16].
