# Fusion Reactor Component Failures: A Review of Historical Non-Thermonuclear Energetic Excursions

Lars Warren Ericson<sup>1</sup>

**Resource type:** Technical report

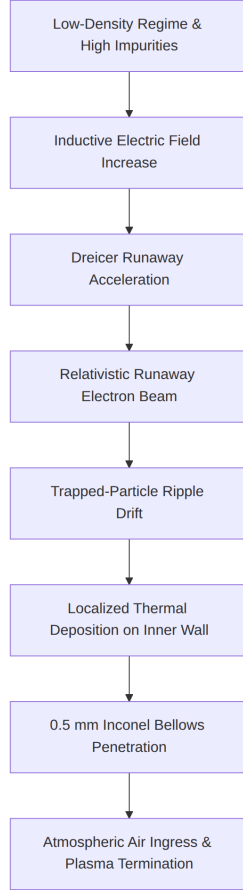
Figure 1: Tfr Runaway Electron

The collimated runaway electron beam deposited its thermal energy onto a sub-centimeter spot on the inner vacuum vessel wall. The localized thermal load exceeded the melting point of the material, burning a hole through the 0.5 mm Inconel bellows. The resulting atmospheric air ingress immediately terminated the plasma [2].

The primary cause was the generation of a high-energy runaway electron population in a low-density, high-impurity regime, combined with toroidal field ripple that focused the beam onto a vulnerable section of the vacuum vessel [2].

The incident required a complete disassembly of the tokamak and the fabrication and installation of a replacement vacuum vessel. It served as the first major empirical warning regarding the localized destructive potential of runaway electron beams, initiating subsequent research into neoclassical ripple transport and disruption mitigation [1, 2].

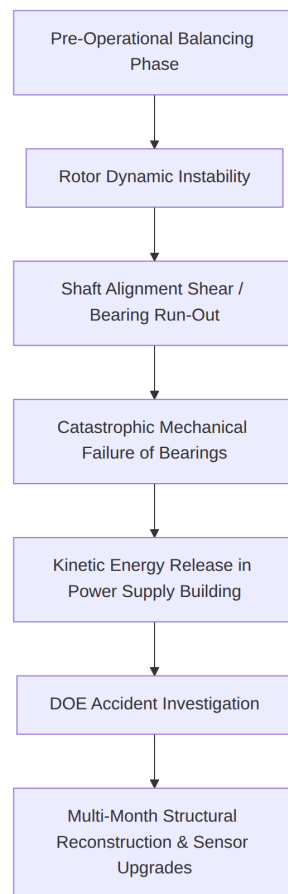
Figure 2: Tftr Motor Generator

On December 11, 1980, during pre-operational subsystem testing and high-speed dynamic balancing of the MG sets prior to first plasma, a major mechanical instability developed in one of the primary generator rotors [4]. The rotor was spinning at high velocity when excessive vibration and bearing run-out initiated a structural failure of the shaft and housing assemblies [4, 5].

The mechanical failure of the rotating assembly released significant kinetic energy within the primary Motor Generator Building at the Princeton Plasma Physics Laboratory (PPPL) [4]. The failure damaged the generator housing, stator assemblies, foundation mountings, and adjacent power distribution systems.

A Department of Energy (DOE) investigation determined that the root cause was a combination of rotor dynamic imbalances and insufficient structural dampening of the generator’s mounting brackets under high-speed cyclic load testing [4].

The incident required a multi-month, high-cost reconstruction of the pulsed power-supply systems. Engineers implemented reinforced concrete foundation brackets, upgraded the rotor dynamic balancing instrumentation, and added advanced vibration monitoring arrays to prevent recurring mechanical resonance [4, 5].

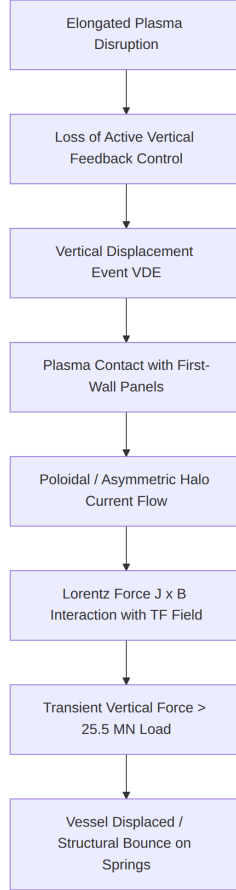
Figure 3: Jet Reactor Bounce

These transient halo currents ( $J$ ) interacted with the background toroidal magnetic field ( $B$ ), generating massive, instantaneous, upward Lorentz forces ( $J \times B$ ) [8]. During extreme disruptions, the upward vertical force exceeded the gravitational load of the entire 2,600-tonne machine ( $> 25.5$  MN).

This force physically lifted the reactor assembly, causing it to “bounce” several centimeters on its structural, shock-absorbing spring mounts [8]. The vertical and lateral shear forces strained structural weldments, diagnostic ports, and vacuum bellows [6].

The root cause was the rapid, unmitigated vertical drift of a high-current, elongated plasma column, which generated asymmetric halo currents that coupled electromagnetically with the toroidal field [8].

JET engineers subsequently upgraded the vacuum vessel’s structural supports, adding heavy external mechanical restraints and radial keys to limit lateral and vertical motion [8]. This experience catalyzed the development of active disruption mitigation systems—such as massive gas injection (MGI) and shatter pellet injection (SPI)—to pre-emptively quench the plasma before asymmetric halo currents can develop [7].

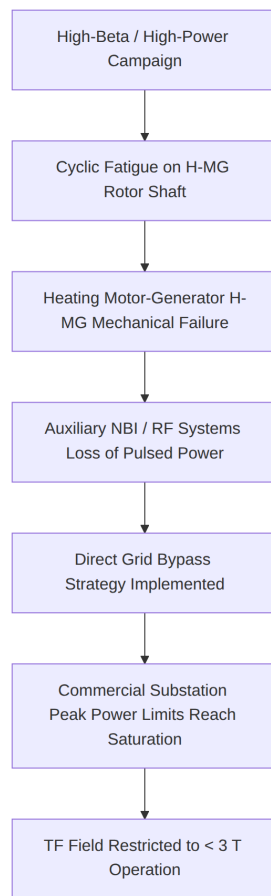
Figure 4: Jt60U Mg Rotor

In February 2004, during a high-beta plasma campaign, the H-MG system suffered a mechanical breakdown of its internal rotor and bearing assemblies while operating at peak rotational speed [9]. The mechanical failure immediately disabled the auxiliary heating systems, halting the operational campaign [10].

The mechanical failure was localized within the generator facility, but repairing the 300-ton rotor and bearing system had an estimated lead time of over a year [9].

The failure was caused by mechanical fatigue and rotor winding stress under the highly cyclic, fast-pulsing duty cycles required for high-power plasma heating [9].

To avoid a prolonged shutdown, engineers bypassed the H-MG, re-routing the auxiliary heating systems to the Toroidal Field Motor-Generator (T-MG) and connecting the Toroidal Field coils directly to the local 275 kV commercial utility grid [9, 10].

Although the bypass successfully restored auxiliary heating, the local commercial utility grid could not sustain the peak power surges required to run the Toroidal Field coils at full design strength [9]. Consequently, the reactor’s maximum magnetic field had to be restricted to under 3 Tesla (down from its 4 T design capacity) for the remainder of the campaign [10]. The H-MG was repaired and returned to service in late 2005.

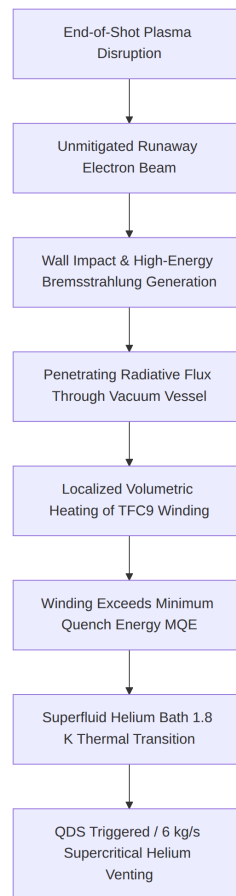
Figure 5: Tore Supra Quench

The high-energy electron impact generated a localized flux of hard gamma-ray and neutron radiation via Bremsstrahlung [11]. This penetrating radiation bypassed the thermal shielding and deposited energy directly into the winding pack of Toroidal Field Coil 9 (TFC9).

The sudden localized heat deposition exceeded the Minimum Quench Energy (MQE) of the superconducting winding, initiating a quench in TFC9 [11].

The quench was driven by secondary radiation heating from an unmitigated runaway electron beam, demonstrating that superconducting coils are vulnerable to radiative energy deposition even when physically shielded by the vacuum vessel structure [11].

The magnet system was discharged without permanent damage and returned to nominal operations. The incident highlighted the necessity of integrated thermohydraulic and nuclear shielding models when designing magnet protection systems for steady-state tokamaks [12].

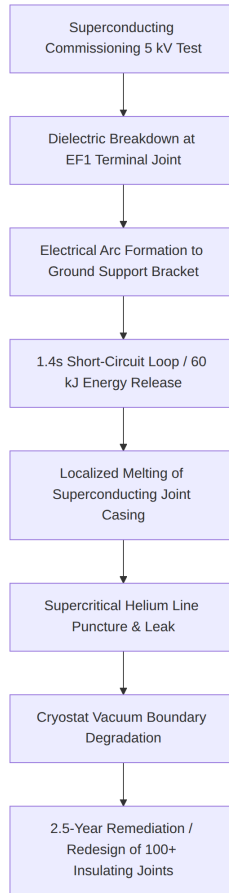
Figure 6: Jt60Sa Hv Arc

An insulation defect where a diagnostic cable emerged from the coil terminal joints allowed a high-current path to form [14]. An electrical arc discharge formed between the positive terminal

joint and its grounded support bracket, followed immediately by a second arc on the neighboring negative terminal joint [13]. These arcs created a short-circuited loop that discharged for approximately 1.4 seconds, releasing an estimated 60 kJ of energy [13].

The electrical arc melted several holes into the cylindrical metal joint of the coil, puncturing the pressurized helium cooling pipe [13]. Pressurized cryogenic helium leaked directly into the insulating vacuum cryostat, degrading the vacuum from  $10^{-3}$  Pa to 7000 Pa and triggering a thermal quench of the magnet system [13]. A rupture disc on the helium cooling line released the venting helium gas into the torus hall [14].

The investigation determined that the root cause was insufficient local electrical insulation at the terminal joints of the EF1 coil, which was unable to withstand the high-voltage test conditions under vacuum [14].

The incident required a 2.5-year shutdown to warm the reactor, open the cryostat, repair the damaged joints, and redesign the insulation [15]. Engineers reinforced and re-insulated more than 100 electrical connections across the magnet systems [14, 15].

They also implemented “Global Paschen Tests” (GPT) at varying vacuum levels within the cryostat to verify electrical insulation integrity before cooling the magnets back down [15]. The lessons learned from this remediation work were shared with the ITER project, and JT-60SA successfully achieved first plasma in October 2023 [16].
