EUROSTEEL 2017, September 13–15, 2017, Copenhagen, Denmark

## Weathering steel – 30 years of experience in Banedanmark

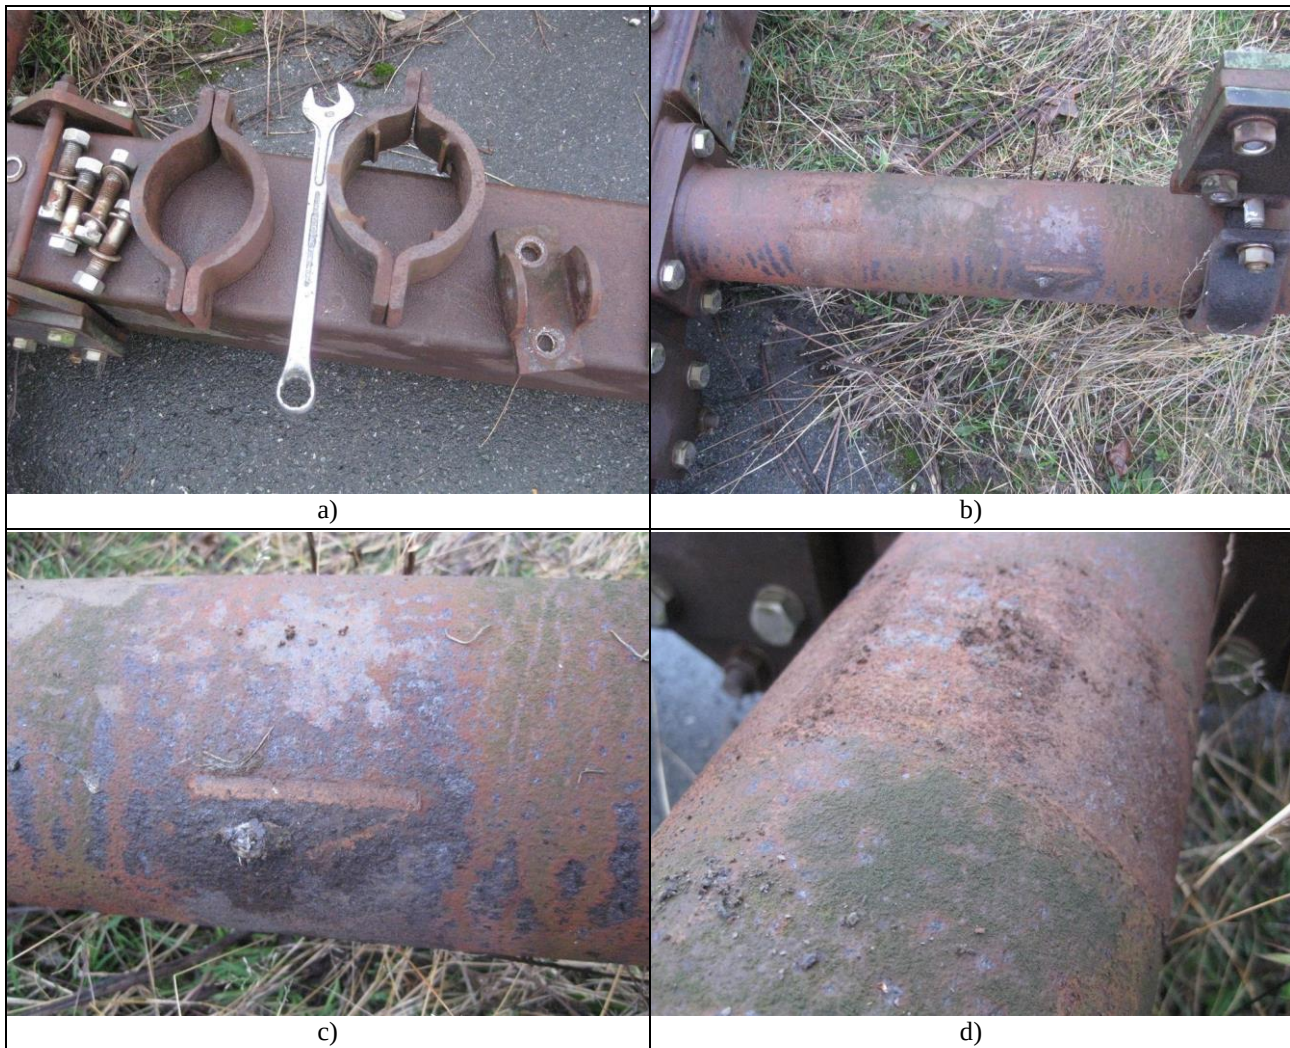
When considering the details of the test-mast little difference was noticed in corrosion of details that follows the design philosophy and details that does not. Even the clamps that were made of a poor design by intension did not show significant more corrosion than clamps with spacers. Thus it appears that the design philosophy is too conservative for detailing in a mild environment. Refer *Fig 6* that shows clamps with and without spacers.

Fig.6. a) Dismantled clamps with and without spacers; b) CHS where both clamps have been mounted; c) CHS where clamp with spacer was located; d) CHS where clamp without spacer was located
