## CHECK-OUT REPORT

## INVENTORY MANAGEMENT SOLUTIONS

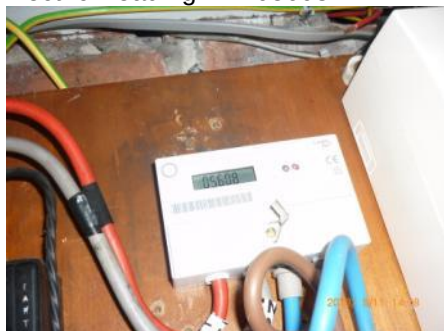
Electric Reading 05608

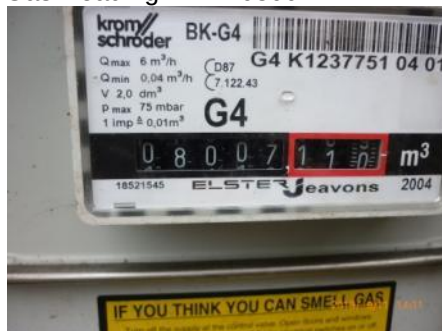
Gas Reading 08007

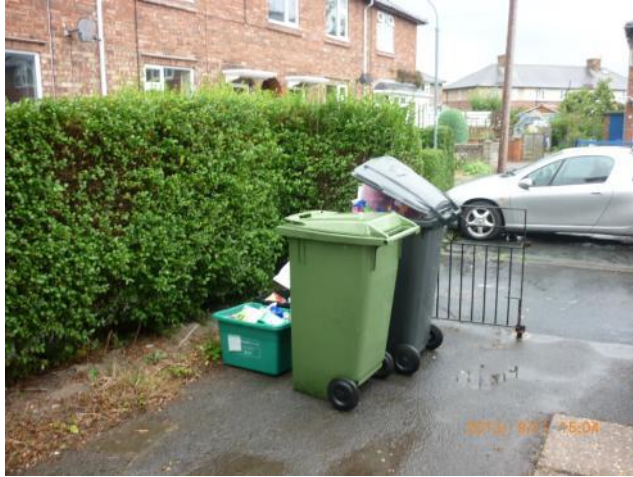
| Item Ref.<br>(as on inv) | Room | Item | Description | Comment | Photo # |
|---|---|---|---|---|---|
| 3. | Front approach | Refuse | Recycling boxes | All full CC | 1 |
| 12. | Rear garden | Refuse | Green wheelie bin<br>Grey wheelie bin | Bins full CC | 1 |

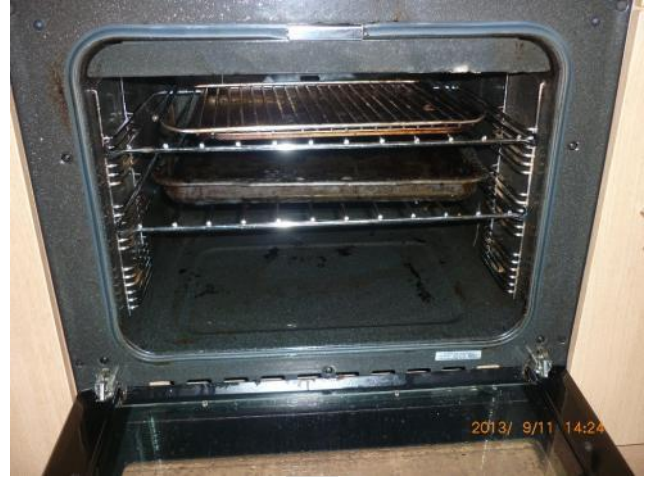
| Item Ref.<br>(as on inv) | Room | Item | Description | Comment | Photo # |
|---|---|---|---|---|---|
| 58. | Kitchen | Appliances | Fridge freezer<br><br>Extractor hood<br><br>Oven | NTC on top CC<br><br>Outer casing NTC CC<br><br>Cleaned, few BOM remain on grill pan and oven bottom, appears better than inv. FWT | 2 |

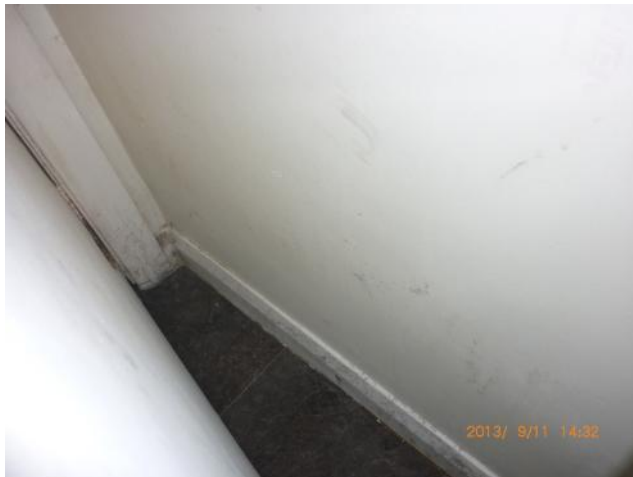
| Item Ref.<br>(as on inv) | Room | Item | Description | Comment | Photo # |
|---|---|---|---|---|---|
| 68. | Utility | Skirting | WGP | Dirty behind door CC | 3 |

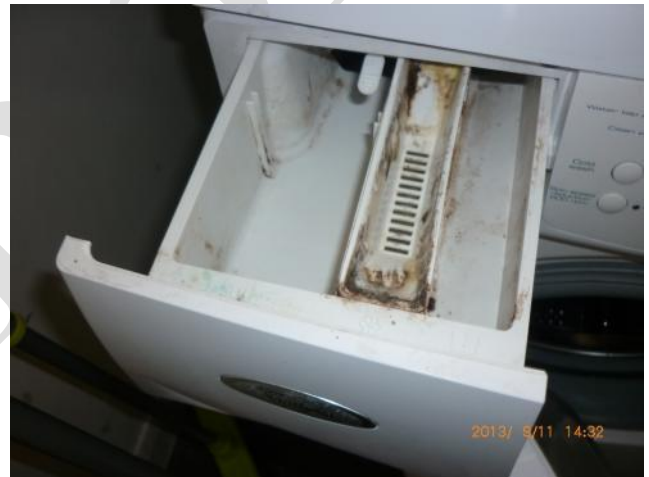
| Item Ref.<br>(as on inv) | Room | Item | Description | Comment | Photo # |
|---|---|---|---|---|---|
| 71. | Utility | Appliances | Washing machine | Seal stained as inv. LL-CC<br>Drawer powder gunged CC | 4 |

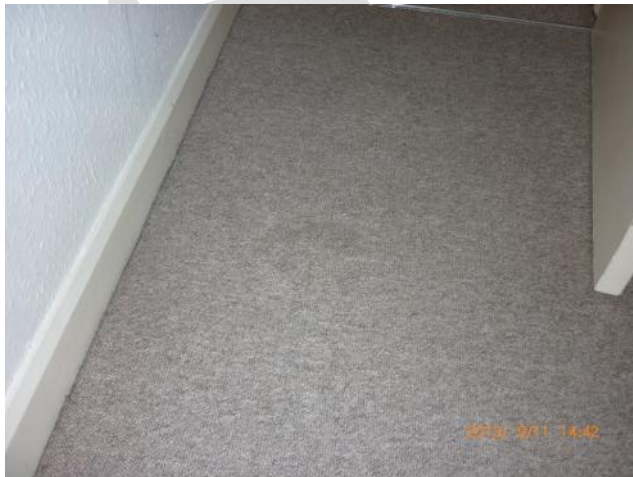
| Item Ref.<br>(as on inv) | Room | Item | Description | Comment | Photo # |
|---|---|---|---|---|---|
| 118. | Bedroom 2 | Flooring | Brown carpet | Rough patch/burn mark in doorway, T says existing? Damages TC? | 5 |
