# Akiachak

## Energy Action Plan

6/18/2019

Akiachak Energy Efficiency Project

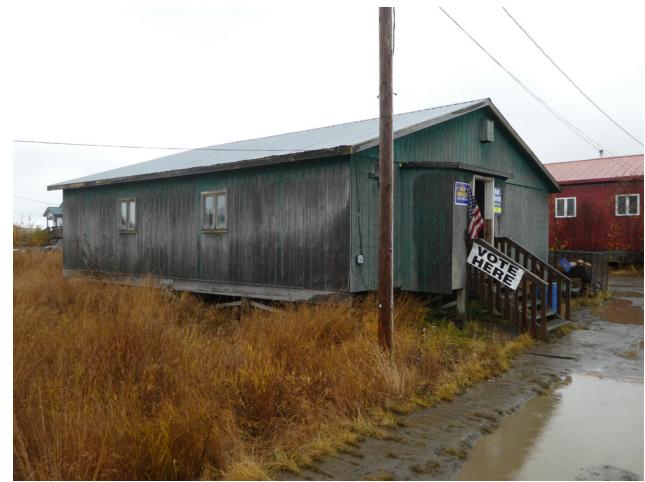
The 1,440 square foot building sits on an elevated pier foundation. The building shell is in poor condition as the siding has suffered extensive weather damage, the insulation in the attic has been damaged, and most of the windows are broken. There is no domestic water plumbing. An oil-fired direct-vent Toyotomi heats the building and the lighting is mostly provided by fluorescent fixtures. Other than a refrigerator and bingo display board, there are very few electrical appliances.

The bingo hall hosts bingo four nights a week despite the building's poor condition.

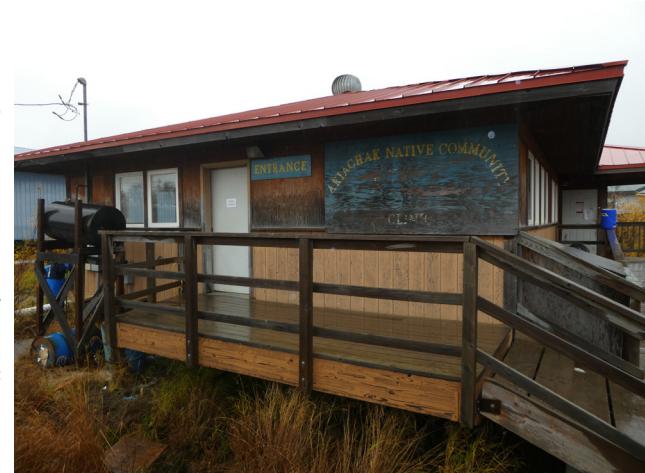
The 1,820 square foot building is one of the oldest buildings in the community **and was built in the early 1990s**. The building shell is in adequate condition. An oil-fired System 2000 Energy Kinetics boiler provides heat. Heating zones are controlled by zone valves and manual thermostats. There is domestic water plumbing for this building. Exterior lighting is provided by high pressure sodium (HPS) wall packs and interior lighting is mostly fluorescent fixtures. There are many electrical appliances in this building including medical equipment and a prescription refrigerator in addition to the traditional electric appliances found in an office setting.

The clinic, open every day, is an essential building in Akiachak.

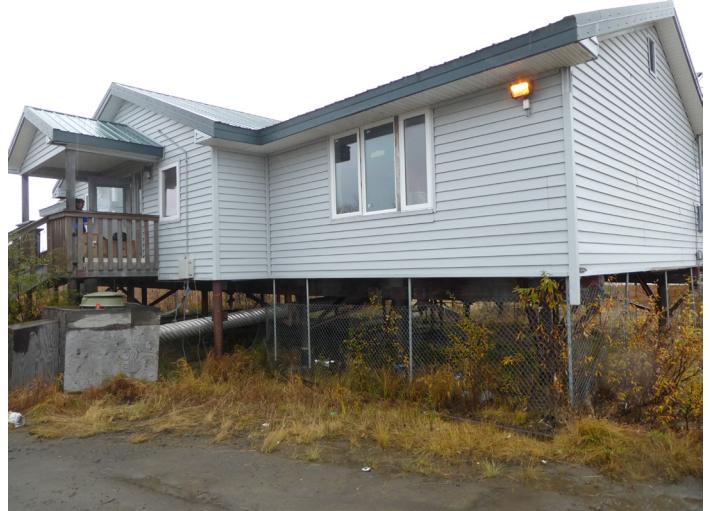
The 1,876 square foot building is on an elevated pier foundation. The building shell is in primarily good condition, except for the north side which has experienced significant frost heaving. Attic insulation has been removed in many locations throughout the building. An oil-fired, hydronic System 2000 Energy Kinetics boiler with an integral, on-board controller provides heat. The on-board controller relays to motorized zone valves and manual thermostats. The interior lighting consists of fluorescent fixtures.

The daycare building frequently experienced overheating at the time of the building surveys.

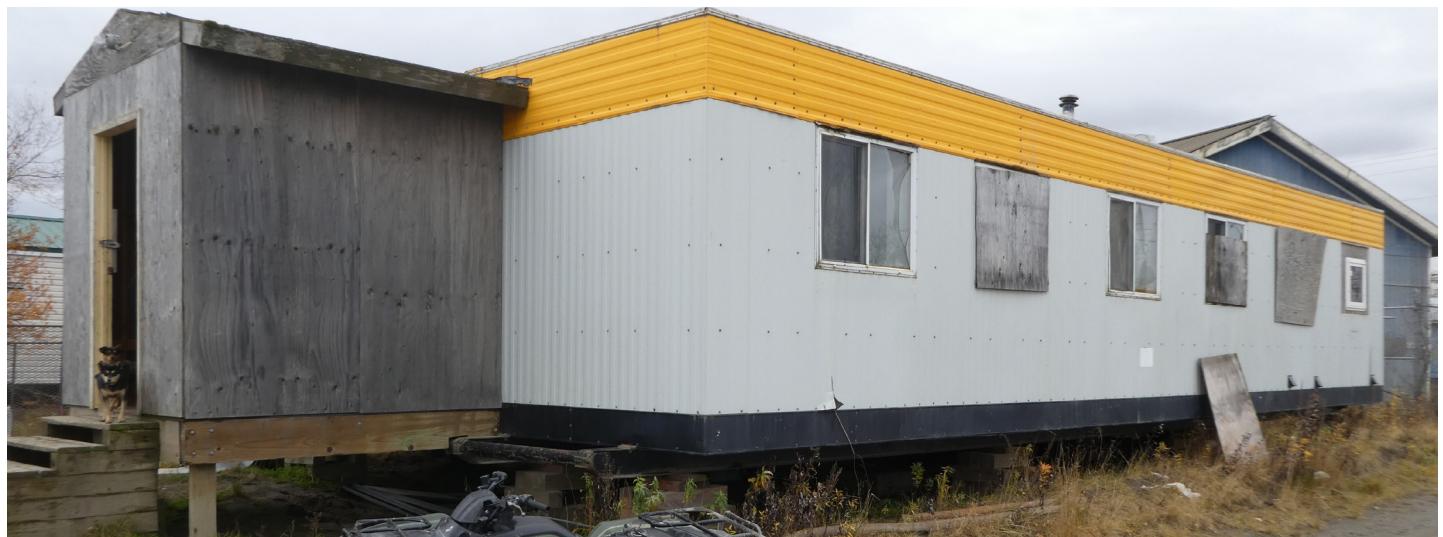
The 1,344 square-foot building is a repurposed temporary construction housing camp and has a skid foundation. The structure is comprised of three shipping containers that were joined along their long sides in 1998. The building shell is in average condition. There are two oil-fired, forced air furnaces that provide heating for the outside containers with a supplemental electric wall convector in the central container. Heating is controlled by manual thermostats. Hot water is created by an oil-fired, on-demand Toyotomi water heater. The laundry services consist of four clothes washers that run off cold water only and four electric clothes dryers. Plug loads are low besides the laundry appliances. There is no exterior lighting and interior lighting is mostly fluorescent fixtures.

The laundry building is composed of three shipping containers from a former construction housing camp.

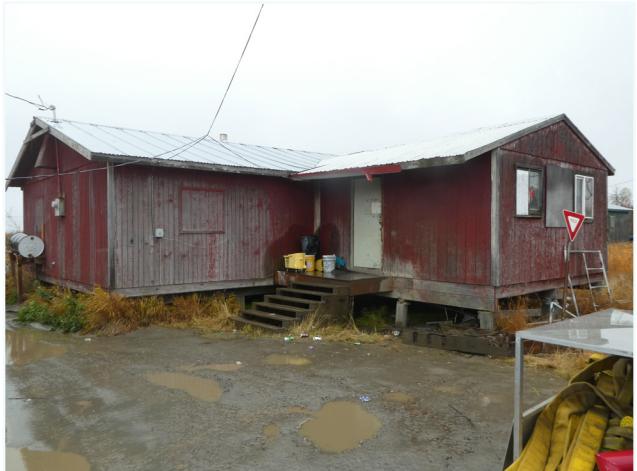
The 1,280 square foot building is built upon an elevated pier foundation. The L-shaped building contains the jail and a small office area. The building shell is in poor condition with heavily weathered siding and windows in disrepair. There is no plumbing in the building. Heating is provided by an oil-fired Toyotomi heater. There is no exterior lighting for the facility. The interior lighting consists of fluorescent fixtures.

The jail is in poor condition and has no plumbing or exterior lighting.

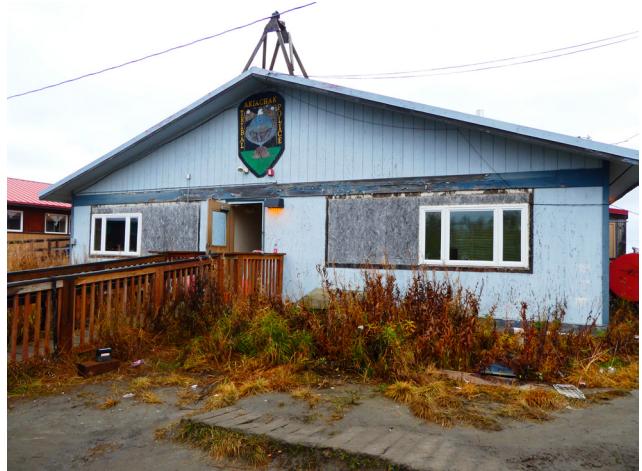
The 2,520 square foot building has a crawlspace foundation. The building shell ranges from poor to average condition. There is no domestic water plumbing in this building. An oil-fired, hydronic Well McLain boiler provides heat. The heating is controlled by electronic zone valves, manual thermostats, and other control valves. Exterior lighting is provided by high pressure sodium (HPS) wall packs and interior lighting is mostly fluorescent fixtures.

The police station is the hub for the community's law enforcement and court personnel.

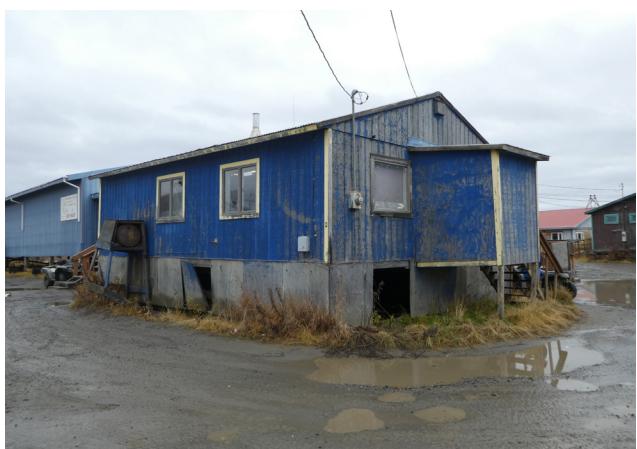
Despite comfort issues caused by poor lighting and cold drafts, the TANF building hosts around ten visitors each day.

The 768 square-foot building is on an elevated pier foundation. The building shell is in poor condition with a majority of the windows in disrepair. There is no domestic water plumbing in this building. Heating is provided by an oil-fired, Toyotomi Laser 56 heater with two electric resistance heaters providing

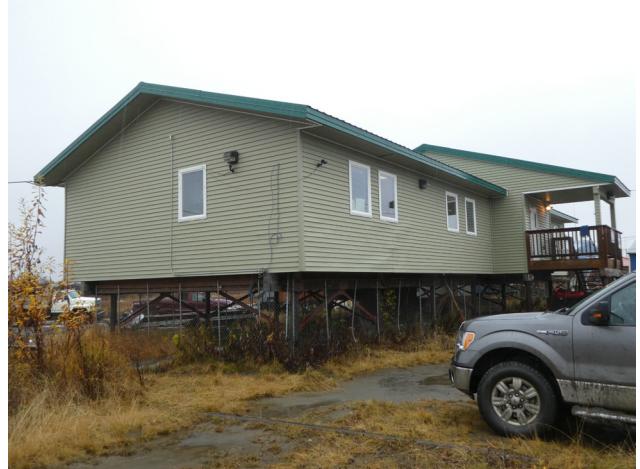
The 2,184 square-foot building sits on an elevated pier foundation. The building shell is in good condition. An oil-fired, hydronic Burnham boiler with electronically controlled zones provides heat. Heating zones are controlled electronically. There is domestic water plumbing in the building. Exterior lighting is provided by high pressure sodium (HPS) wall packs and interior lighting is mostly fluorescent fixtures. Electrical use in the building is high due to the concentration of office equipment. The I.R.A. Council is hoping to reduce the energy use of this building in a future energy retrofit project.

The Tribal I.R.A. office houses the 11 tribal staff members and is the central administrative hub for Akiachak.

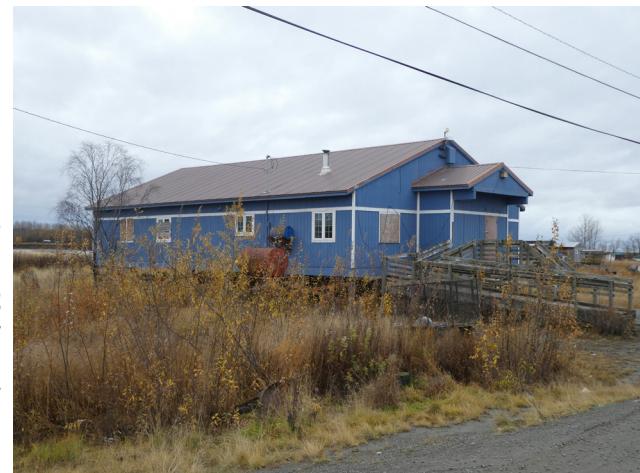
The 2,940 square foot building is built upon an elevated pier foundation. The building shell is in average condition, although several windows are in disrepair. **The foundation has significant damage due to frost heaving and the building is potentially structurally unfit for occupancy.** There is no functioning heat or plumbing in the building. Interior lighting is comprised of linear fluorescent fixtures. There are a few appliances to keep food fresh and snacks available in use at the building.

The Youth and Elder building needs rehabilitation so it will be safe to host more activities.

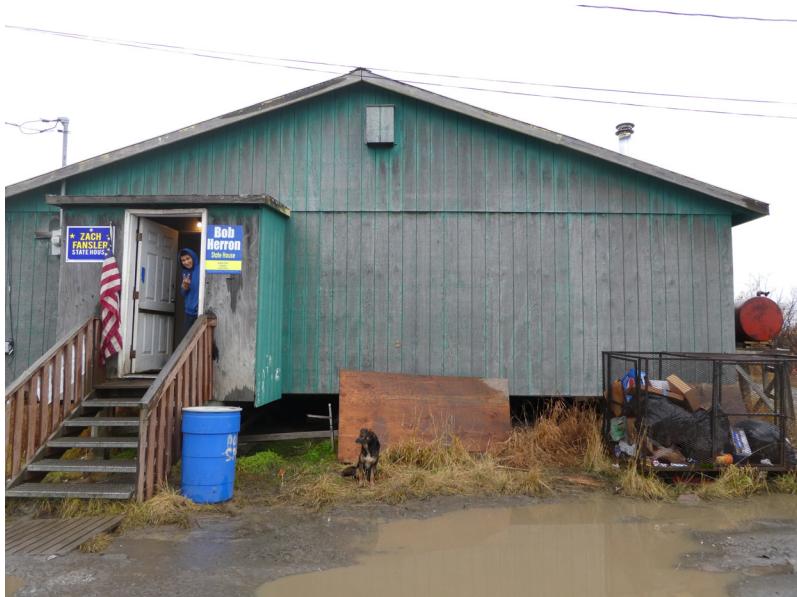
Top recommendations for the bingo hall include programming the setback feature on the Toyotomi stove, and adding more insulation in the attic.

1. Programming the existing setback feature on the Toyotomi stoves will immediately reduce heating energy use for no upfront cost. Building occupants will need to re-program the Toyotomi stoves after power outages as well, to maintain the energy savings from the setback temperatures. This action has an immediate simple payback, and can save over \$500 per year.

2. Remove the stored items in the attic and add more insulation. The attic should not be used for storage as items compress the insulation and reduce its ability to slow heat transfer. This action will result in approximately \$250 in annual savings.
3. Replace the broken windows to improve safety and comfort. It will result in \$70 in annual energy savings.
4. Treat and paint the T1-11 siding on the building exterior to preserve it and extend its lifetime.

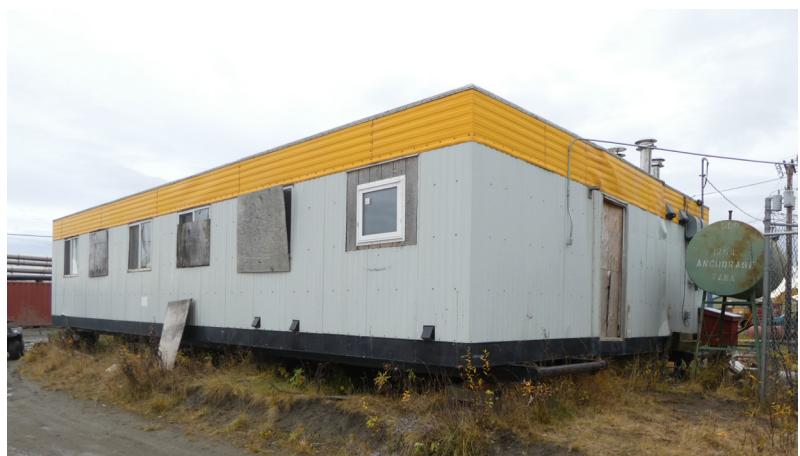
If all audit recommendations are implemented, the laundry could reduce its annual energy costs of \$18,000 by approximately \$5,000.

Other recommendations include installing a number of setback thermostats, replacing lighting fixtures with more efficient LEDs, and replacing the two furnaces with newer models with minimum 80% thermal efficiency. A financially non-cost effective item on the list was to replace the four clothes dryers with hydronic models and adding a second Toyotomi boiler – while the cost savings per year are indicated to be \$2,733, the installed cost is \$23,000 with a payback of 8.4 years.

If the Tribe is able to implement all recommendations, with the exception of the non-cost effective dryer replacement and Toyotomi addition, the annual energy use would decrease by 77.6 MMBTU, resulting in an energy and maintenance savings of **\$4,882**. At an approximate installation cost of \$22,770, the simple payback of a retrofit project would be **6.2 years**.

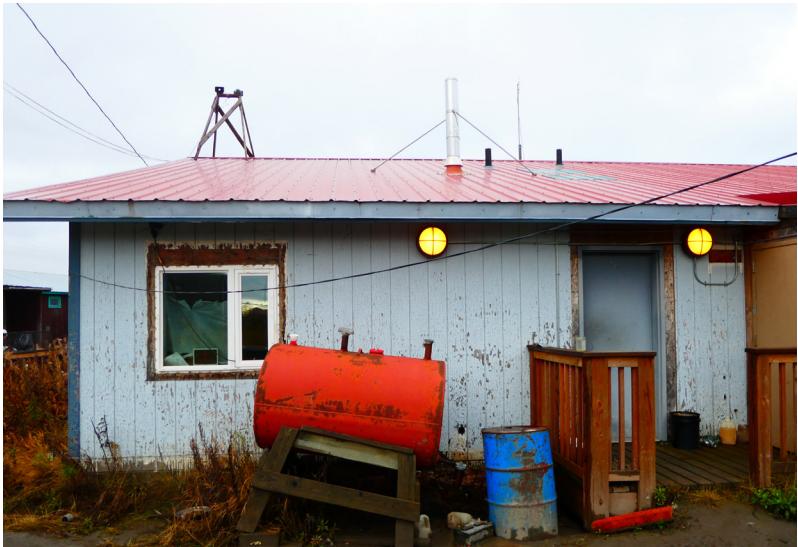
Like many tribal buildings in Akiachak, the police station has issues with malfunctioning thermostats and zone valves in its heating system.

1. Investigate issues with thermostats, zone valves, and boiler controller causing the south end of the building to be 7 degrees warmer than the rear portion of the building.
2. Treat and paint the T1-11 siding on the building exterior to preserve it and extend its lifetime.
3. An unknown electric load of 1,433 kWh/yr was discovered during the analysis – this is more than 11% of the building's entire annual consumption. This unknown load should be investigated further and eliminated.

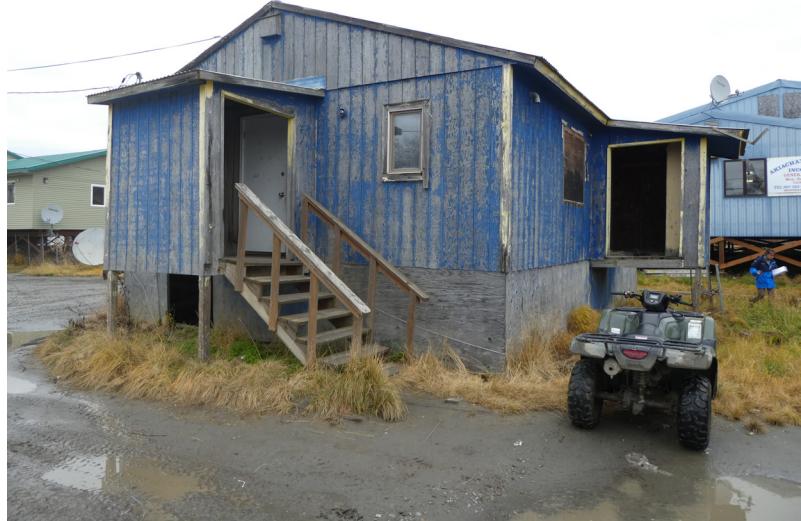
The TANF office could reduce energy costs by replacing supplementary electric heaters with another Toyotomi stove.

1. Install a second Toyotomi heater to eliminate the need for costly electrical heaters compensating for inadequate temperatures.
2. Program the Toyotomi's clock and setback feature and set temperatures back when building is unoccupied.
3. Treat and paint the T1-11 siding on the building exterior to preserve it and extend its lifetime.
4. Remove items stored in the attic and replace or add to the compressed insulation. In its current state, the compressed insulation is only providing half of its insulative value.

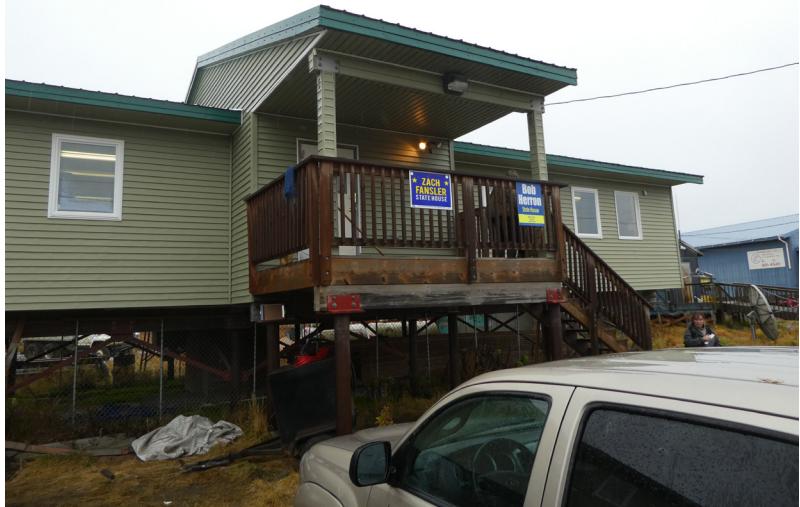
Energy retrofits for the Tribal I.R.A. building have a short payback, of approximately 2 years, if each recommendation is implemented.

Other recommendations include replacing existing lighting with LED, installing setback thermostats in each room, add an occupancy sensor in bathroom, troubleshoot Taco zone valve that is manually forced open and not operating correctly, and replace damaged fintube baseboard radiators.

If the Tribe is able to implement all recommendations, the annual energy use would decrease by 51.2 MMBTU relative to modeled costs for full occupancy, resulting in an energy and maintenance savings of **\$6,189**. At an approximate installation cost of \$12,369, the simple payback of a retrofit project would be **2 years**.

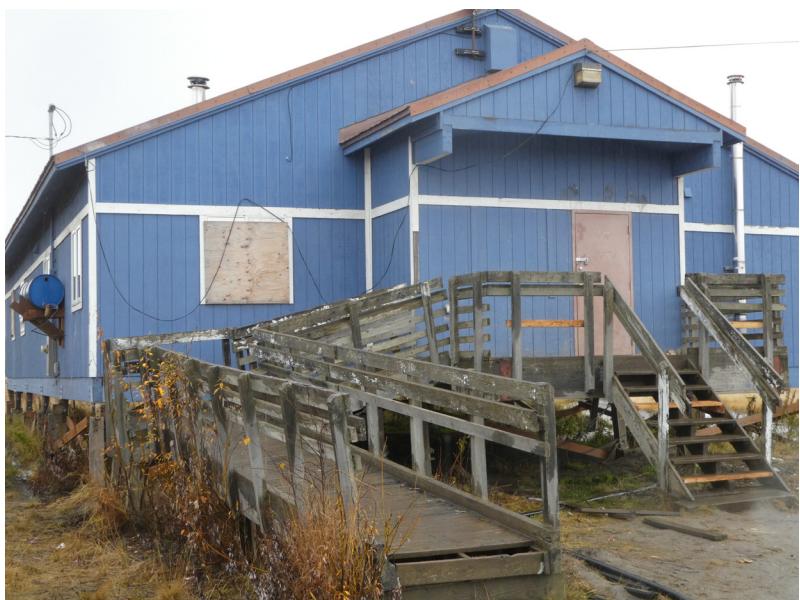
The top recommendation for the youth and elder building is to repair the failing foundation; this should be addressed prior to energy efficiency upgrades.

- 1. The foundation is in serious need of immediate repair and may be considered unsafe.** It is recommended that before any energy efficiency upgrades be considered, the foundation issues be addressed (and windows be repaired or replaced).
2. Treat and paint the T1-11 siding on the

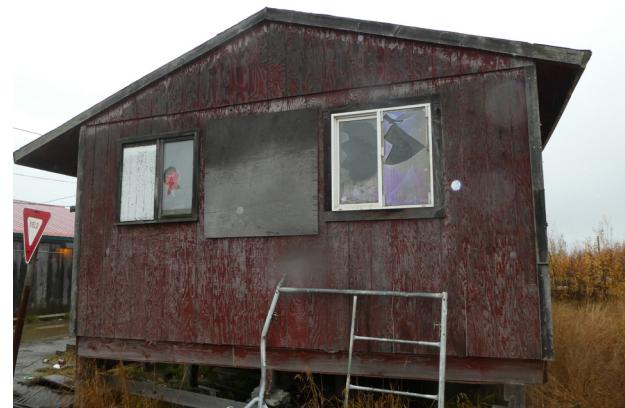
Cracked windows should be replaced when possible. This increases safety and comfort and decreases energy use.

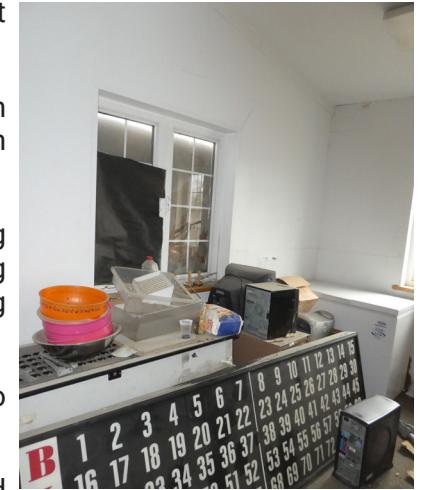
Unplug the chest freezer when it is empty in order to save energy.

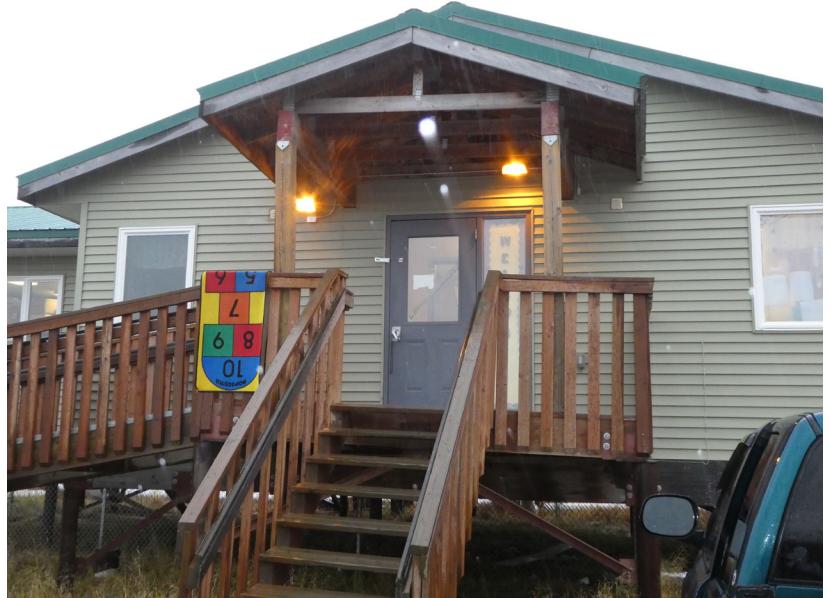
The head start building is relatively new but could benefit from lighting upgrade and setback thermostats.

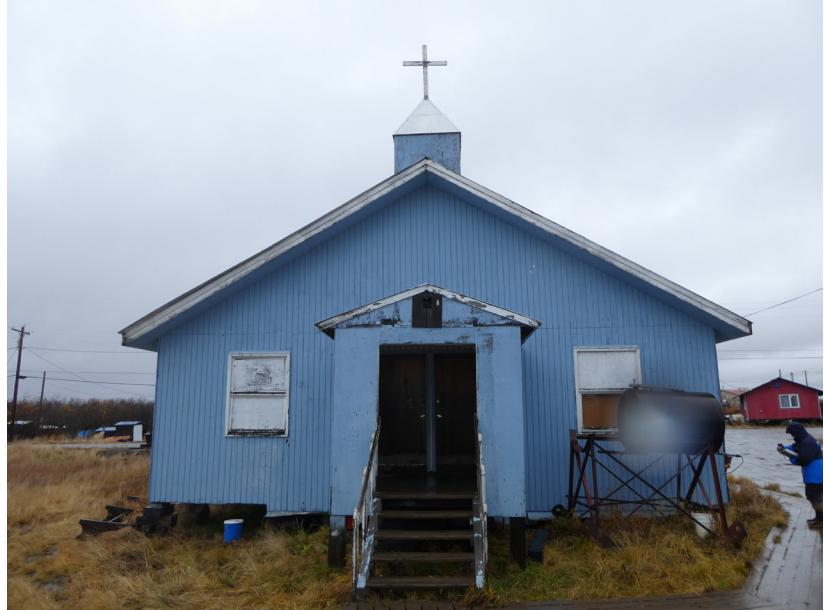
The Moravian Church, which is open on Sundays, could save energy by reroftting its lighting to LED bulbs.

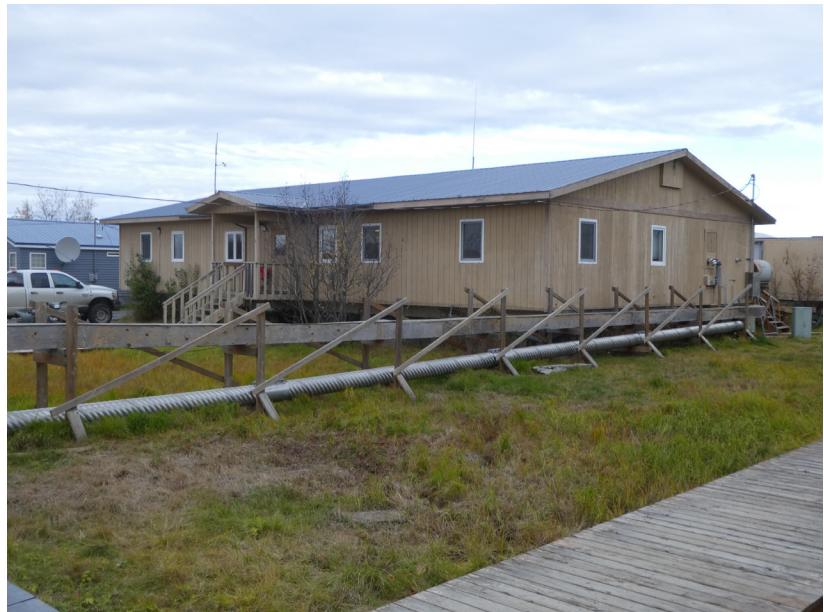
The number one retrofit for the school office is to implement a setback temperature.

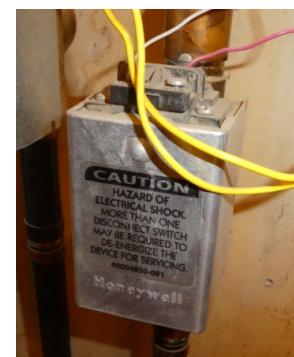
- System 2000 Boiler & controller
- Side-arm heat exchanger and DHW storage tank
- 2 manual thermostats
- Honeywell zone valves (photo at right)

located in boiler room

Contractor shall trouble shoot existing thermostats and zone valves including hot water generator zone valve (Clinic), for proper operation (If the thermostats have been replaced with new, no thermostat troubleshooting is required); identify and repair or replace non-functional units.

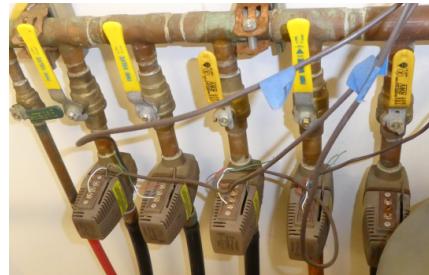
- Weil McLain WGO boiler & Taco ZVC 404 zone valve controller
- No DHW
- 4 manual thermostats
- Taco zone valves located in boiler room (photo at right)
