INSPECTION LIST REVISION #2 (SNAG LIST @ PC)

STELLENBOSCH UNIVERSITY

COETZENBURG STADIUM ADDITIONS & ALTERATIONS
ELECTRICAL SERVICES

15 June 2023

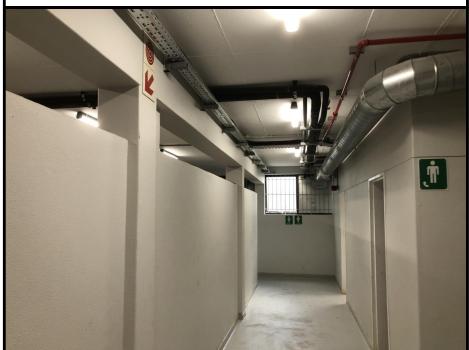
642.Row of fittings to be the same height between both store rooms.

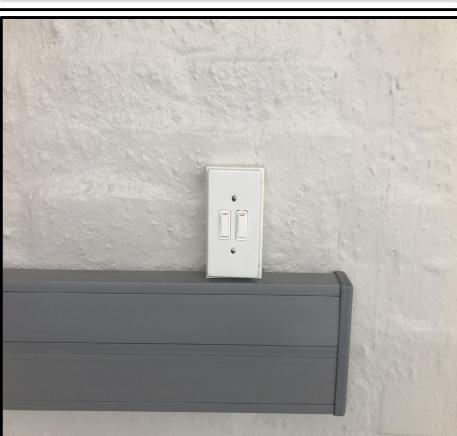
031.All socket outlets and lightswitches to be labelled.

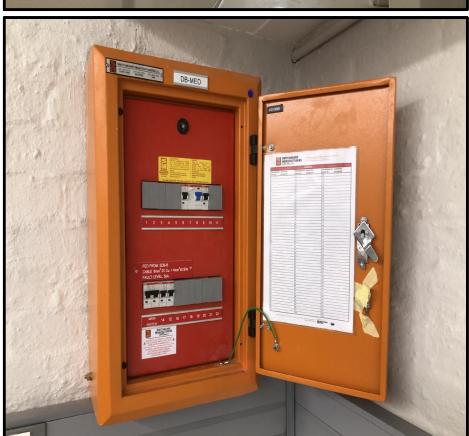
218.DB legend to be completed.

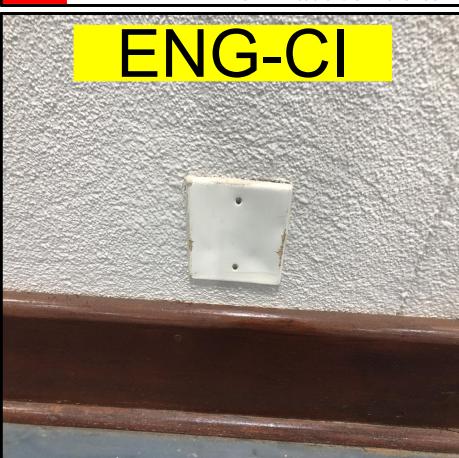
143.Please consider replacing these bent covers with modern PVC cover plates.

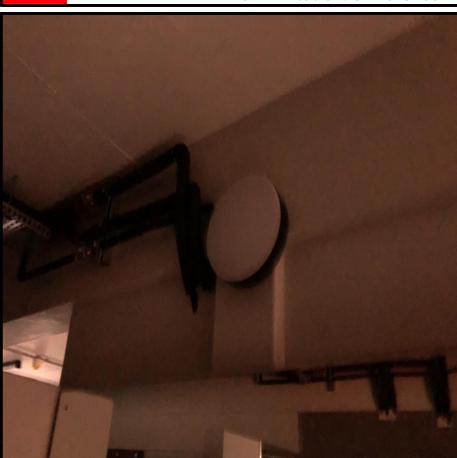
424.Please remove wall fittings above mirrors in change room. Not required and classhing with plumbing.

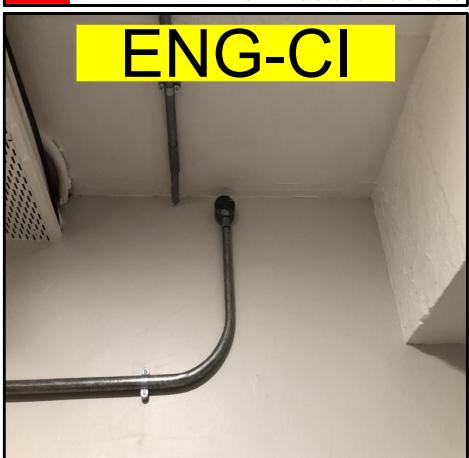
865.Data cable required for LAN point.

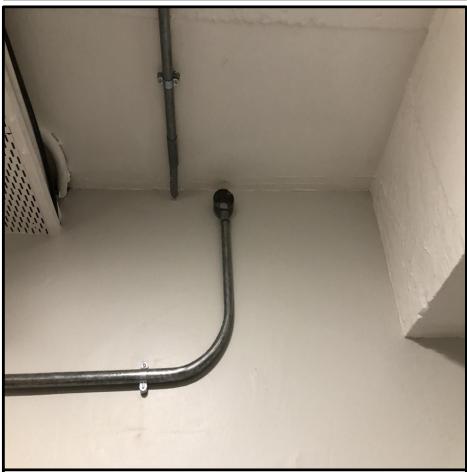
865.LAN point route to be completed.

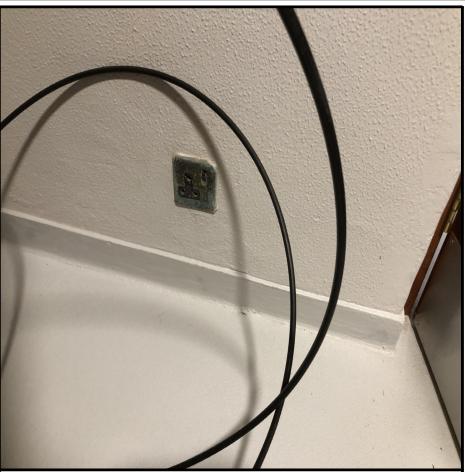
430.Socket outlet to be replaced with new in room 01.

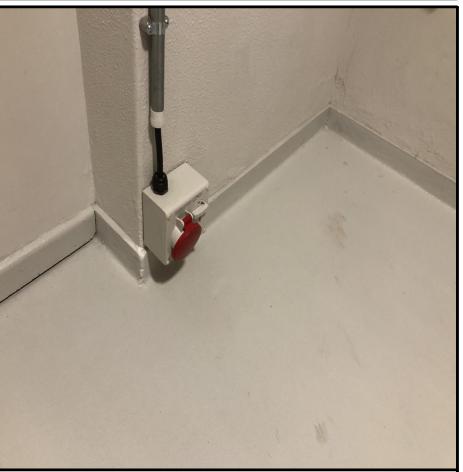
895.Please raise three phase outlet in room one to 300mm or up to 700m (from top edge).

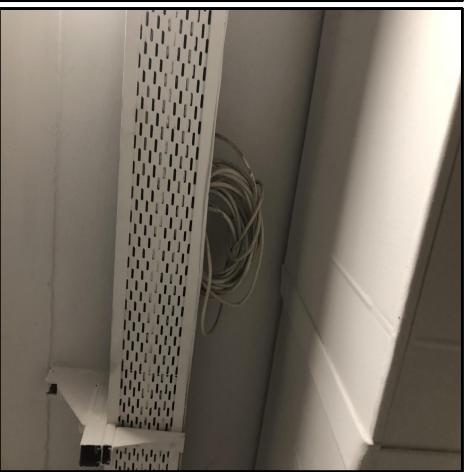
428.RED].Please remove redundant wiring if not needed.

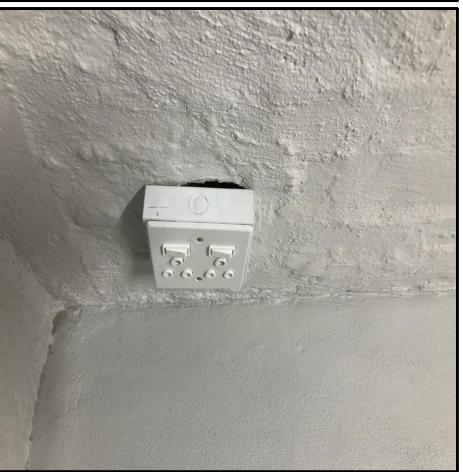
095.Please seal gap around socket outlet.

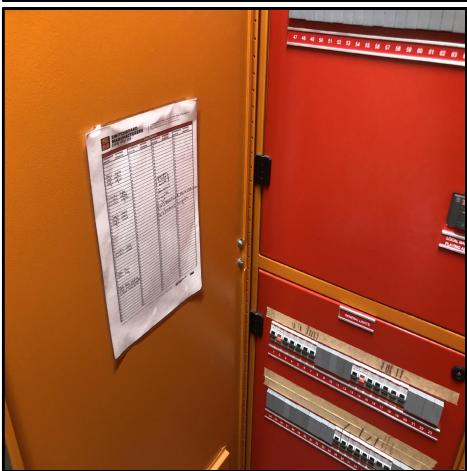
920.MDB Lighting section Legend to be typed.

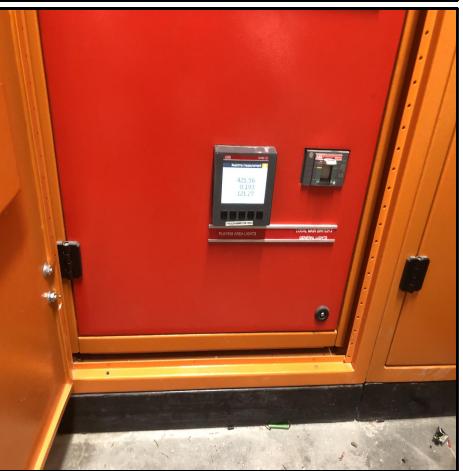
580.Please correct label. needs to be general lighting.

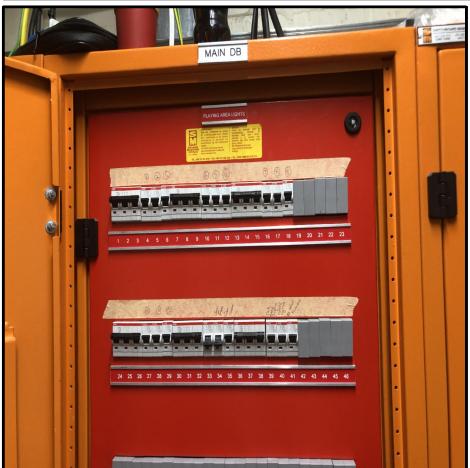
554.[RED] Circled circuits to go to general section.

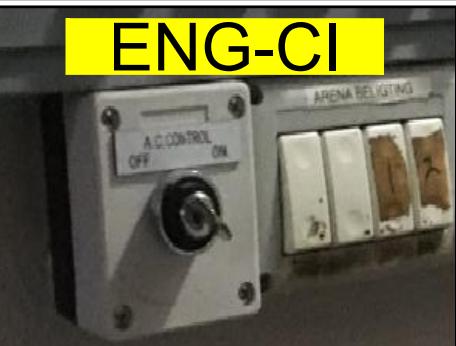
Various keyswitches to be reinstated (HVAC, FANS).

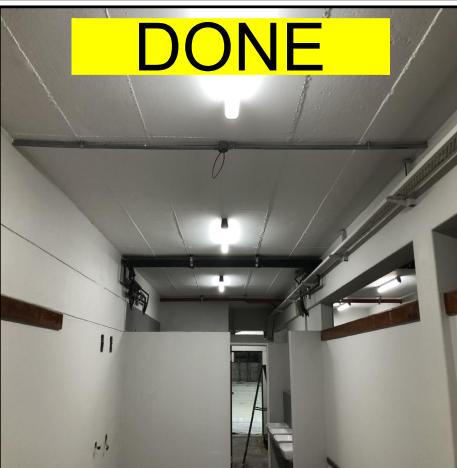
Lightfittings to align.

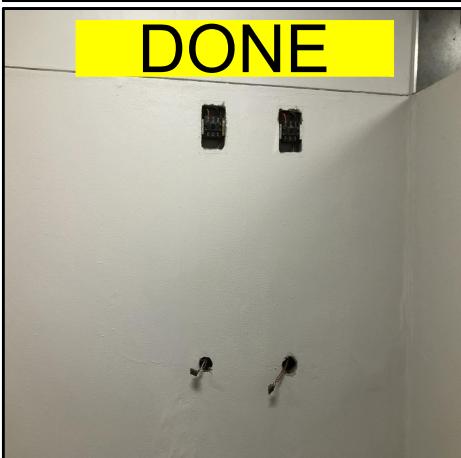
Redundant isolators to be disconnected and removed.

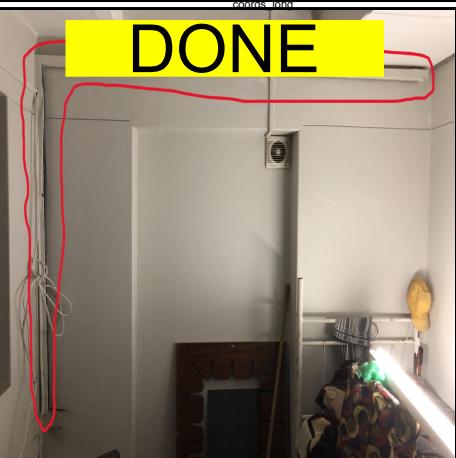
Room 1 - Please cut and remove redundant cabling and surface trunking up to wall penetration.

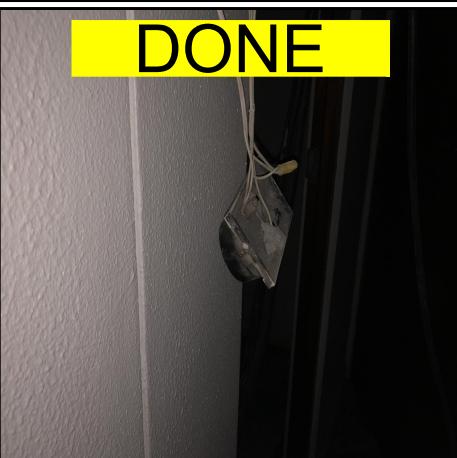
Please disconnect and remove doorbell.

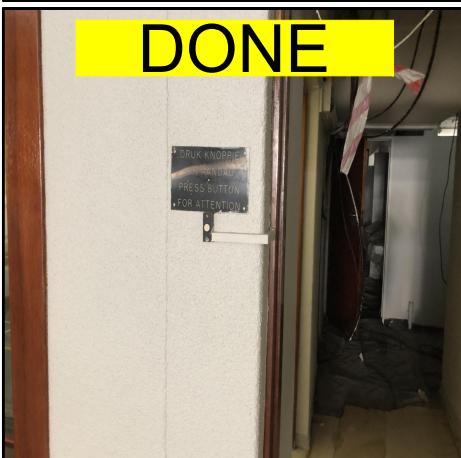
Please remove doorbell and plaque.

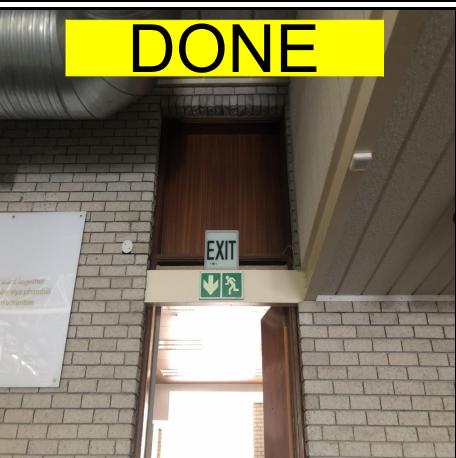
Exit light at incorrect location.

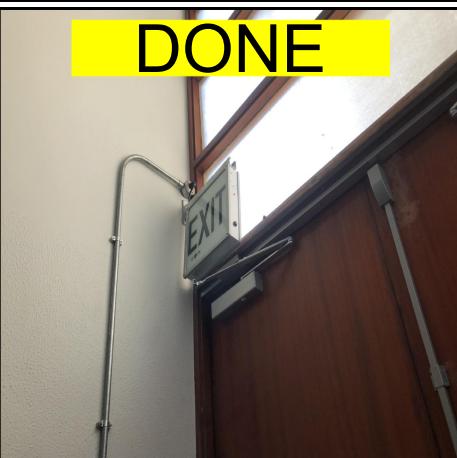
Exit light is fitted off perpendicular. Please refit.

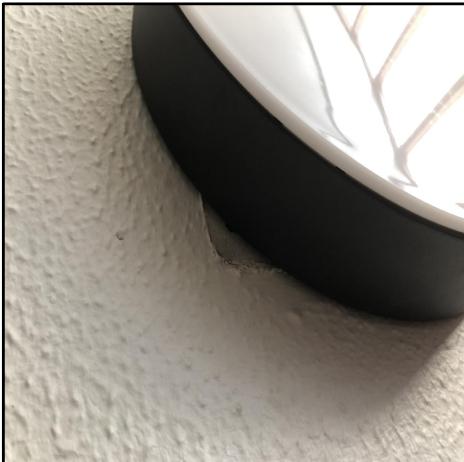
Paintwork to be fixed behind lightfitting (East escape).

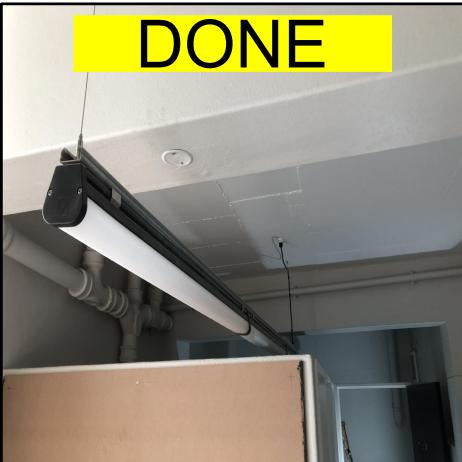
Please raise lightfitting line to structural beam soffit.

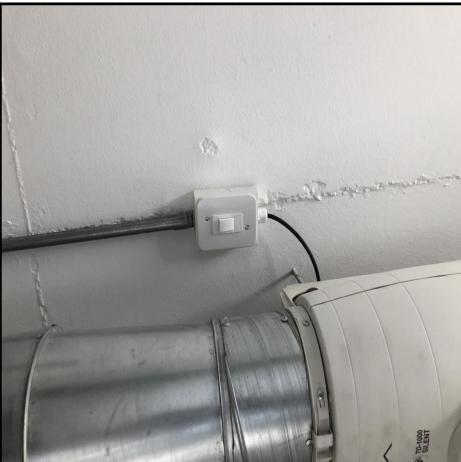
Missing labels at socket outlets and switches etc.

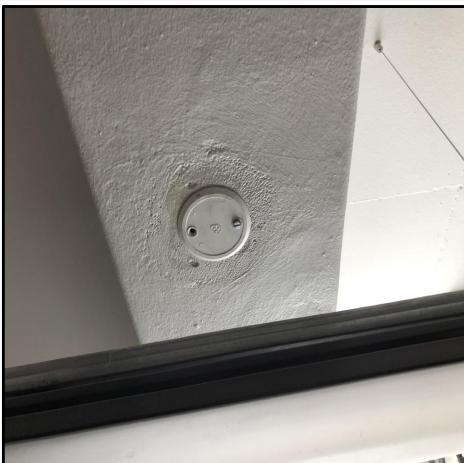
West toilets in changeroom. Missing screw.

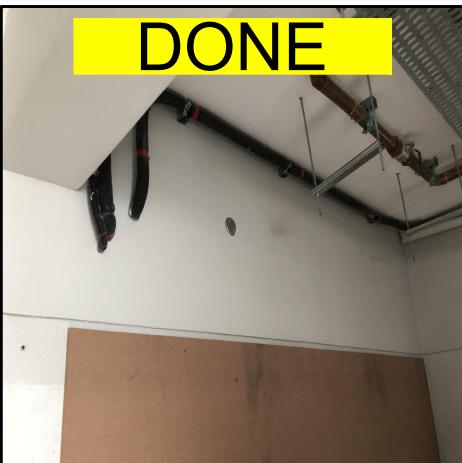
West toilets. Missing wall lightfitting.

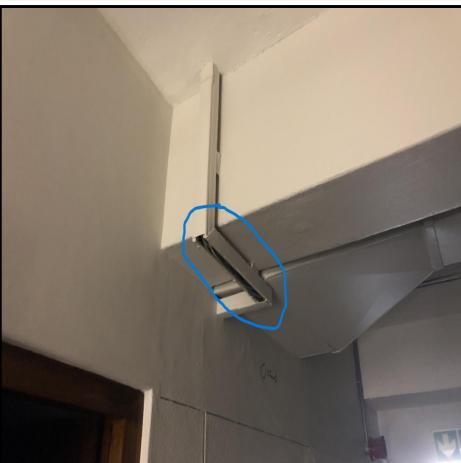
This trunking and wiring is redundant. Please however fix a cover plate.

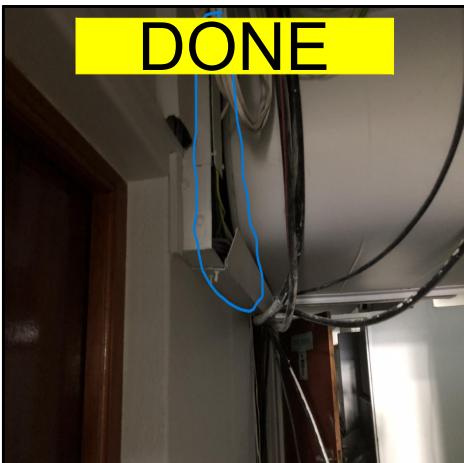
Please install a new lid to the existing powerskirting.

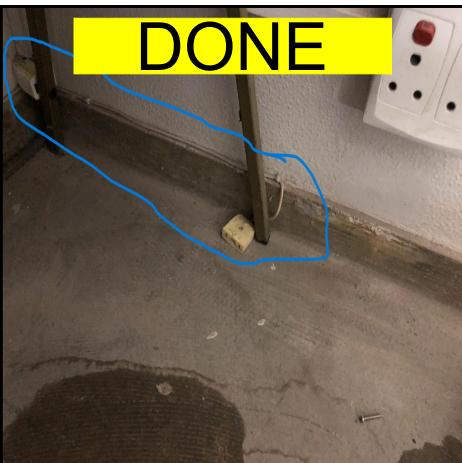
Room 1 - Please remove redundant phone point and conductor.

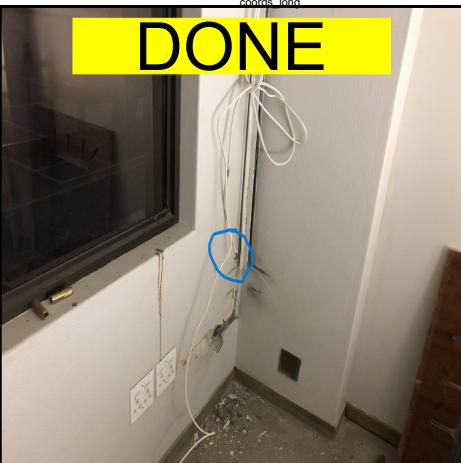
Please reinstate plug point and conductor to the NO-SMOKING sign.

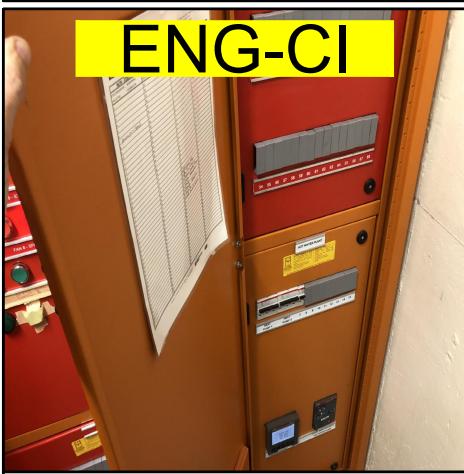
Earth leakage required for Heat Pump.

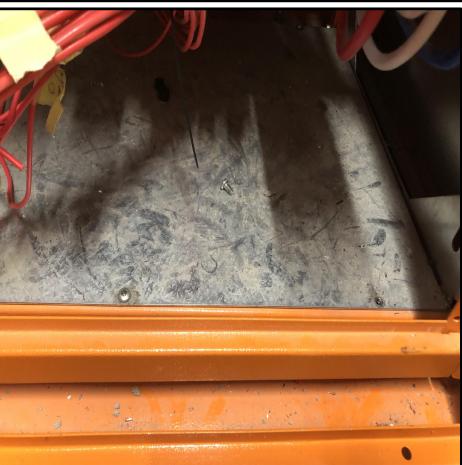
MDB internals to be dust free.

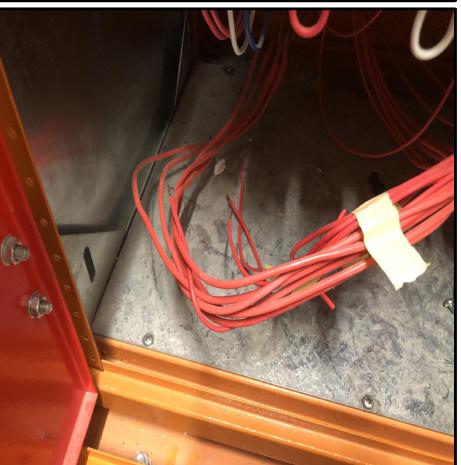
Please tuck redundant circuits in MDB out of way and end with heat shrink.

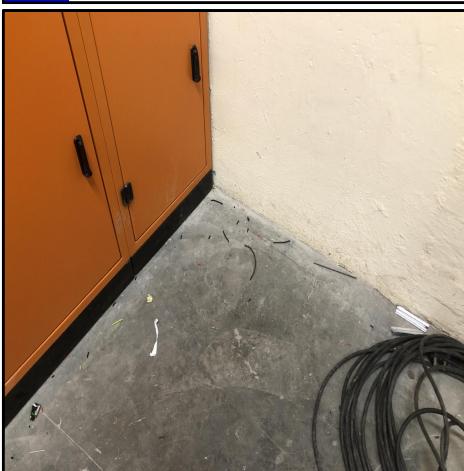
MDB room to be cleaned and painted.

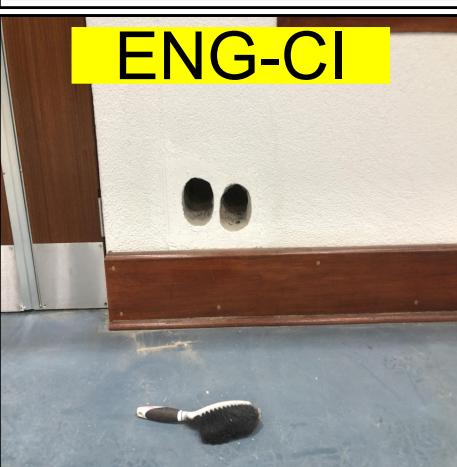
945.Cover plate missing. Engineer to check if this was issued.

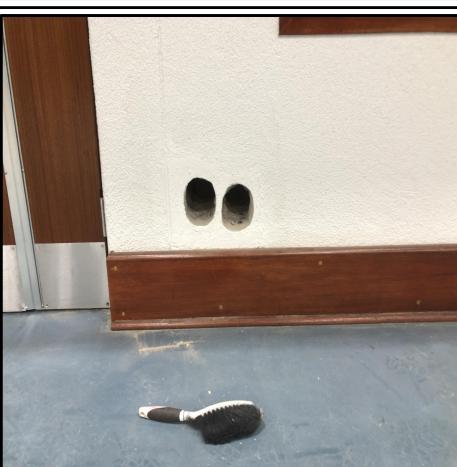
945.Please align, clean and paint wall penetrations.

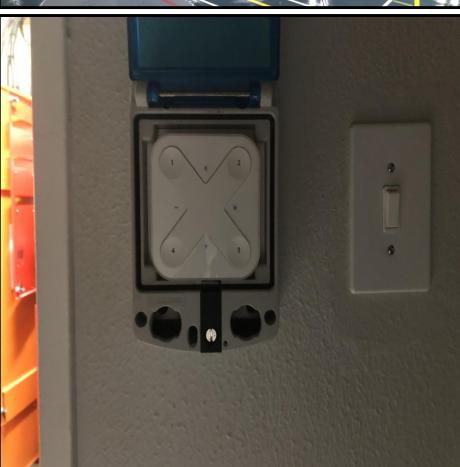
260.ITERRA press siwtch to be seated correctly inside housing.

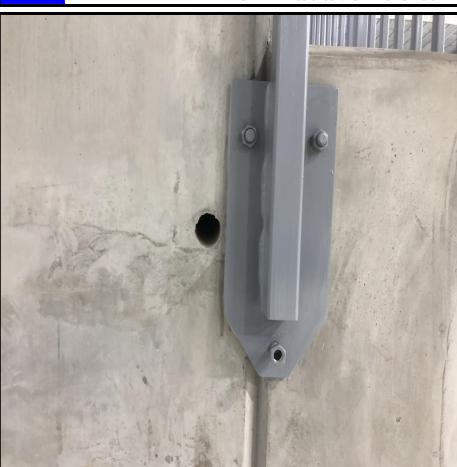
971.Please permanently plug penetration.

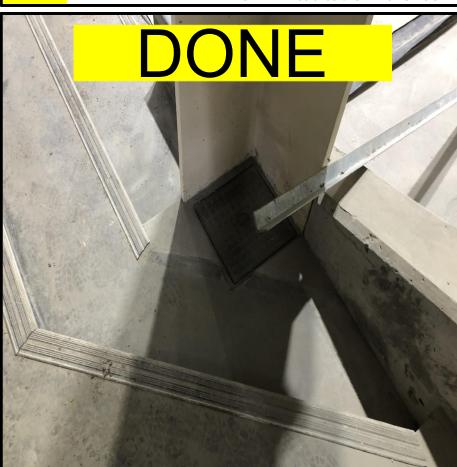
Method to connect vertical conduit to manhole to be discussed on site.

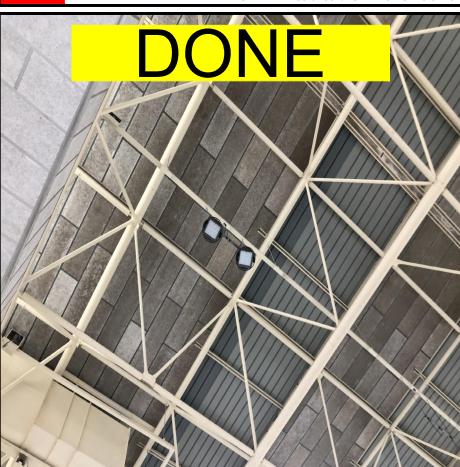
Lightfitting rotation not aligning.

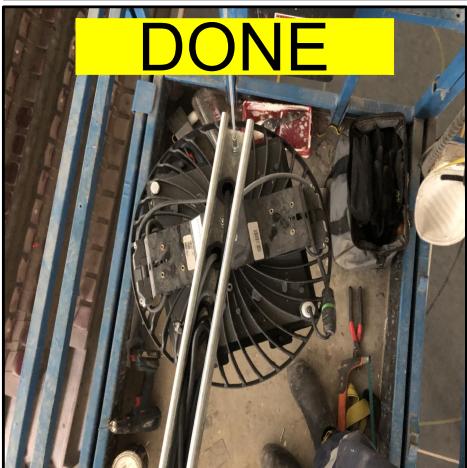
Please dust top of fittings while performing the alignment rectification activity.

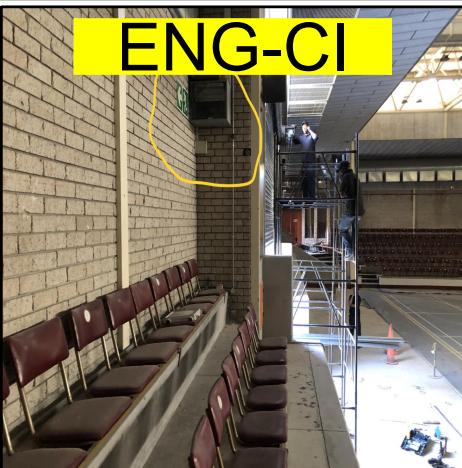
SUN IT to reactivate.

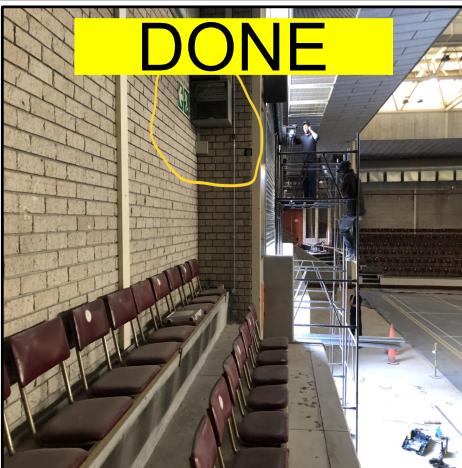
Please reconnect LAN cabinet to electrical supply (please take from DB-TV).

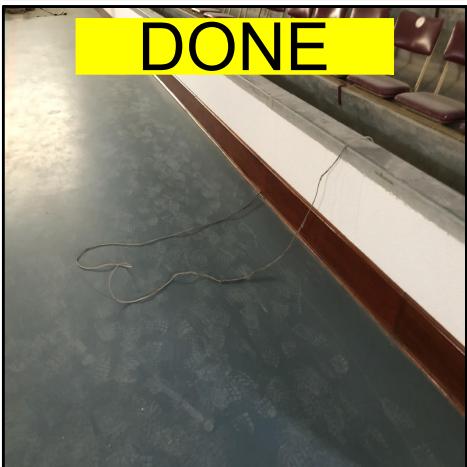
Please remove electronic cable entirely (runs along playing area perimeter).

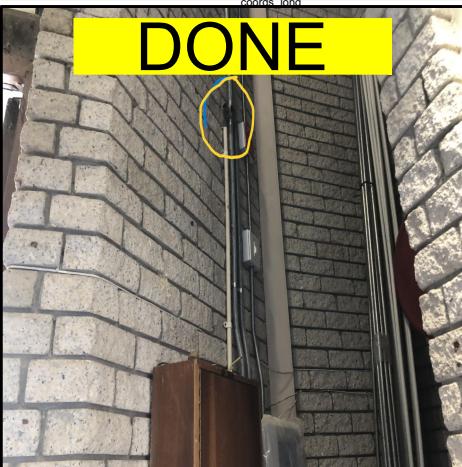
Missing conduit over plate (over the firepanel).

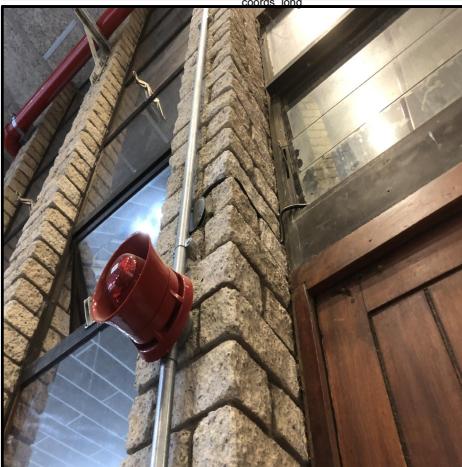
Please seat cover plate to box.

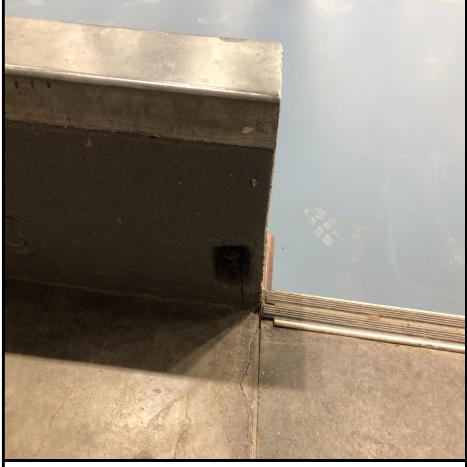
Missing cover plate. Please advise of CI required.

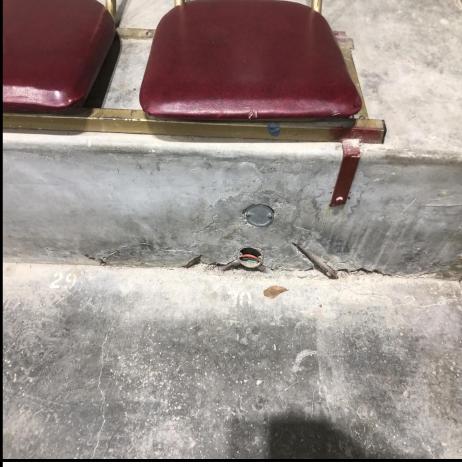
Missing cover plate. Please advise if CI required.

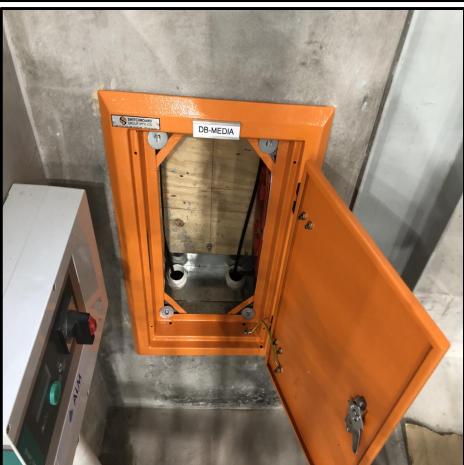
818.Fibre splice missing.

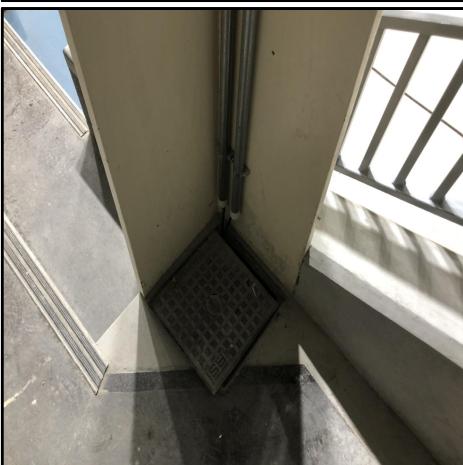
437.Please cut hole in cover plate to let cable to pass through.

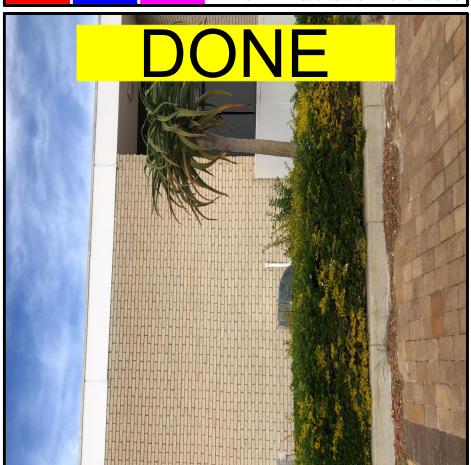
Missing Data Point. Please liaise with engineer for position.

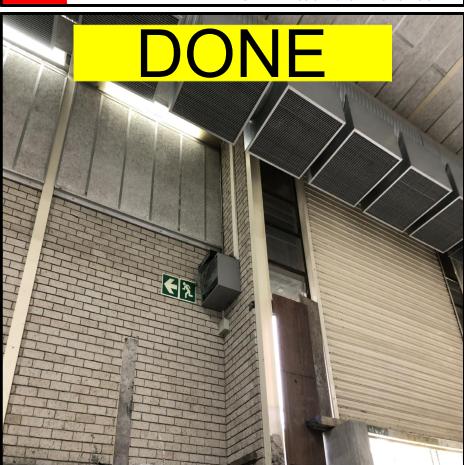
LAN cabine power to be restored from a temporary supply.

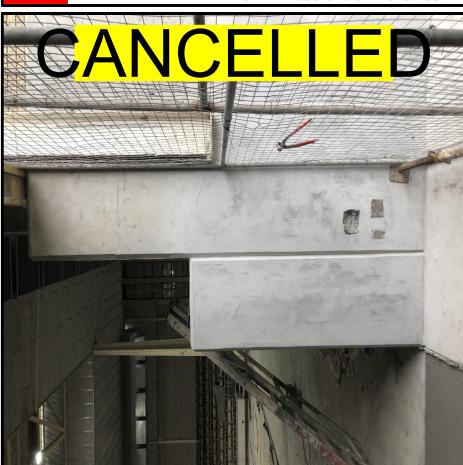
Missing sleeve penetration to power manhole.

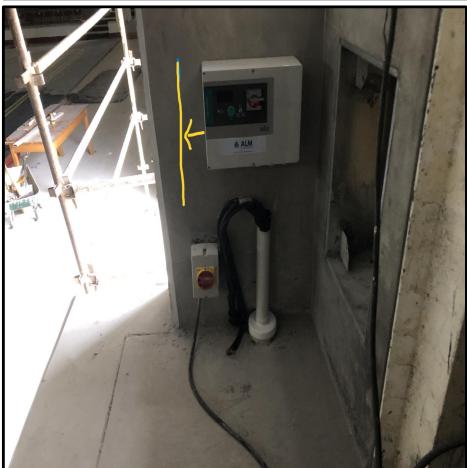
Please shift the sump pump panel to the left to align edge with socket outlet.

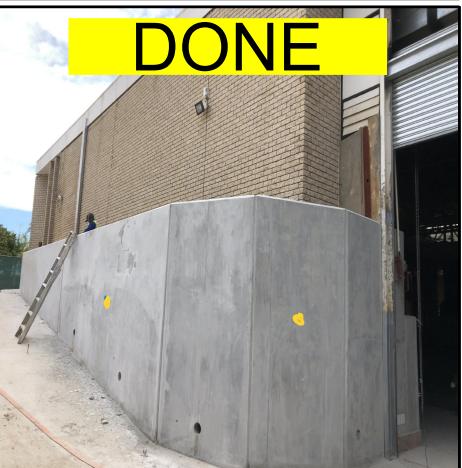
Missing ramp lighting. Points must be at or below grade.

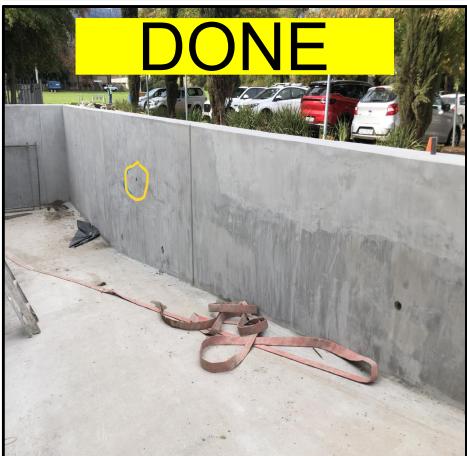
Redundant lighting points to be filled with plaster (no cover plates).

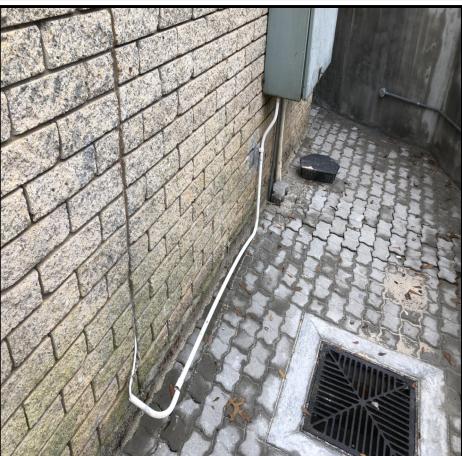
Please fix conduit to wall. Please advise if CI required.

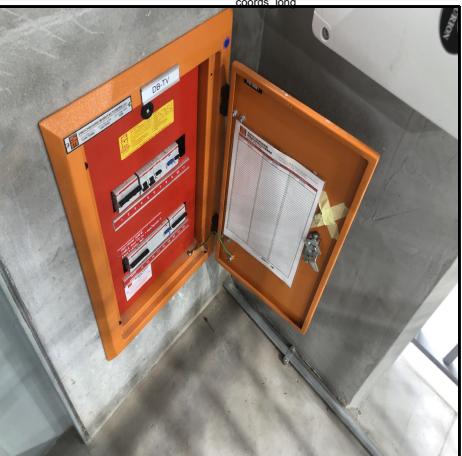
Legend card to be completed in DB-TV.
