A thermosyphon solar water heater system for a hospital laundry.

Background

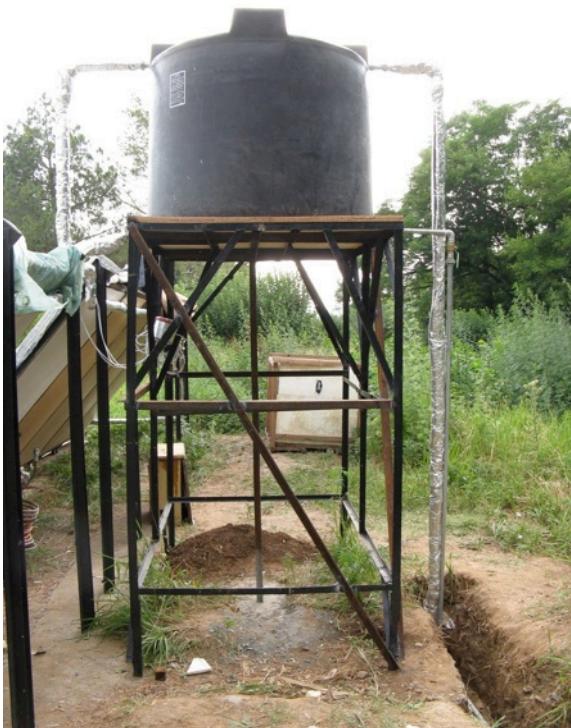
New tank atop reinforced stand.

The tank stand (knocked together from pieces of old angle iron by one of the workshop guys), while strong enough to hold up the 600l tank, demonstrated its inadequacy when we filled up the new 1200l tank. Fortunately we spotted one of the legs beginning to bend in time to avert a complete collapse, and the stand was then beefed up considerably with an extra central support and some proper diagonals made of some nice new chunky angle iron to stop it flexing.

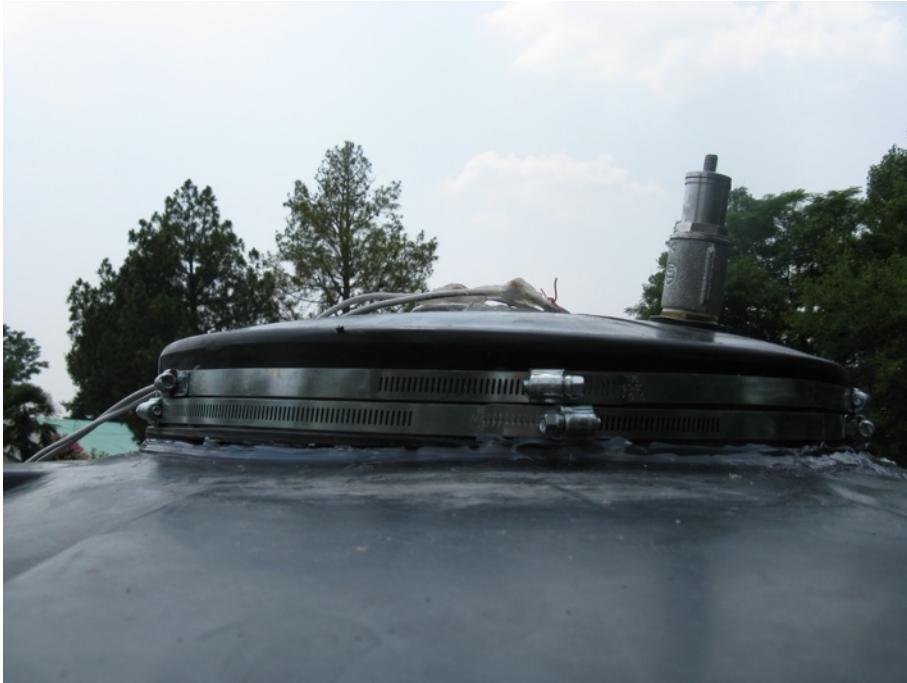
The first attempt at securing the lid was an interesting failure - there were no visible cracks or tears, so I think the pressure in the tank stretched the lid just enough for the teeth of the screw thread to slip over each other - and the top popped off. After re-silicone-ing and adding a bunch of jubilee clips around the top of the lid (with the idea of keeping the screw threads interlocked), the tank seemed to hold okay.

Bulging lid - the rest of the tank is similarly bloated.

However, I really wasn't happy with the way the tank was bulging (it was holding okay, but I had serious doubts about its future longevity). This tank clearly isn't designed for pressures much beyond what it experiences from the weight of the water it contains. At this point we have two options: 1. go back to the heat exchanger/unpressurised tank version; 2. find/buy a metal tank suitable for running under pressure.

Given that we have already obtained the heat exchanger components, option 1 is favoured as a starting point, and after a couple of days' work getting the kinks out of our copper tubes and reinstalling them in the tank, we had it up and running again. If I had a few more weeks here I would see about sourcing a metal tank that we could run under pressure - for now I'll have to leave that to the guys here for a future upgrade.

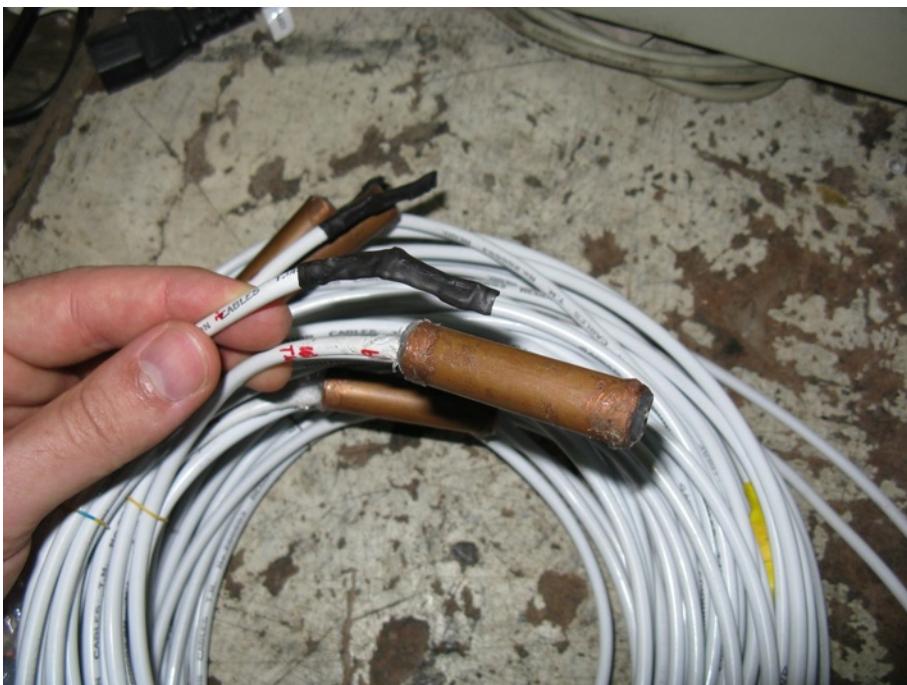
Sensors ('dry' in heat-shrink, 'wet' in copper/silicone).

The day after I mounted my temperature sensors we had a big storm. This would not have been an issue had it occurred after the glazing was in place, but in this case meant that several of the sensors shorted out (I'm down to 12 out of 18 still functioning). I'm still slightly surprised at this, since the sensors were encased in a big blob of silicone - I think the water must have done some amazing capillary action where the wires enter. I also had (more expected) problems with a couple of the sensors inside the tank, particularly when the tank was under pressure.

Waterproof your sensors *really* carefully.
