### NUMERICAL ANALYSIS OF HIGH PRESSURE COLD BEND PIPE TO INVESTIGATE THE BEHAVIOUR OF

### **TENSION SIDE FRACTURE**

# Celal Cakiroglu, Amin Komeili, Samer Adeeb, Roger Cheng, Millan Sen

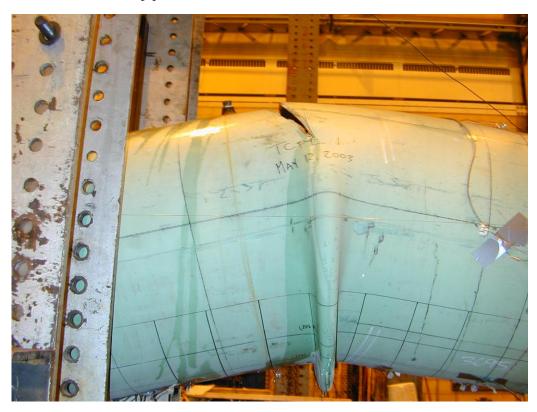
In this paper the behaviour of a cold bend pipe by a combination of internal pressure and bending load has been simulated for the case of a specimen which is demonstrated in Figure 1 that exhibited tension side fracture following compression side buckling in order to obtain a better understanding of this rare but critical phenomenon. This is a type of pipe failure which is rarely considered during design, whereby tensile failure is generally only considered to be at risk at girth weld locations. Also this occurs rarely in the testing of pipes although the loading is realistic and immense energy release takes place during the fracture of a gas pipeline which leads to a sudden loss of the containment capability of the pipe. This energy release could have some harmful effects on the environment. Therefore it is crucial to investigate

Figure 1: Wrinkle and Fracture of the Test Specimen [2]

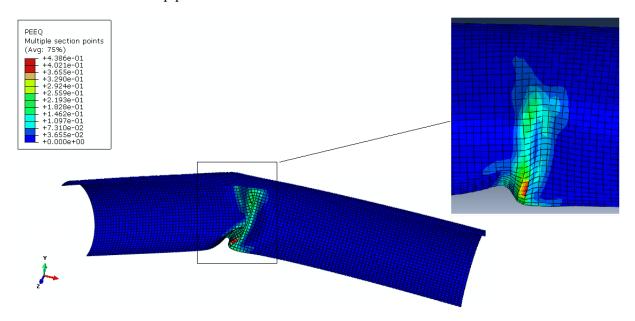
Figure 4 shows the distribution of the plastic strain in the post-buckling range after the displacement controlled loading has been completed. The initiation of buckling on the compression side of the pipe took place almost immediately after the start of the simulation as the load – displacement curve in Figure 6 demonstrates the decreasing stiffness of the pipe during the loading. It is clear from Figure 4 that throughout the post-buckling range no plastic strain can be observed on the tension side of the pipe whereas on the compression side the plastic strain is concentrated at the wrinkle location where the majority of the deformation associated with the loading took place. This observation indicates that the tension side fracture of the cold bend in the experimental studies is mainly caused by the internal pressure. In addition to the plastic strain also the distribution of the von Mises stresses have been visualized for loading without internal pressure in Figure 5. The visualization of the von Mises stress distribution also confirms that the stresses are concentrated at the compression side of the wrinkle location.

Figure 4: Plastic strain distribution under bending load without internal pressure

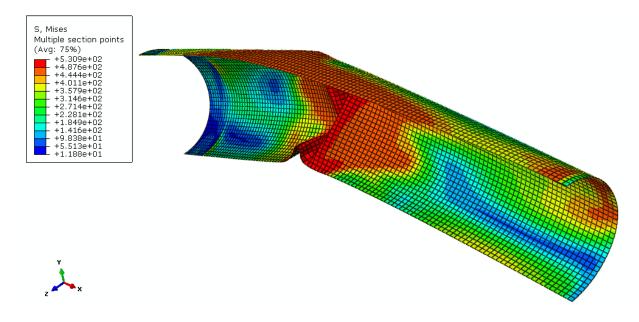
Figure 5: Von Mises stress distribution under bending load without internal pressure

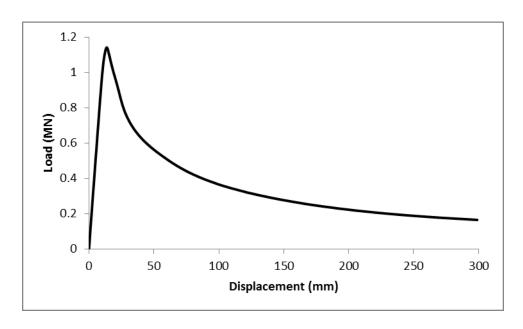
Figure 6: Load - displacement response under bending load without internal pressure

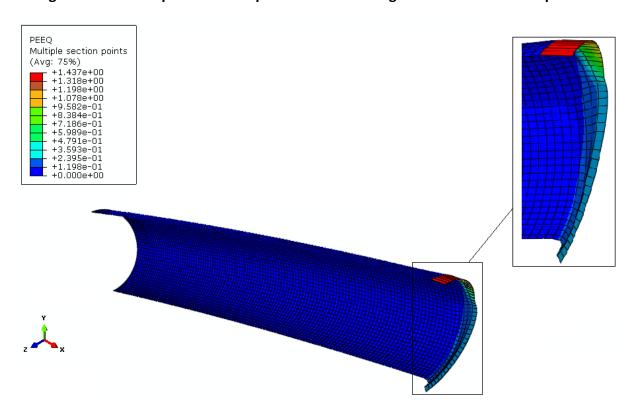
The plastic strain distribution in the case where displacement controlled loading has been applied on the pressurized pipe is demonstrated in Figure 7. It can be clearly observed that plastic strains have been concentrated on the tension side of the pipe at the wrinkle location where they eventually caused the failure of the pipe. The plastic strains started to develop at the compression side of the wrinkle location from the first load increment of the displacement controlled loading. After reaching a level of about 37%,

Figure 7: Plastic strain distribution under bending load and internal pressure

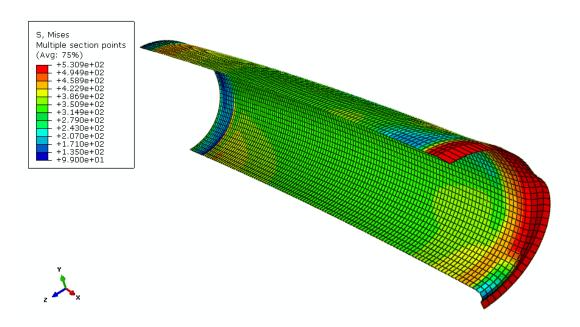
no considerable increase of the plastic strain at the compression side has been observed during the entire simulation whereas the plastic strain at the tension side continued to increase until the failure on the tension side. Figure 8 shows the von Mises stress distribution for the case of combined loading with internal pressure. The magnitude of the stresses and the distorted element shapes on the tension side indicates the failure of the pipe on the tension side.

Figure 8: Von Mises stress distribution under bending load and internal pressure

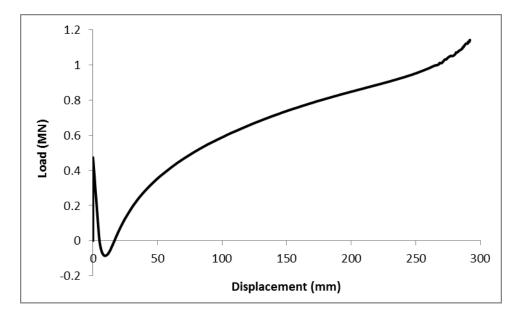
Figure 9: Load - displacement response under bending load and internal pressure

The load-displacement curve in Figure 9 shows that immediately after the initiation of buckling the first stiffness decrease takes place and the reaction forces assume negative values which is a consequence of the applied internal pressure.

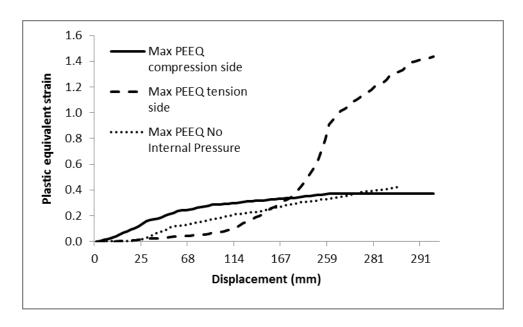
Figure 10: Comparison of maximum equivalent plastic strain curves

Figure 10 demonstrates a comparison of the maximum equivalent plastic strains at the compression and tension sides of the cold bend under bending load with internal pressure as well as the maximum equivalent plastic strain under bending load without internal pressure. Figure 10 shows that for the load case with internal pressure, after 74% of the displacement loading has been applied the plastic strain on the compression side stays constant throughout the remaining load increments whereas the plastic strain on the tension side continues to increase. The investigation of the plastic strain in case of loading without internal pressure shows that the curve of maximum plastic strain variation for this case has a development similar to the curve for compression side maximum plastic strain in case of loading with internal pressure.

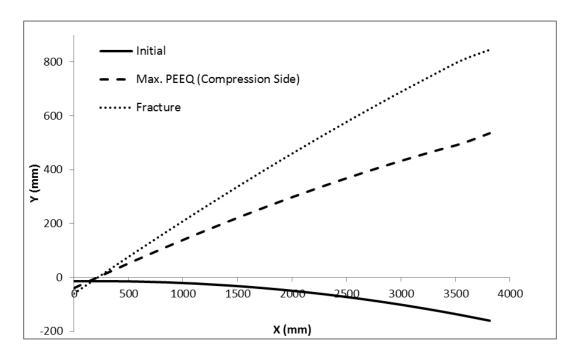
Figure 11: Variation of the displacements in the longitudinal direction
