# AI-Assisted Electrical Installation Inspector

Upload a site photograph or video walkthrough to receive a preliminary compliance assessment under SS 638: Code of Practice for Electrical Installations.

# Electrical Installation Inspection — SS 638 Preliminary Assessment

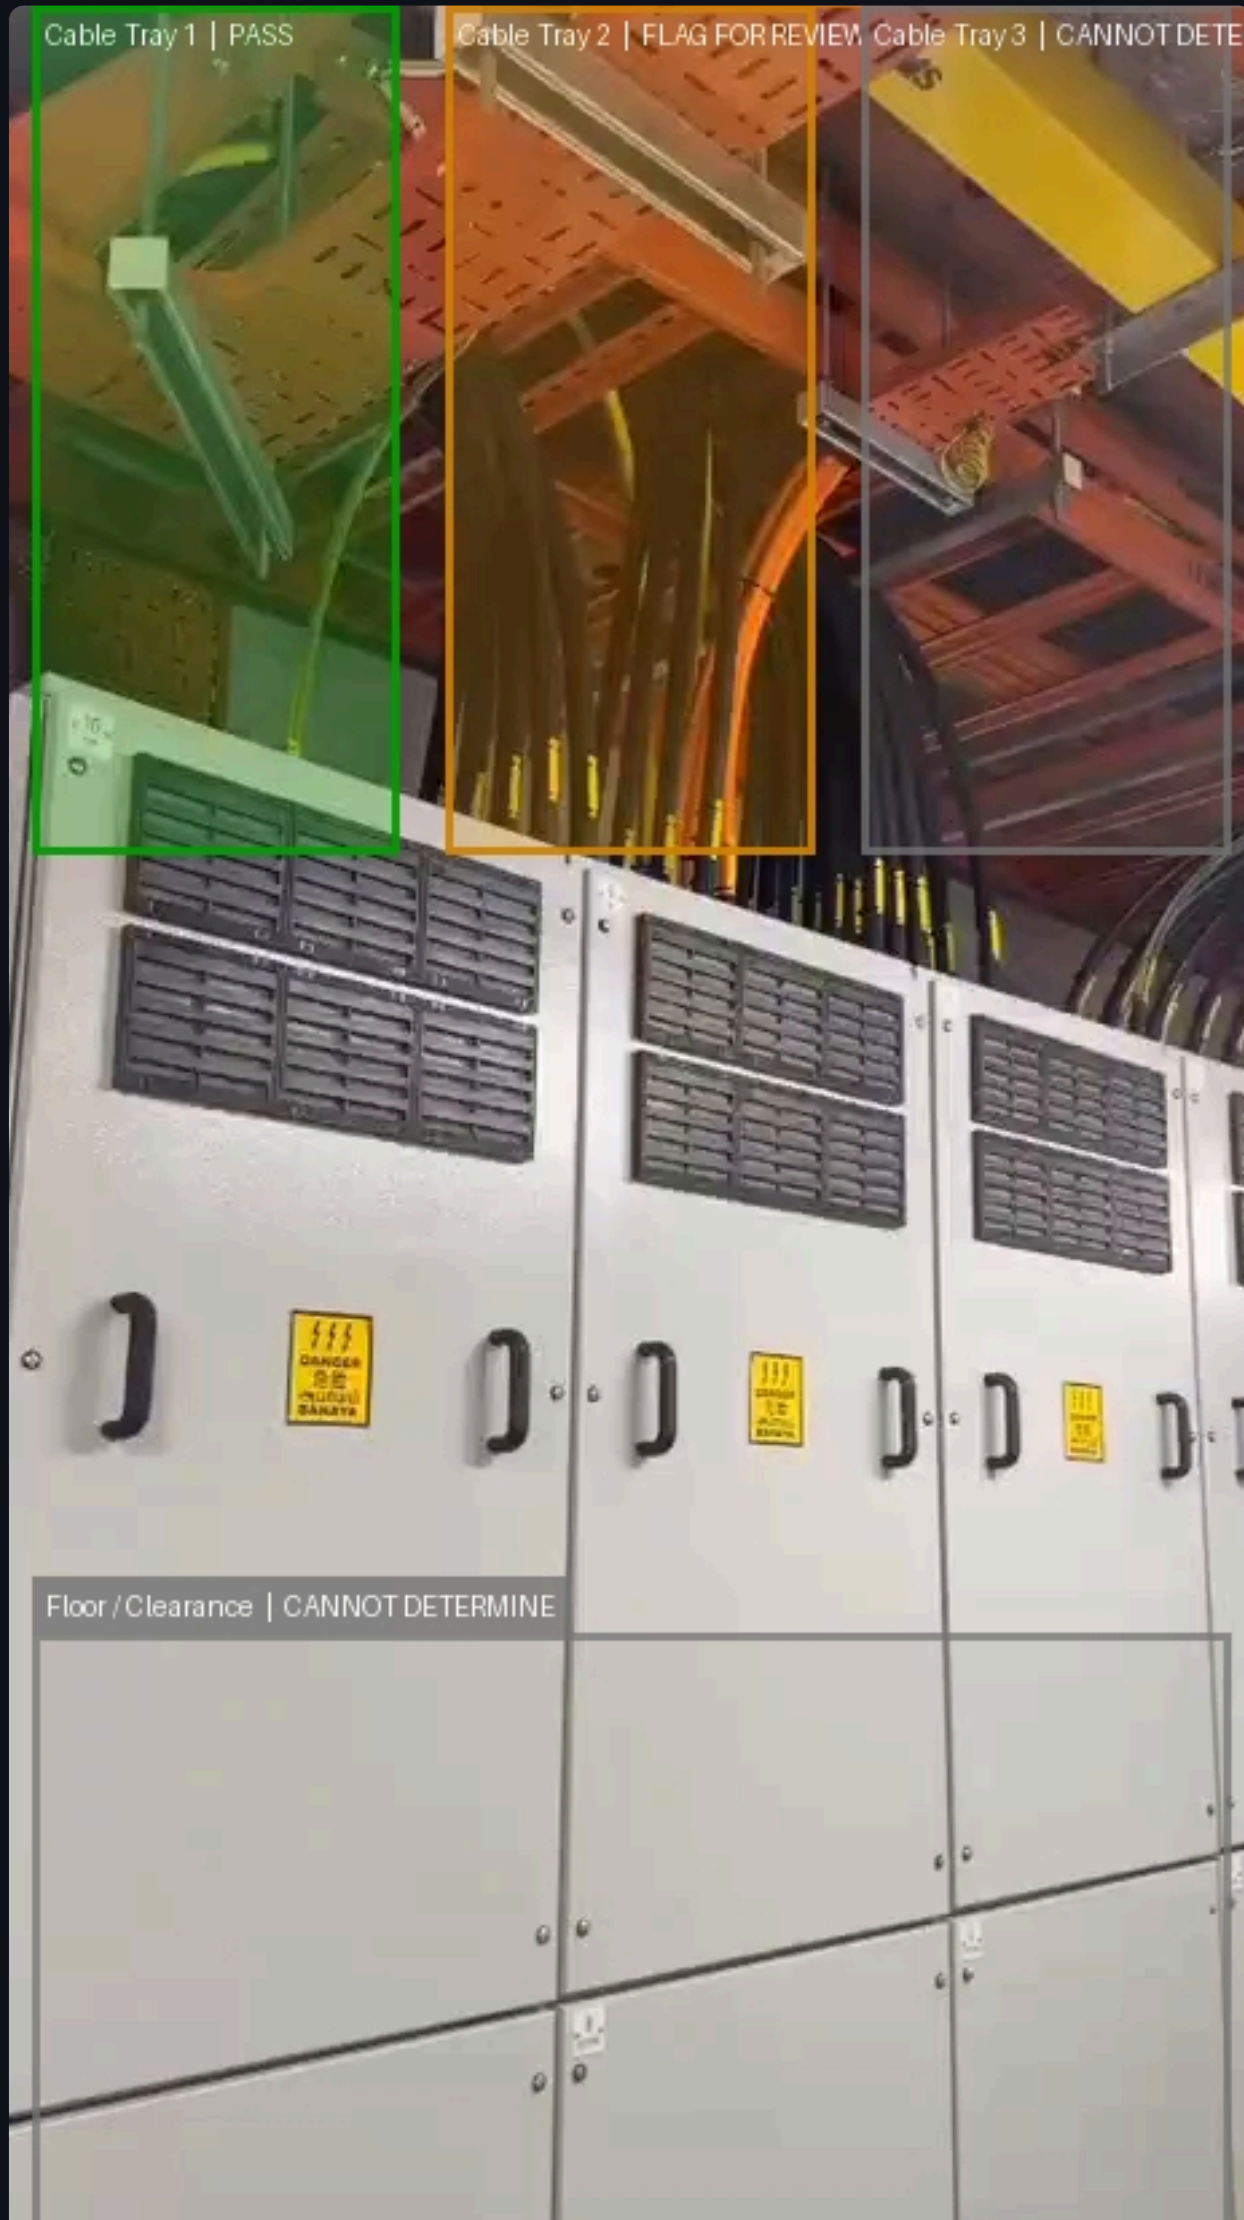
Frame 1 | t=0.0s | Result: FLAG FOR REVIEW

**Cable Tray 1 (upper orange perforated tray, top-left/horizontal):** Fill level appears low to moderate — well under 40%. No visible crushing or deformation. No green-and-yellow earth conductor clearly visible. Condition: PASS. Earth continuity: CANNOT DETERMINE.

**Cable Tray 2 (orange tray carrying the cable bundle into the switchboard):** This tray feeds a dense black/orange cable bundle into the cubicles. Fill in the visible cross-section appears to approach or potentially exceed 40% where cables converge — **FLAG FOR REVIEW**. No clear deformation visible. No distinct green-and-yellow earth conductor visible among the descending bundle. Earth continuity: CANNOT DETERMINE.

**Cable Tray 3 (rear/secondary orange tray, partially obscured):** Largely hidden behind the cable drop and structural beams. Fill, condition, and earthing: **CANNOT DETERMINE** — insufficient view.

**NO** — no loose cables are visible lying on the floor in this image.

The cable drop into the switchboard shows a dense bundle where fill may approach or exceed the 40% threshold, and no earth continuity conductor (green-and-yellow) is clearly identifiable in any run, warranting verification on site. Tray condition appears acceptable where visible, but several runs are obscured and key compliance items (earthing, accurate fill) cannot be confirmed from this single photograph.

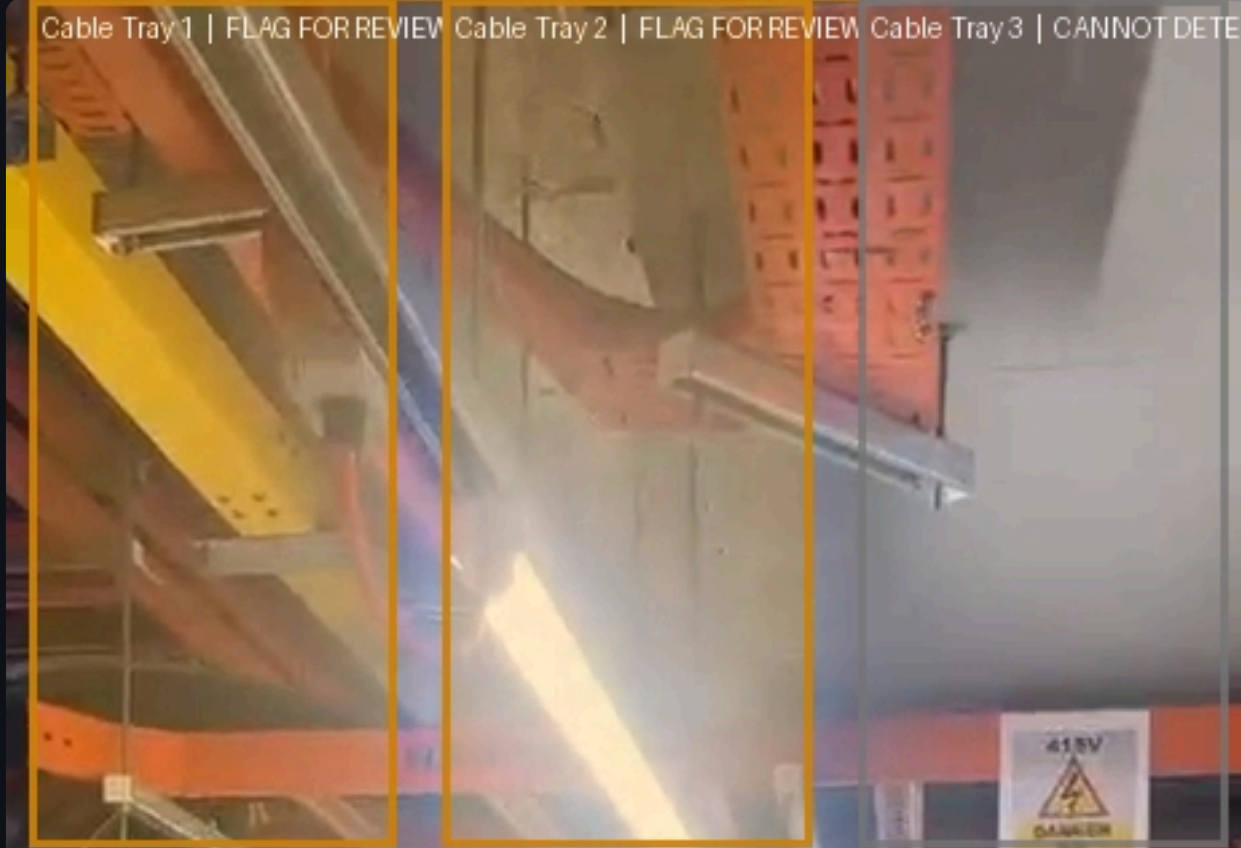
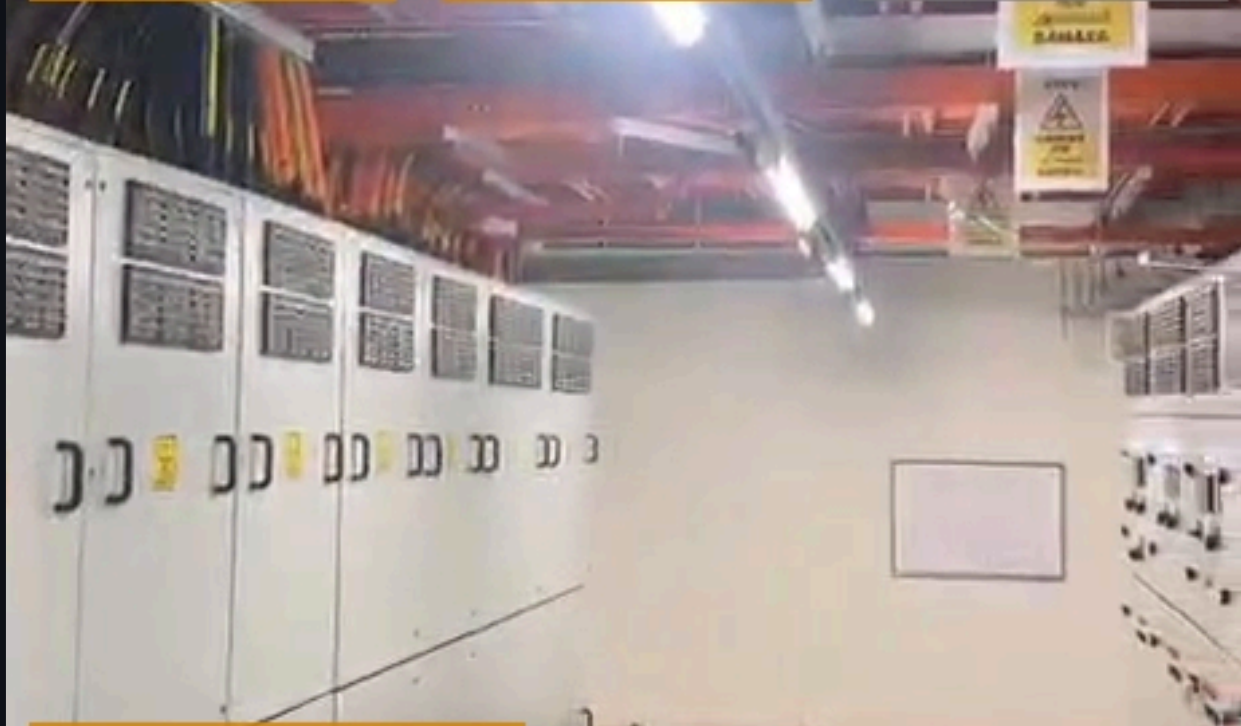
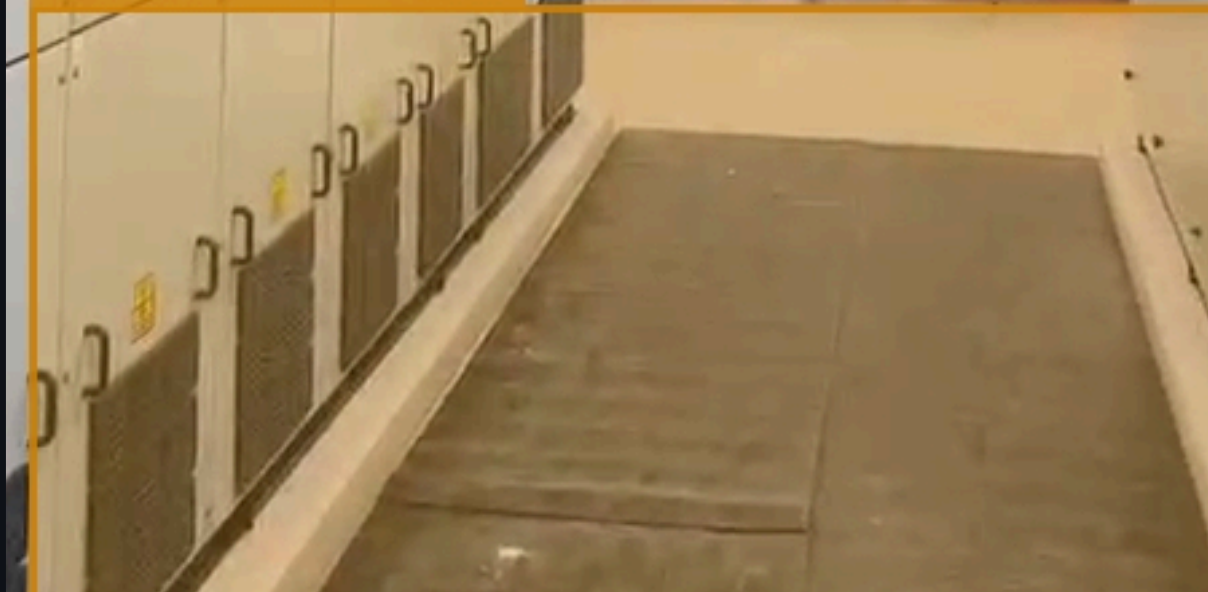
- Fill level:** The cables appear densely bundled and tightly packed in this run. Fill may approach or exceed the ~40% threshold, but the tray cross-section and depth are not clearly visible to confirm. → **FLAG FOR REVIEW**
- Tray condition:** No visible crushing, cracking, or deformation in the visible section. → **PASS**
- Earth continuity conductor:** No green-and-yellow conductor clearly distinguishable among the dark cables due to lighting glare and distance. → **CANNOT DETERMINE**

- Verdict: FLAG FOR REVIEW

- Fill level: Tray appears lightly loaded or partially empty in the visible portion. → PASS
- Tray condition: No visible deformation; perforated tray structure intact. → PASS
- Earth continuity conductor: Not clearly visible; backlit by the luminaire glare. → CANNOT DETERMINE
- Verdict: FLAG FOR REVIEW (earthing cannot be confirmed)

- Fill level: Cannot assess — partially obscured by signage, distance, and lighting glare. → CANNOT DETERMINE
- Tray condition: No obvious damage visible, but resolution is insufficient for confidence. → CANNOT DETERMINE
- Earth continuity conductor: Not visible. → CANNOT DETERMINE
- Verdict: CANNOT DETERMINE

- Floor cables: NO loose cables visible on floor — the floor area appears clear in the foreground.
- Overall: FLAG FOR REVIEW
- Summary: Several overhead cable trays are visible but lighting glare, viewing angle, and distance prevent confirmation of earth continuity conductors and exact fill levels across all runs. Tray 1's dense cable bundle and the inability to verify protective earthing on multiple runs require on-site verification before any pass can be issued.

*Note: This is a preliminary visual assessment only. Earth continuity, fill percentages, and tray condition should be physically verified on-site, as photographic limitations (glare, angle, resolution) prevent definitive compliance verdicts for most items here.*

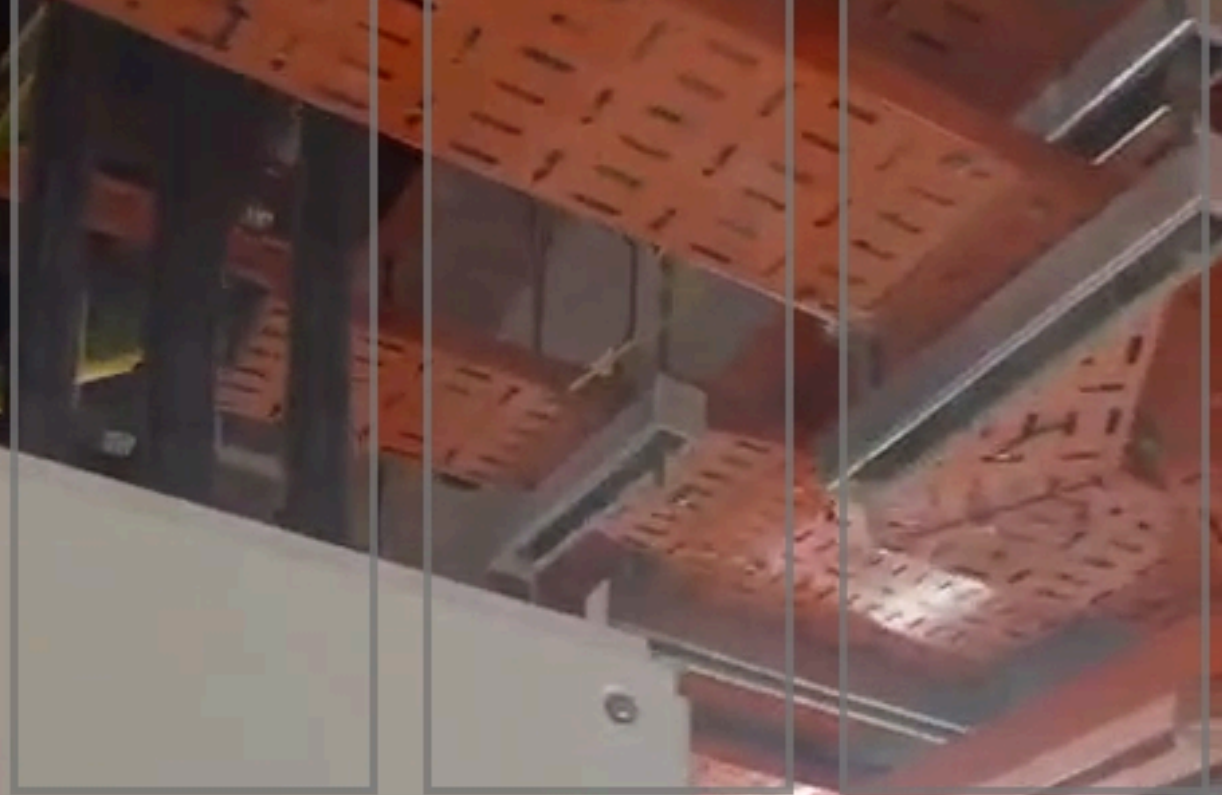
▼ Frame 3 | t=10.0s | Result: FAIL

- Fill level — No cables clearly visible within the tray. CANNOT DETERMINE.
- Tray condition — No obvious crushing or cracking visible, but resolution and angle are poor. CANNOT DETERMINE.

3. Earth continuity conductor — No green-and-yellow conductor visible. CANNOT DETERMINE.

1. Fill level — No cable bundle resolvable; tray appears empty or out of focus. CANNOT DETERMINE.
2. Tray condition — No deformation visible from this angle. CANNOT DETERMINE.
3. Earth continuity conductor — Not visible. CANNOT DETERMINE.

1. Fill level — These appear to be structural beams or support brackets rather than populated trays; no cables visible. CANNOT DETERMINE.
2. Tray condition — No visible damage. CANNOT DETERMINE.
3. Earth continuity conductor — Not visible. CANNOT DETERMINE.

- **Floor cables:** NO loose cables visible on floor (floor area is largely obscured by the partition/panel; cannot confirm clear floor either).
- **Overall: CANNOT DETERMINE**
- **Summary:** The image shows overhead orange perforated tray/support steelwork but no clearly resolvable cabling, fill level, earth bonding conductors, or damage, so no compliance verdict can be issued. A re-inspection with proper lighting, closer/level camera angles, and unobstructed views of each tray run is required before any PASS/FAIL determination under SS 638.

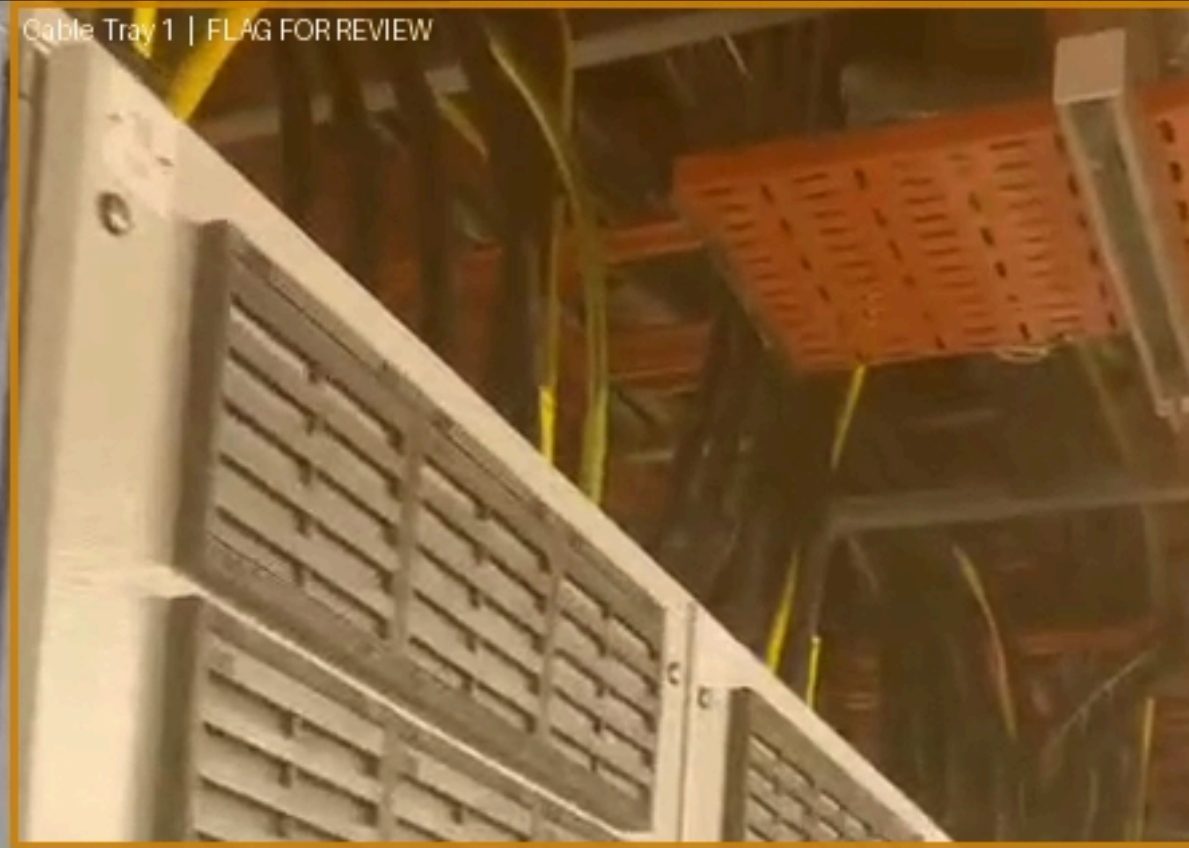
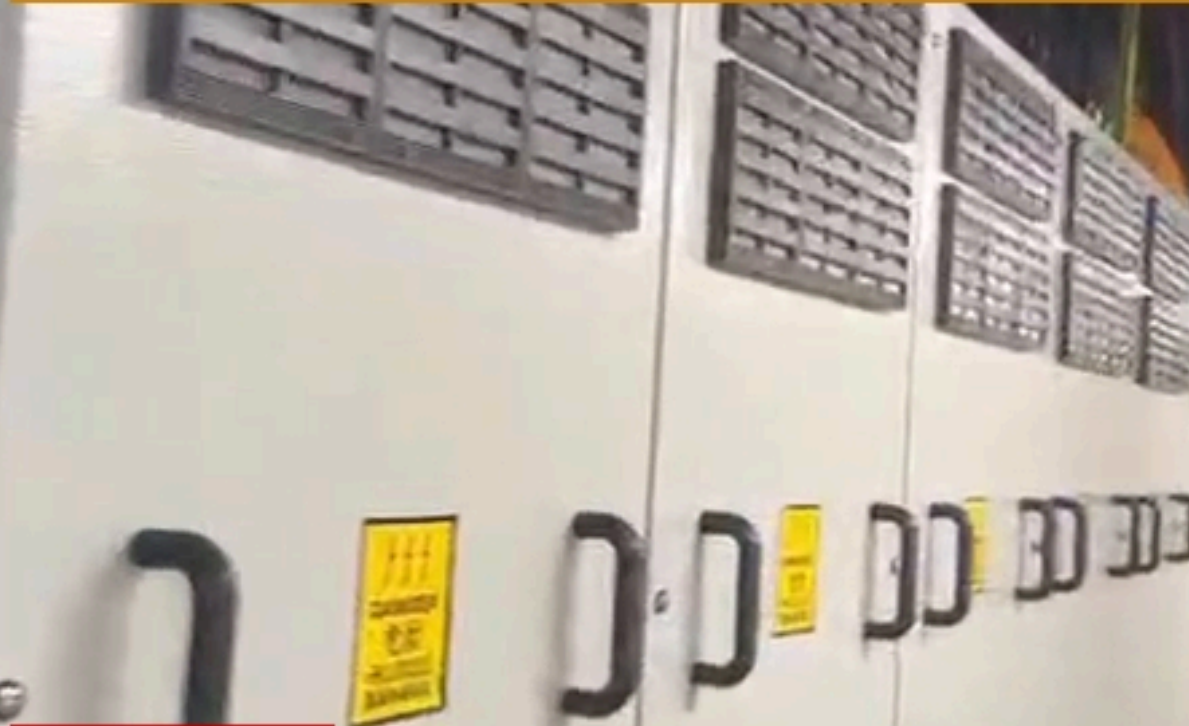
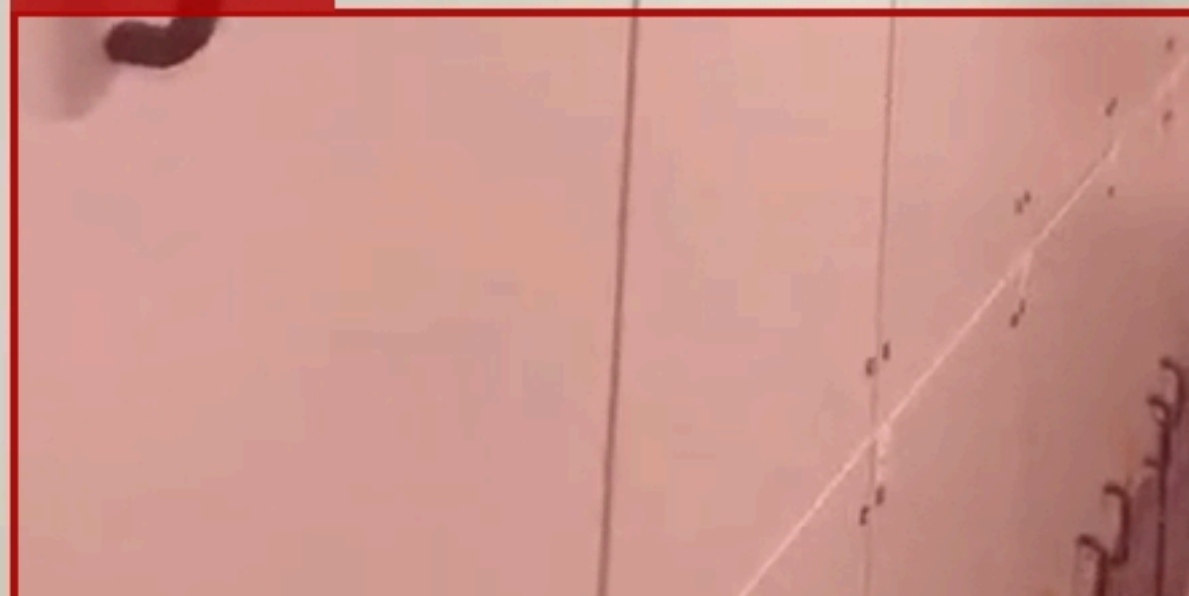
▼ Frame 4 | t=15.0s | Result: FLAG FOR REVIEW

- Fill level** — The visible yellow cable bundle appears to occupy a significant portion of the tray, but the tray's full cross-sectional depth and the complete cable arrangement are obscured by viewing angle and lighting. **CANNOT DETERMINE.**
- Tray condition** — No obvious crushing, cracking, or deformation is visible in the portions shown, but much of the run is poorly lit and partially out of frame. **CANNOT DETERMINE** (insufficient clear view to confirm sound condition along the full run).
- Earth continuity conductor** — No green-and-yellow earth conductor is clearly distinguishable among the cable bundle. The cables visible appear predominantly yellow; I cannot confirm presence or absence of a dedicated G/Y CPC. **CANNOT DETERMINE.**

**Verdict: FLAG FOR REVIEW** — earth continuity cannot be verified and tray condition/fill require closer physical inspection.

- **Floor cables:** NO loose cables on floor visible (floor is not in frame).
- **Overall:** FLAG FOR REVIEW
- **Summary:** Only one overhead cable tray is clearly identifiable, and key compliance items — fill percentage, full tray condition, and presence of a green-and-yellow earth continuity conductor — cannot be reliably confirmed from this single angle and lighting condition. A closer on-site inspection with better illumination and access to the full tray run is required before any pass/fail determination can be made.

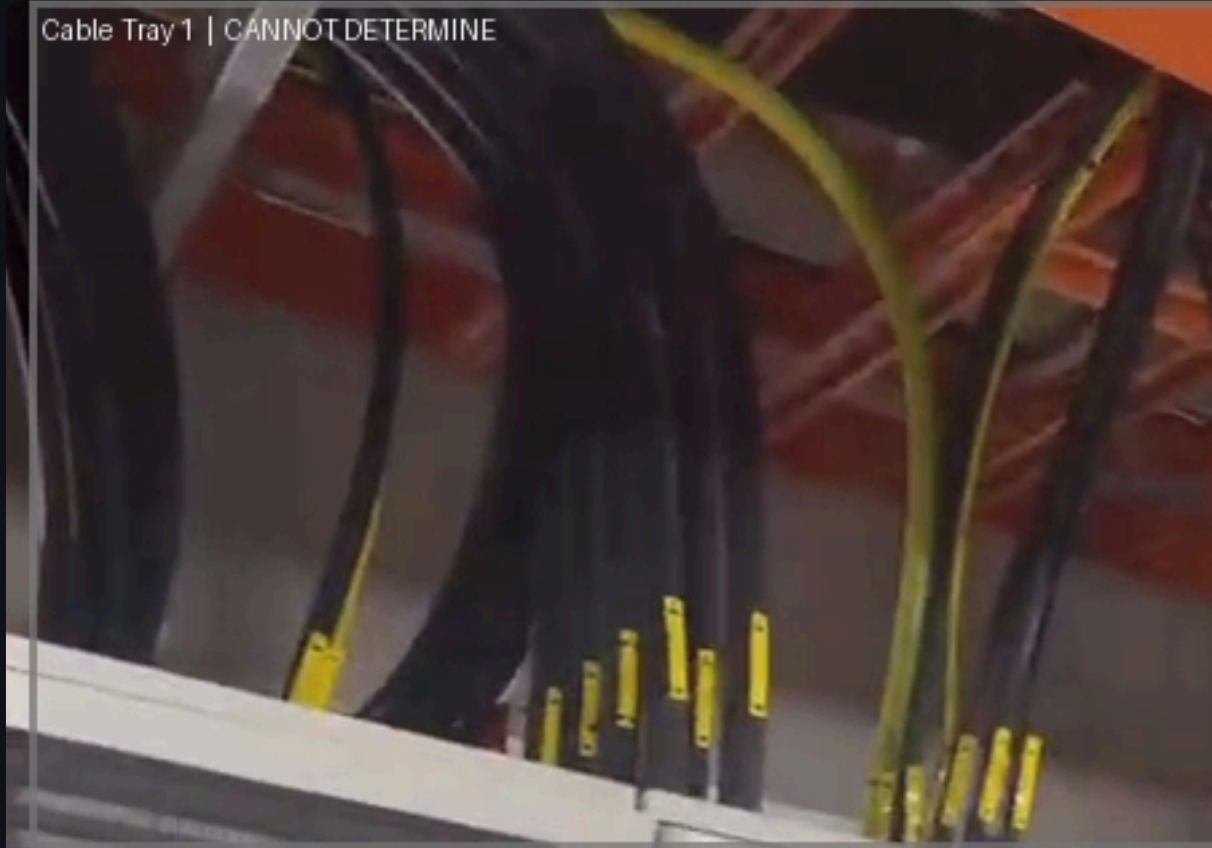
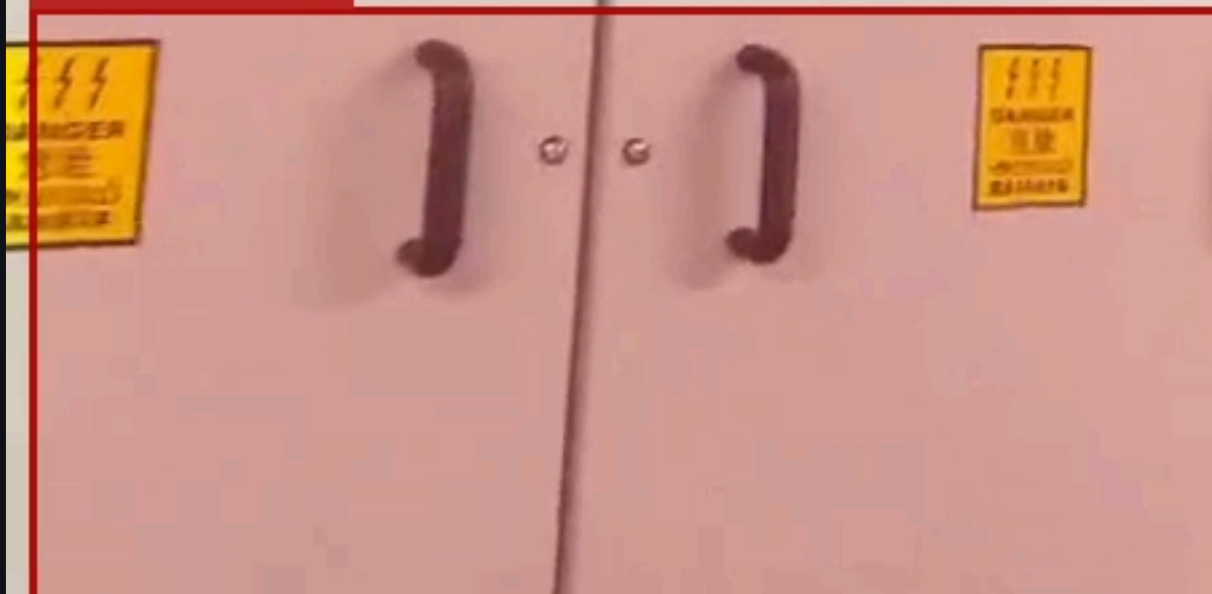
▼ Frame 5 | t=19.9s | Result: FAIL

I can see cabling entering the tops of electrical distribution cabinets/panels. However, I must note that **no actual cable tray or trunking structure is clearly visible** in this image. The cables (black conductors and green-and-yellow conductors) are seen emerging from the ceiling area and routing into the cabinet tops, but the supporting tray/trunking infrastructure itself is obscured by the cabinets and the upper framing.

- Fill level** — CANNOT DETERMINE. No tray cross-section is visible to assess the ~40% fill threshold.
- Tray condition** — CANNOT DETERMINE. No tray surface, side rail, or rung is clearly visible to inspect for crushing, cracking, or deformation.
- Earth continuity conductor** — FLAG FOR REVIEW. Multiple green-and-yellow conductors ARE visible running alongside the black live conductors entering the cabinets. Their presence is positive, but proper bonding/termination cannot be confirmed from this view.

- The orange/red structure at the top is likely structural framing or busbar support, not a cable tray.
- Green-and-yellow earthing conductors are present, which is a positive indicator.
- Cable entry into the cabinets appears generally orderly.

- 
- **Floor cables:** NO — no loose cables visible on the floor in this frame.
  - **Overall: CANNOT DETERMINE**
  - **Summary:** No cable tray or trunking structure is sufficiently visible in this image to assess fill level or physical condition against SS 638 requirements. Green-and-yellow earth conductors are present alongside the live conductors, which is encouraging, but a clearer view of the tray runs and conductor terminations is required before any pass/fail verdict can be issued.

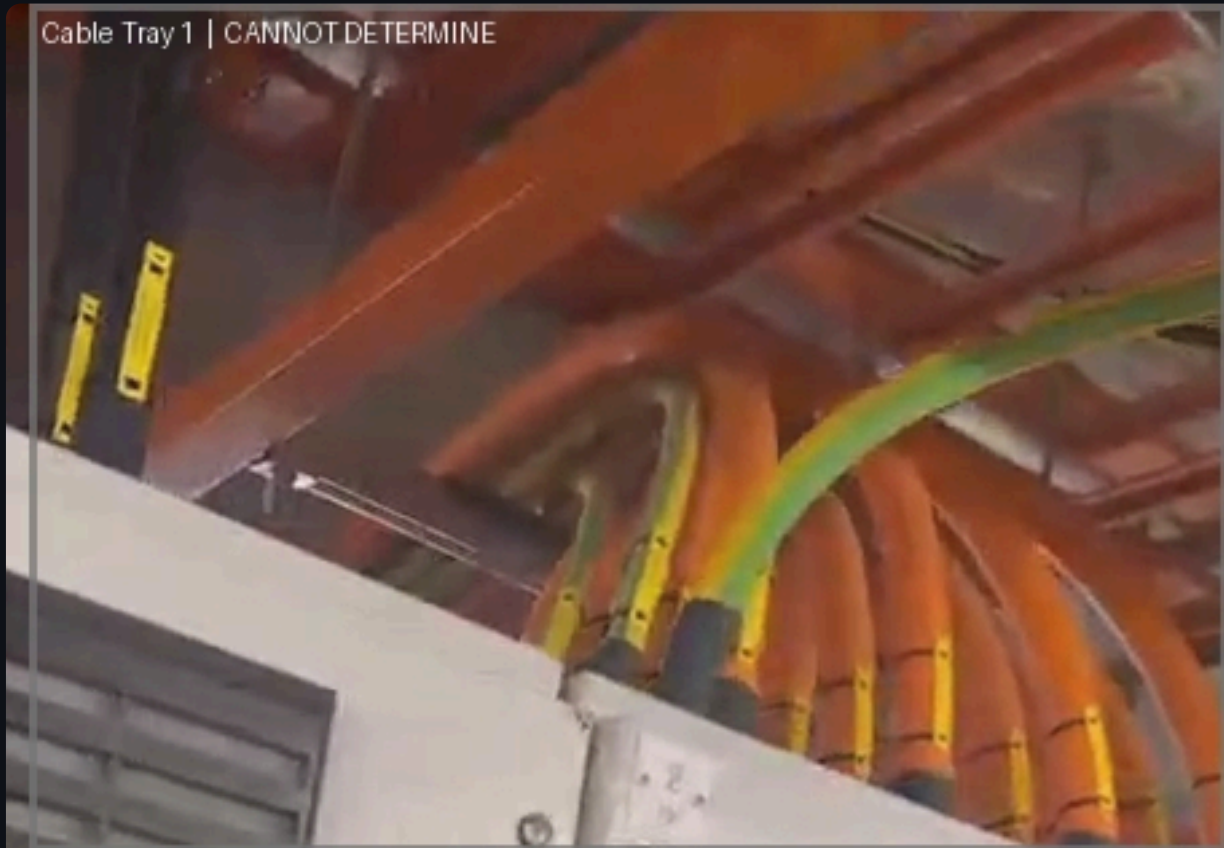
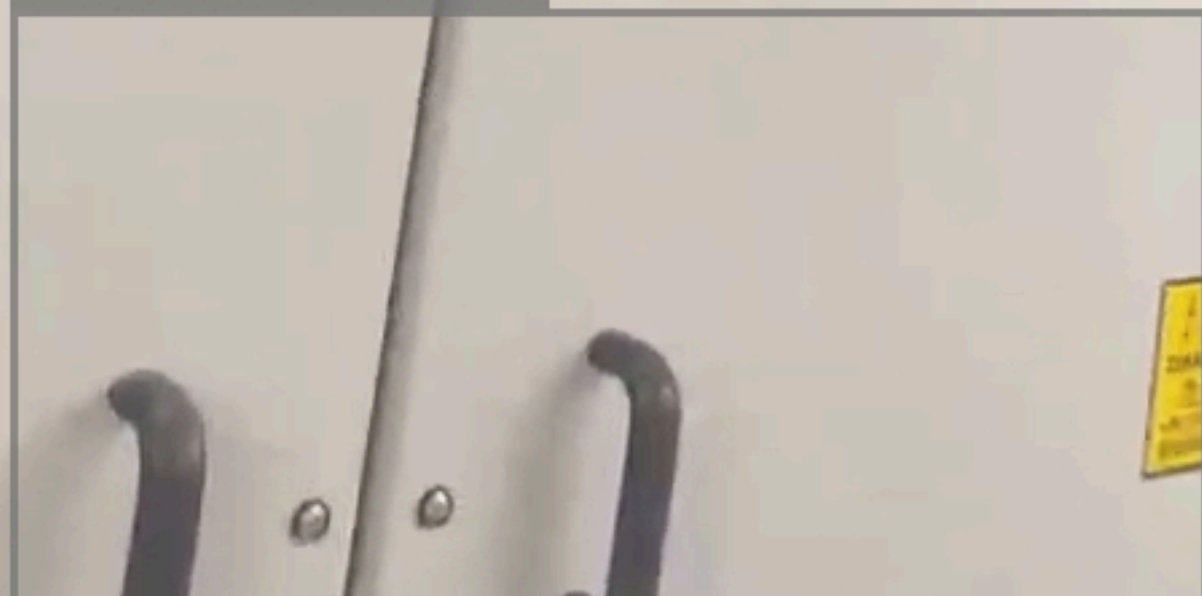
▼ Frame 6 | t=24.9s | Result: FLAG FOR REVIEW

The image shows what appears to be a ceiling/overhead run of conduits and cables above an electrical enclosure/switchgear cabinet. I do **not** see a conventional ladder-type or perforated cable tray in this image. What is visible is a bundle of orange conduits (likely uPVC or HDPE ducting) curving overhead, with no clearly defined tray structure. I will assess what is genuinely visible and avoid guessing.

- Fill level:** CANNOT DETERMINE. These are individual orange conduits, not an open tray with a measurable cross-sectional fill. No tray cross-section is visible to assess a 40% threshold.
- Tray condition:** CANNOT DETERMINE. No tray structure visible; the conduits themselves are not clearly deformed, but no supporting tray is in view to inspect for crushing/cracking.
- Earth continuity conductor:** FLAG FOR REVIEW. A green-and-yellow conductor IS visible running across/alongside the orange conduits in the upper portion of the image. Its termination, bonding to the enclosure, and continuity cannot be confirmed from this view.
- Verdict:** CANNOT DETERMINE (for tray-specific criteria); earth conductor presence noted positively but bonding unverified.

**Summary:** No standard cable tray is clearly visible in this image — only overhead orange conduits and an enclosure face — so fill level and tray condition cannot be properly assessed under IEC 61537 / SS 638 Clause 522.6.1. A green-and-yellow earth conductor is visible among the conduits, which is positive, but its continuity and bonding require physical verification and a clearer photograph of the full tray/trunking run and cabinet interior.

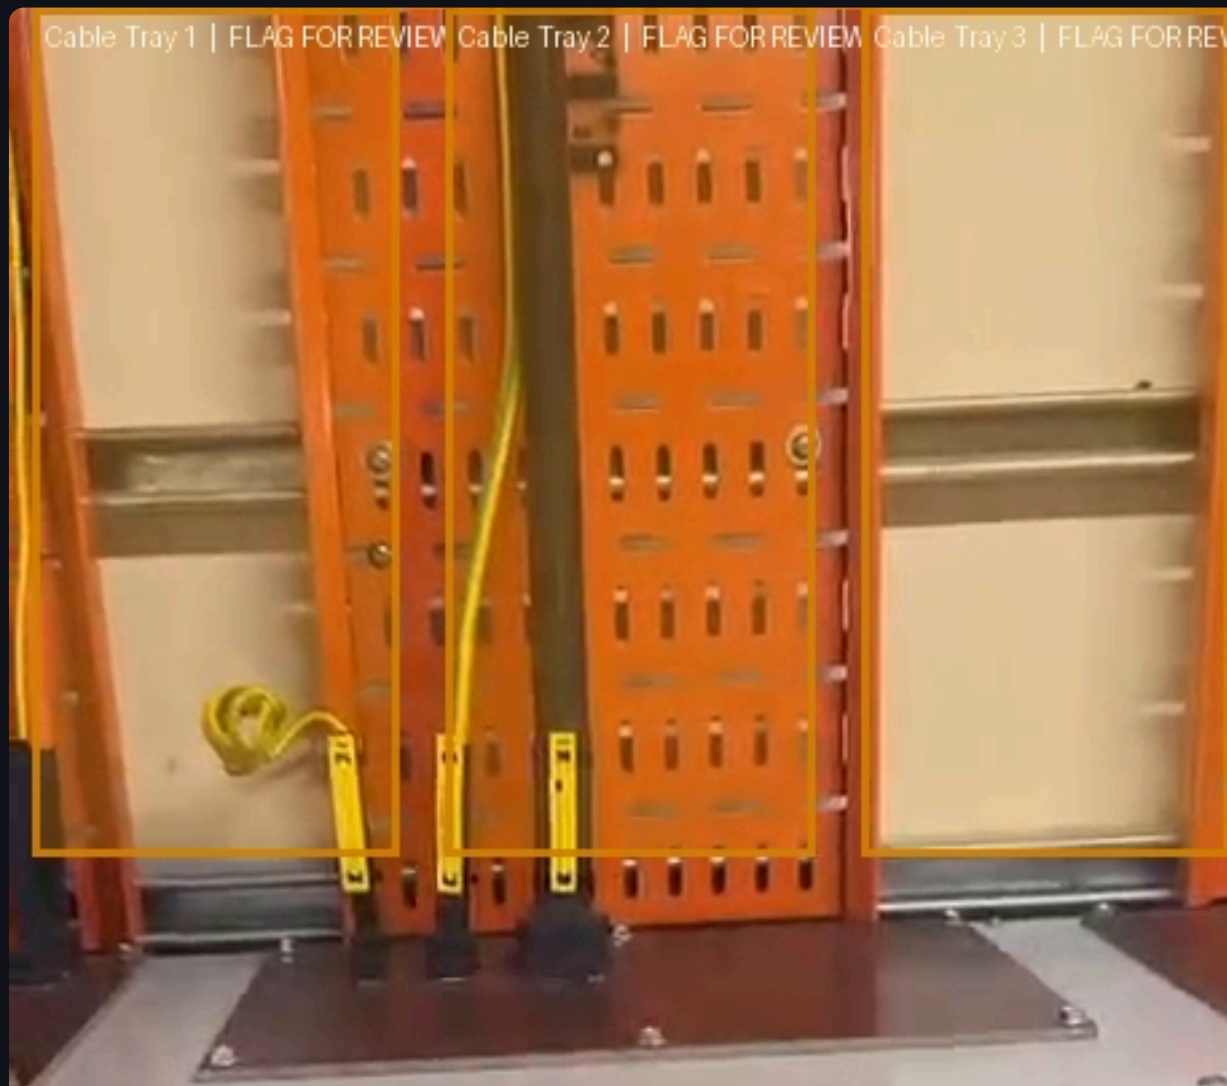
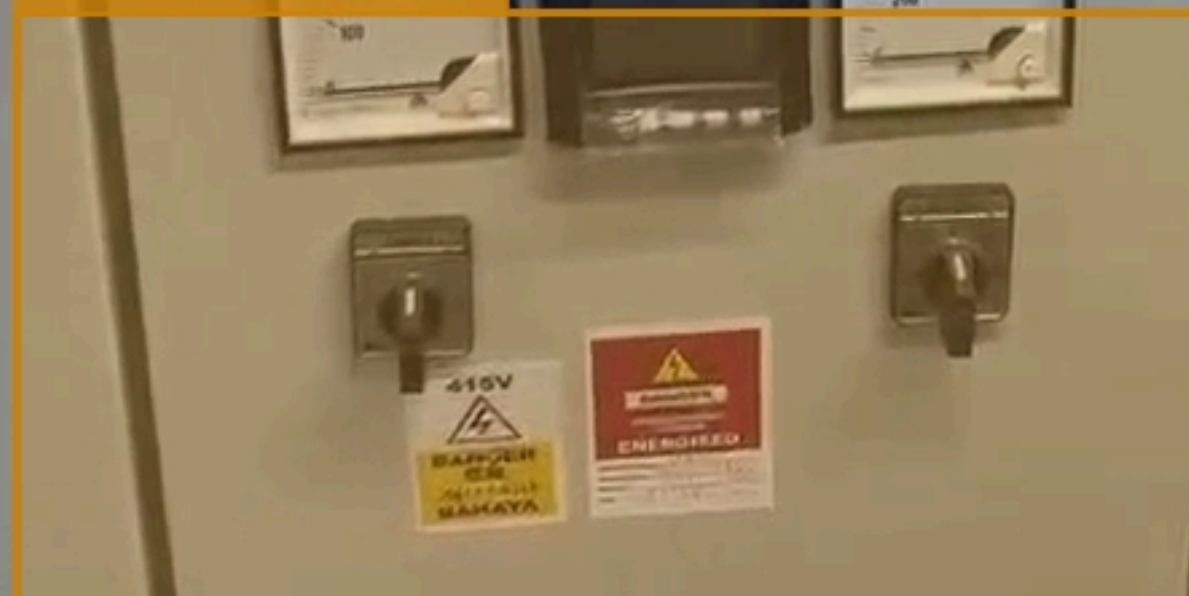
- Fill level: CANNOT DETERMINE — the conductor bundle is partially obscured behind the perforated barrier; cross-sectional fill not measurable from this angle.

- Condition: No visible crushing or deformation. PASS on visible condition.
- Earth continuity: Green-and-yellow conductor IS visible. PASS on earth visibility.
- **Verdict: FLAG FOR REVIEW** (fill not determinable)

- Fill level: CANNOT DETERMINE — obscured by barrier panel.
- Condition: No visible damage. PASS on visible condition.
- Earth continuity: Green-and-yellow conductor IS visible (yellow conductor loops prominently). PASS.
- **Verdict: FLAG FOR REVIEW** (fill not determinable)

- Fill level: CANNOT DETERMINE.
- Condition: No visible damage. PASS on visible condition.
- Earth continuity: CANNOT DETERMINE — green/yellow not clearly distinguishable in this channel.
- **Verdict: FLAG FOR REVIEW**

**Summary:** The image depicts a switchboard riser arrangement rather than open horizontal cable trays, and the perforated segregation barriers obscure conductor cross-sections so that fill levels cannot be reliably verified against the ~40% IEC 61537 threshold. Earth continuity (green-and-yellow) is visibly present in at least two channels and no physical tray damage or loose floor cables are evident, but on-site close inspection with the barriers removed is required to confirm fill and full earth continuity.

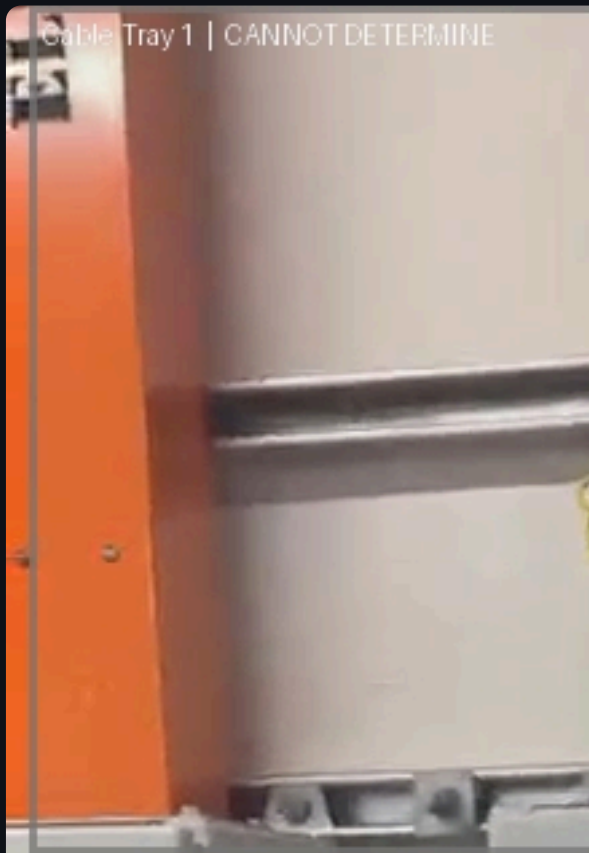
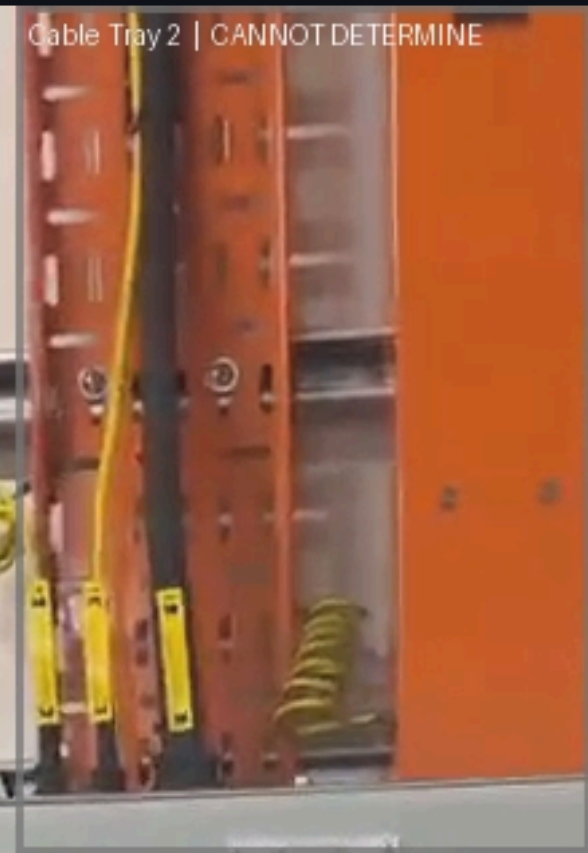
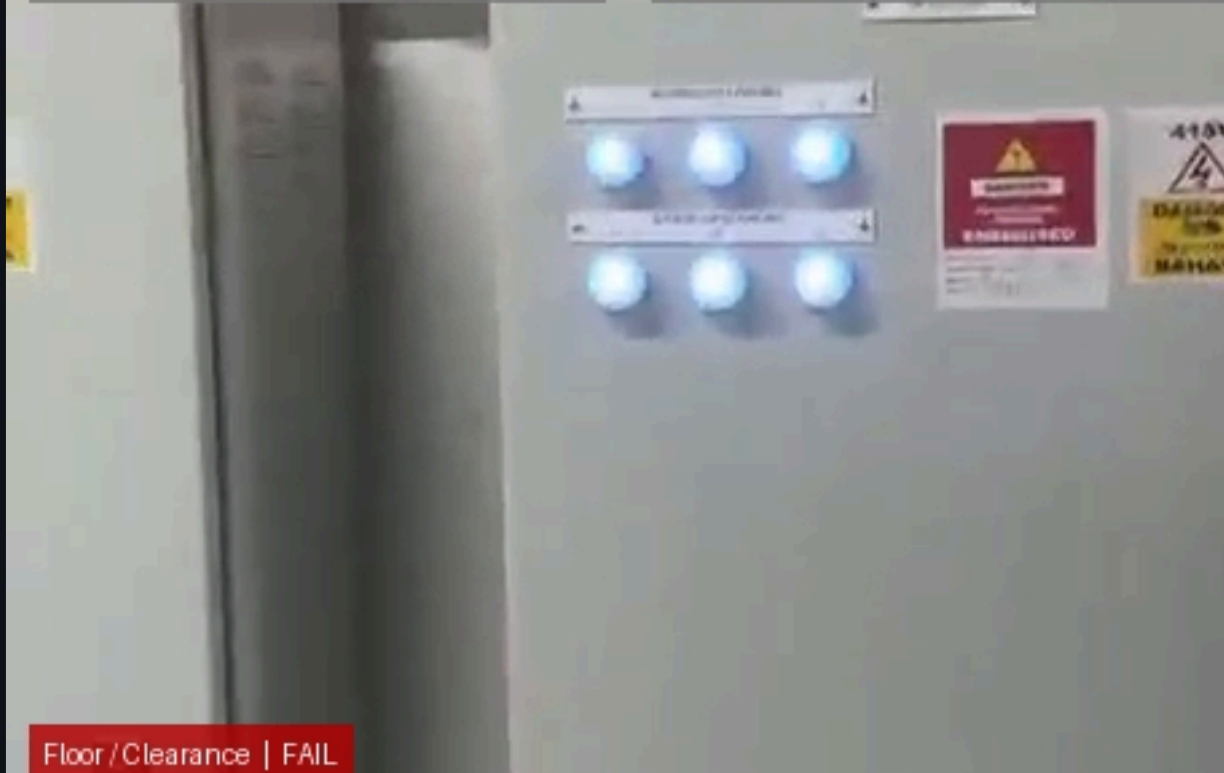
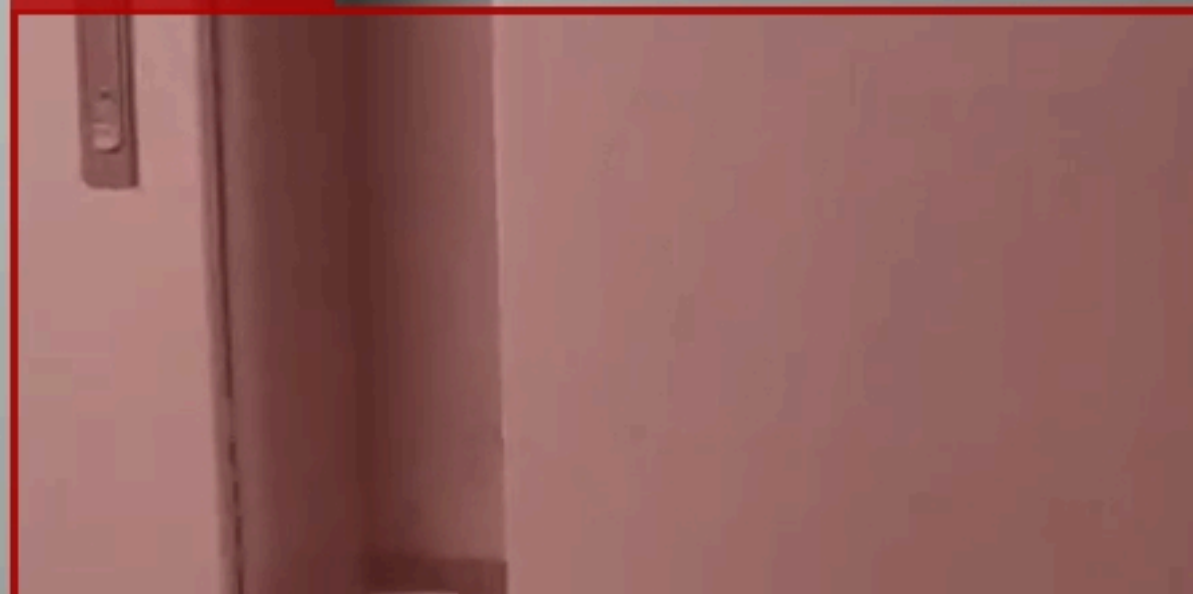
- Fill level: CANNOT DETERMINE — the cross-section is partially obscured and viewed at an angle; actual fill percentage is not reliably visible.
- Condition: No obvious crushing or cracking visible, but view is partial. CANNOT DETERMINE fully.
- Earth continuity: A yellow conductor is visible, but I cannot confirm green-and-yellow striping (earth) versus a plain yellow cable. CANNOT DETERMINE.
- Verdict: CANNOT DETERMINE

- Fill level: Appears lightly populated, but the run continues out of frame. CANNOT DETERMINE.
- Condition: No visible deformation, but partial view.
- Earth continuity: Yellow cable(s) visible; green-and-yellow striping not clearly confirmable. A coiled yellow conductor is present but its function is unclear.
- Verdict: CANNOT DETERMINE

- The lower portion shows **grey switchgear/distribution panels** with illuminated blue indicator lamps, an "ENERGISED" warning label, and a 415V hazard label — these are panel enclosures, not cable trays, so fill/earth criteria do not apply.
- The energised warning suggests **live equipment** — inspection should observe safe-distance/permit-to-work controls.

- **Floor cables:** NO — no loose cables are visible lying on the floor in this frame.
- **Overall:** CANNOT DETERMINE
- **Summary:** The visible cable support channels are seen only partially and at an angle, preventing reliable assessment of fill level, mechanical condition, and earth-continuity conductor identification. A closer, unobstructed inspection of each tray run — with confirmation of green-and-yellow earth bonding — is required before any PASS/FAIL verdict can be issued, and live-equipment safety controls should be verified given the energised panel label.
